Cyfarthfa Coke Works (The Old Thorn Lighting Works) Merthyr Tydfil

Excavation report and analysis

October 2017

GGAT report no. 2017/051
Project no. P1844
National Grid Reference:
SO 03708 06785

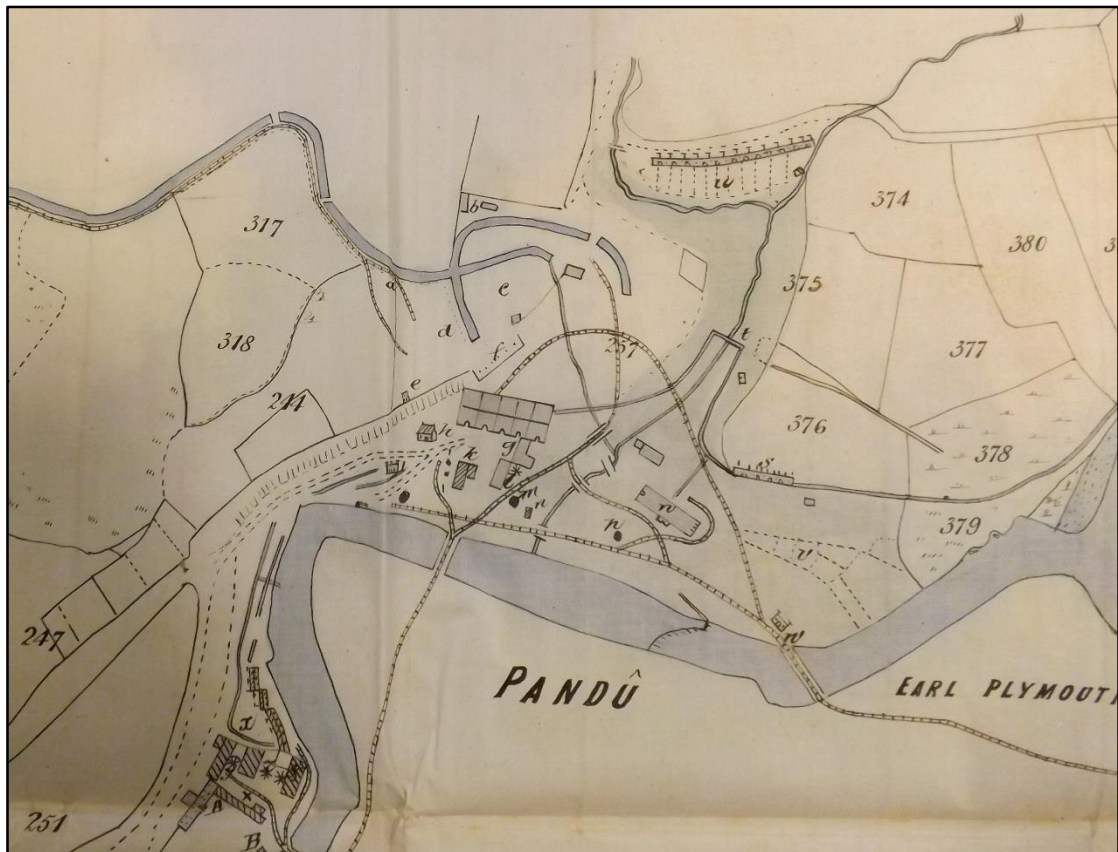
Plate 1. Possibly the earliest known plan of the layout of the Cyfarthfa Ironworks. Purporting to date to January 1795, the plan depicts several inconsistencies with the accepted development of the works. This includes the presence of a tramway from the Ynysfach site (annotated 'a', adjacent to the canal in the top left quarter) and an additional blast furnace. (Glamorgan Archives DG/F/9/10)

Research carried out for the current report has, however, revealed the presence of an earlier map of the Cyfarthfa works. The Glamorgan Archives contains a file relating to a legal dispute involving the Cyfarthfa Iron and Steel works (Glamorgan Archives DG/F/9/10). The file contains a copy of a sketch map of the Cyfarthfa ironworks, purported to date to January 1795, from estate maps belonging to the Dynevor (Lord Talbot) estate which would make it the earliest known representation of the layout of the Cyfarthfa works (Plate 1). The land formed part of the Llancaiach estate, jointly owned by Lord Talbot and Captain Richards. Despite being a sketch map, it contains a wealth of important detail, including the location of Homfray's previously lost cannon boring mill (annotated 'l' on the map), the coke yard ('c') and mine yard ('d'), a tramway connecting the Cyfarthfa mine yard to the Ynysfach site ('a') and the presence of five blast furnaces. These last two features present something of an enigma in the

conventionally understood history of the Cyfarthfa Ironworks; the Ynysfach Ironworks were not designed by Watkin George until 1801, with the tramroad being necessarily later or at least contemporary. By the same token, the Cyfarthfa works was believed to have had just four blast furnaces up to 1806. The conclusion must be that either the sketch map is incorrect, or that the conventional understanding of the development of the Cyfarthfa Ironworks is incomplete. It has not been possible to locate the original estate map in the Glamorgan Archives and at present, the discrepancy remains something of a mystery.

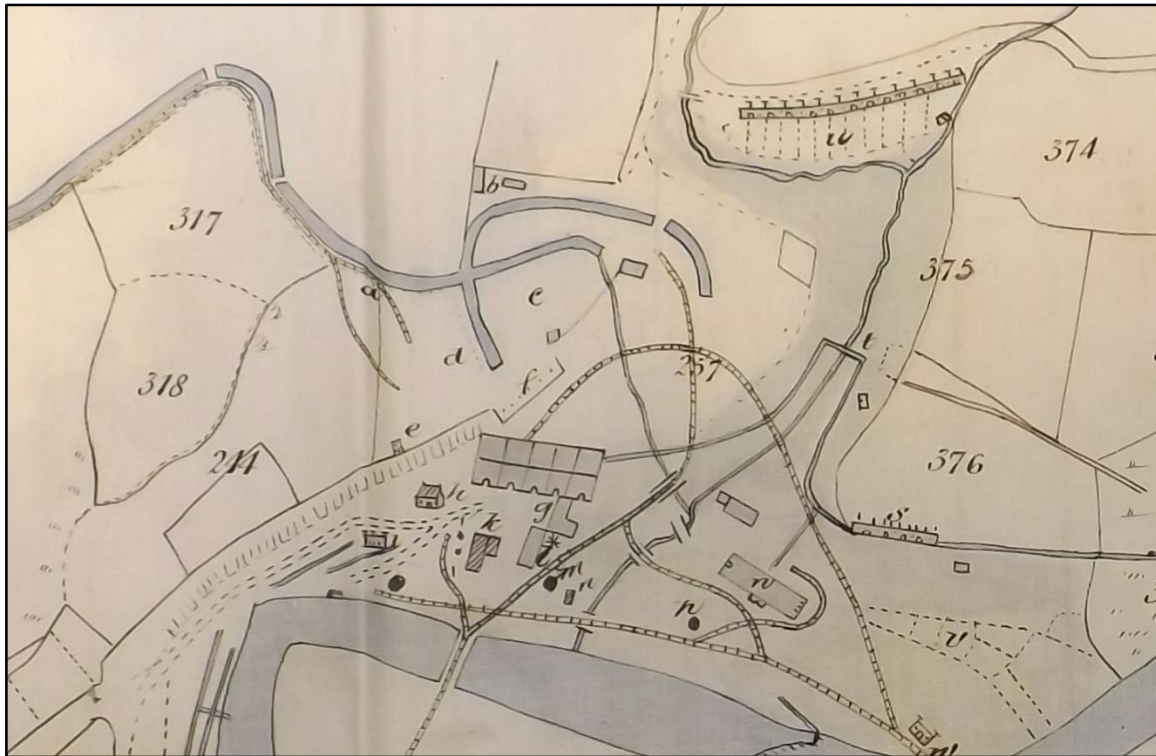
Plate 2. Extract from the map of the Cyfarthfa Iron works taken from a Dynevor Estate map of January 1785. The uppermost curving section of canal adjacent to the buildings labelled 'b' is the section exposed during the archaeological work in 2013. Area 'd' is the mine yard and 'c' is the coal yard (Glamorgan Archives DG/F/9/10).

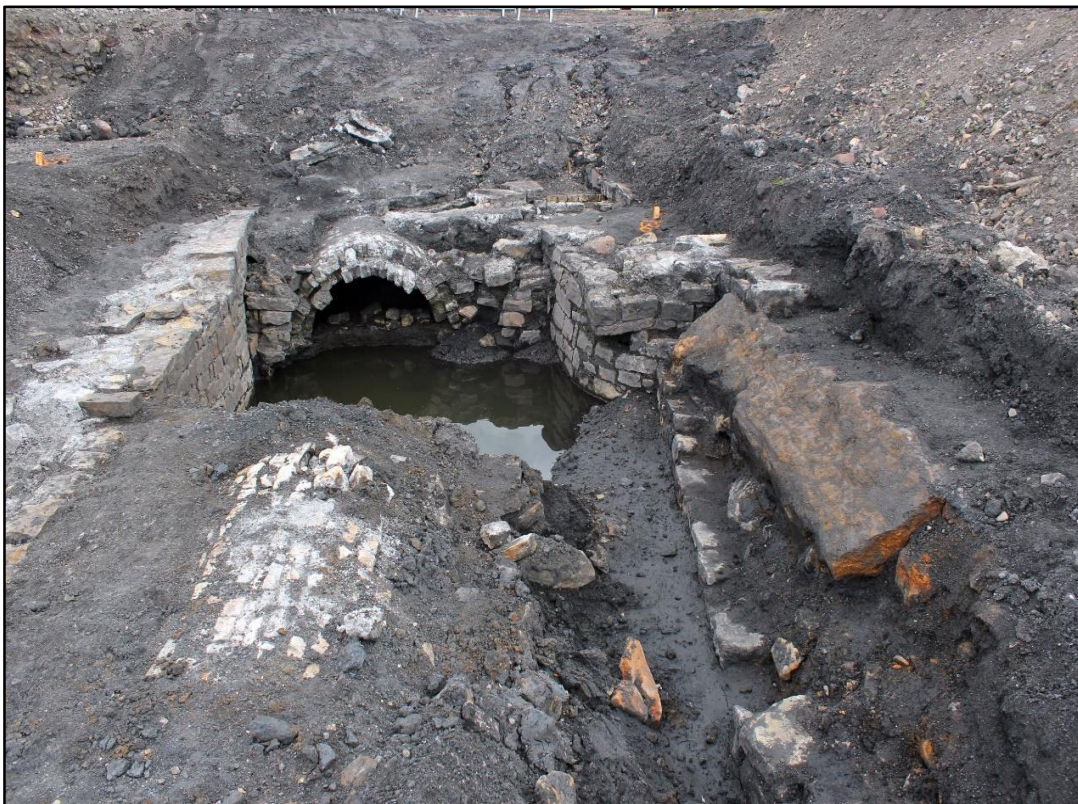
Plate 4. Anthony Bacon's canal. The orange/brown ramp on the right of the photo is believed to be a lading and unlading ramp, to aid transfer of materials to and from the tub boats. Note also the curved walling to allow the widening of the canal for the passage of boats. Note the later brick culvert built into the canal. View to east.

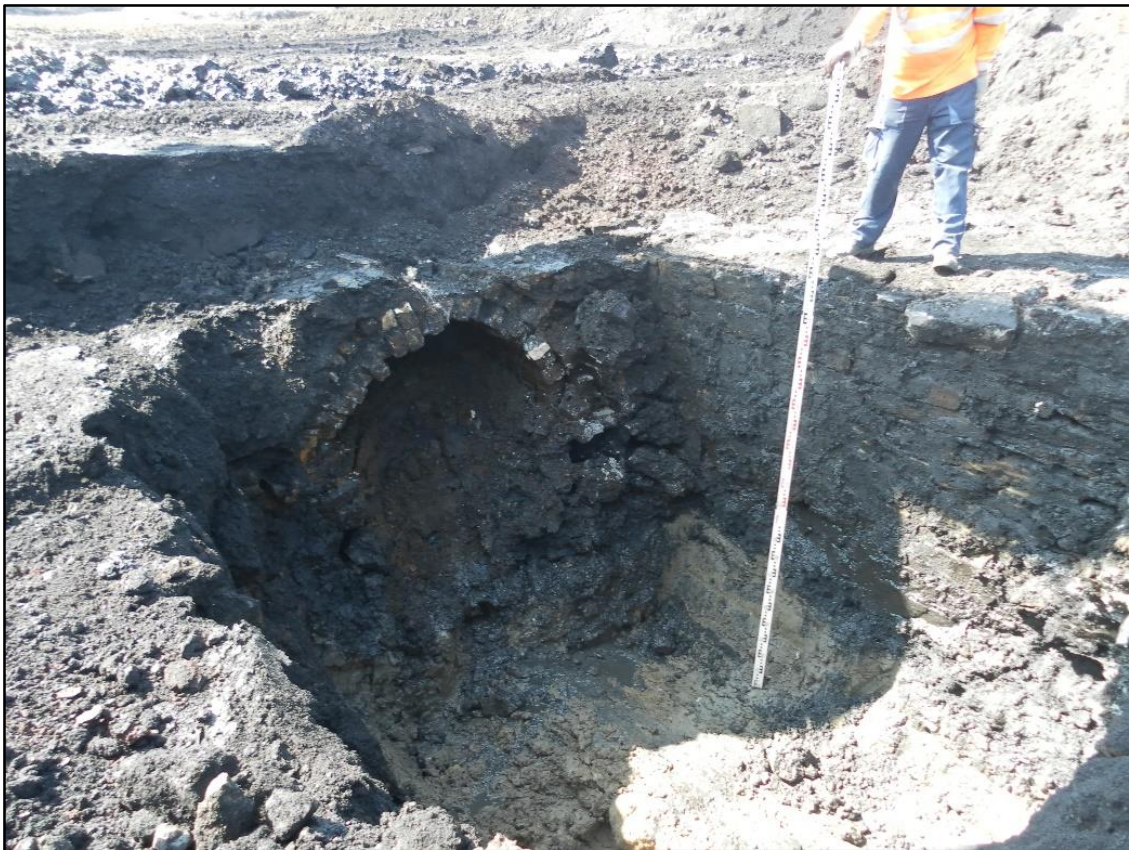
Plate 5. One of the few photographs to show the canal and culvert prior to filling with water. The construction of the culvert can clearly be seen, as can the stone packing (2006) around it. The light brown deposit towards the base may be the natural clay or a build up of silt in the channel prior to construction of the culvert.

The canal had been rendered un-usable as such through the construction of an arched brick culvert (2005) along much of its course (Plates 5 to 6). The culvert roof had been destroyed at the eastern end at an unknown date, which allowed greater visualisation of the canal itself. The culvert spanned the interior of the channel for an internal width of 1.17m and had been built of a double row of un-frogged yellow refractory brick, laid on edge and bonded with soft white grey mortar containing coal flecks and shale-stone flecks. The external height from the arch to the base of the culvert was estimated to be 1.2m to 1.3m although the presence of water in the channel made assessment difficult. The roof of the arch contained occasional engineered breaks, possibly to allow visual inspection of the water level within, although it is difficult to see how this would have worked once the arch had been capped (see below). The interstices between the canal wall and the brick culvert had been filled with irregular blocks of sandstone, shale and coal dust (2006). Greater care had been taken to pack the areas closest to the culvert wall but otherwise, the packing appeared to be somewhat random, probably having been tipped in. As it progressed north, the culvert hugged the east wall of the canal, resulting in a wider gap which had been filled with packing 2006. At its greatest extent, this gap was 1.25m in width.

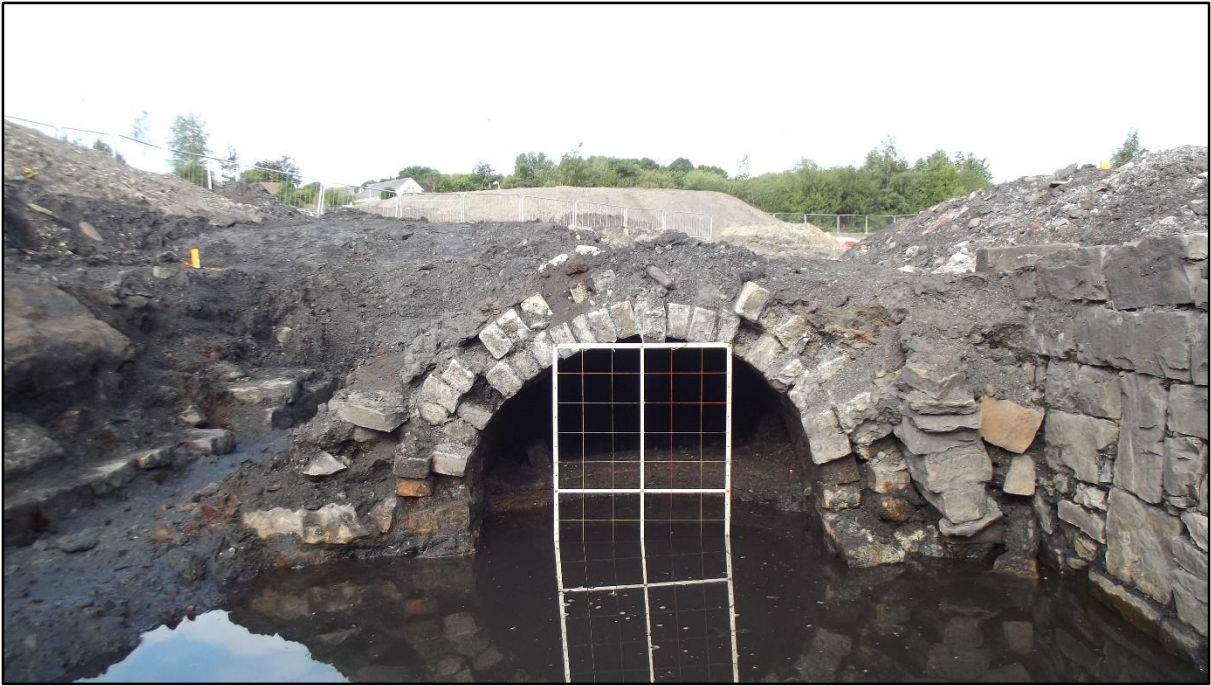
Plate 6. The same features within the canal presenting their more usual view. The planning frame width is 0.6m.

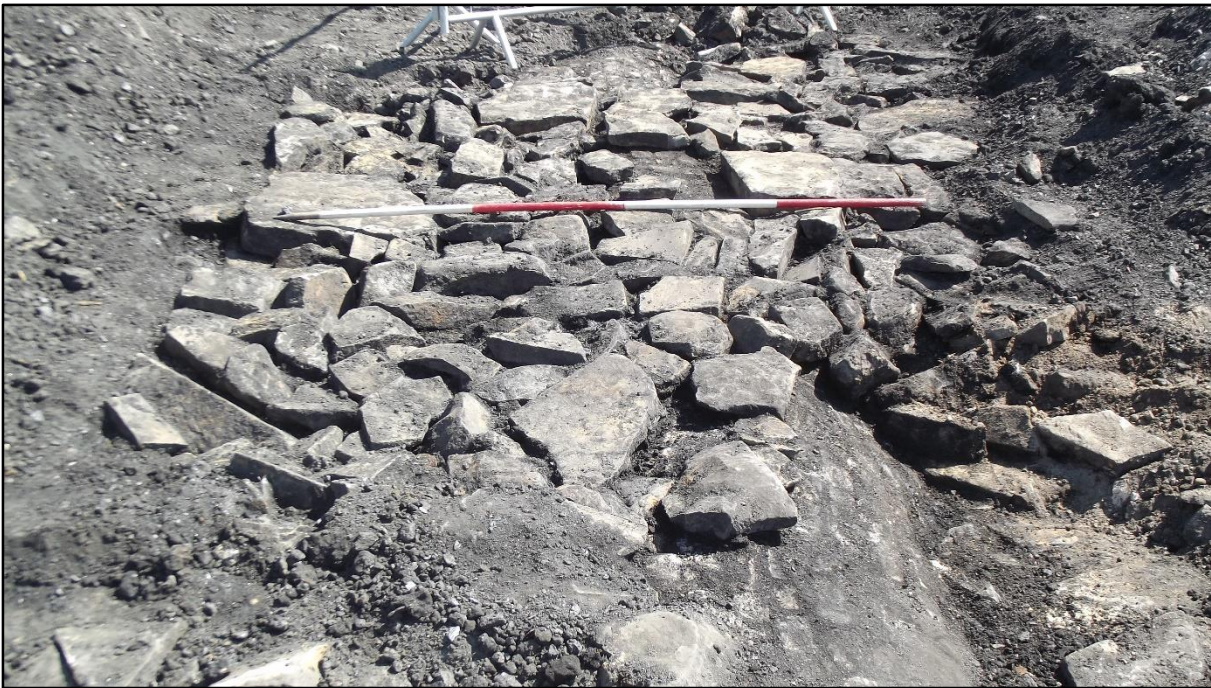
Plate 7. Stone capping 2002 which had been laid over the culvert contained by the canal. It is likely this had been placed both to level the area and protect the underlying culvert, the arch of which is just visible in the bottom right quadrant of the photograph.

There is little doubt that the canal was re-used as a water source in Phase 2 as the construction of the Coppée oven truncated the canal and the culvert at its north end. The brick culvert had been covered over for most of its length by a combination of randomly deposited Pennant sandstones and silty clay (2002) in order to both level the ground and protect the culvert beneath (Plates 7 and 8).

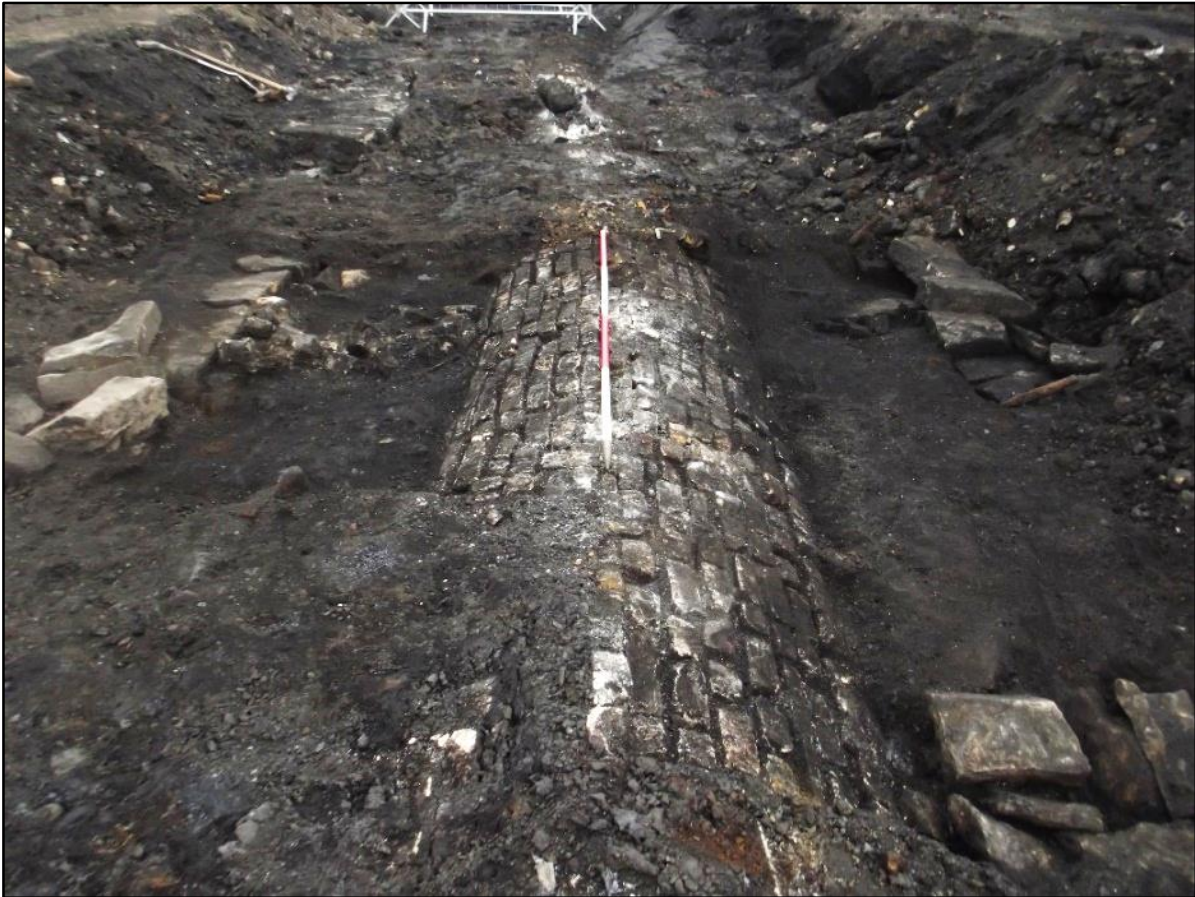
Plate 8. Culvert 2003 on removal of the capping. Note its position within the channel of the canal. View to south.

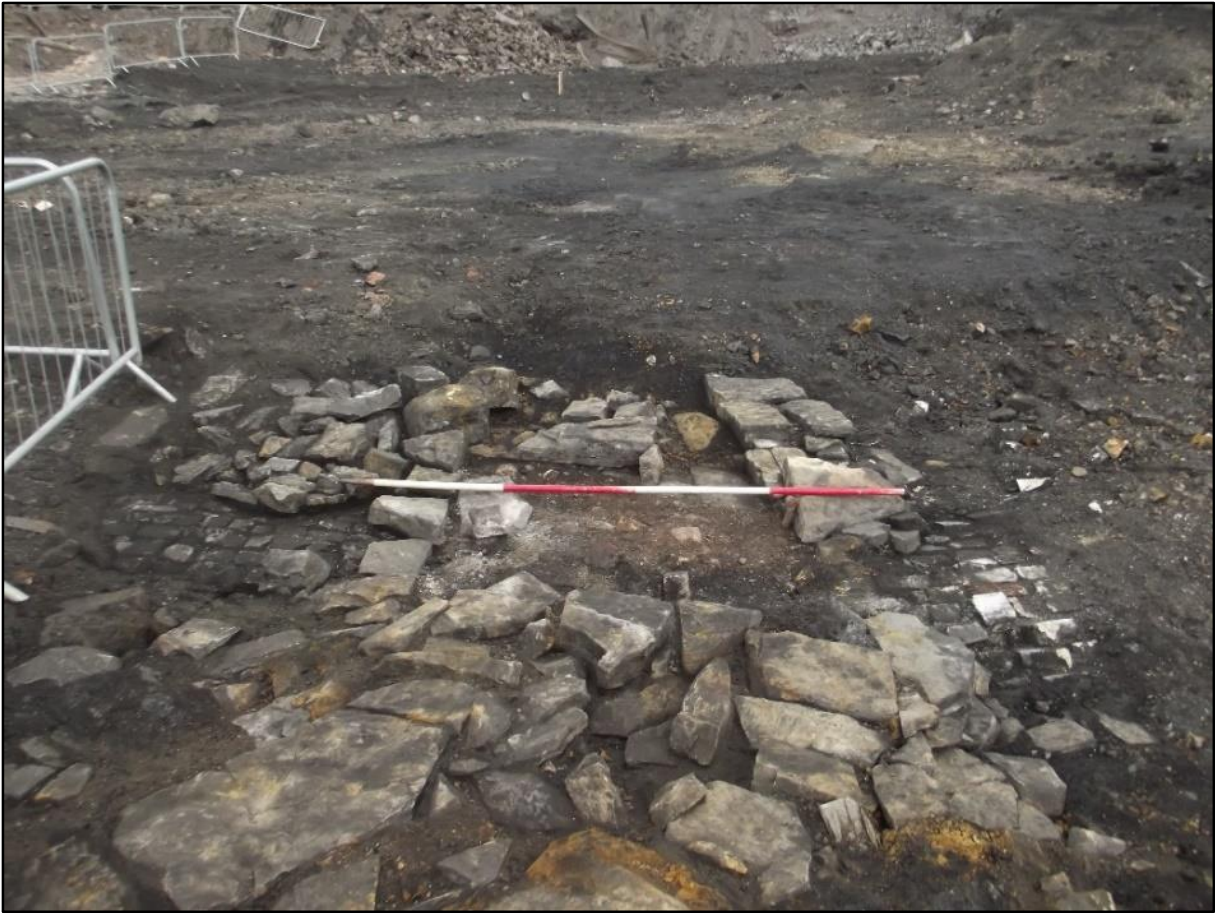
Plate 9. Crossing point 2021 sited over culvert 2003. View to north east.

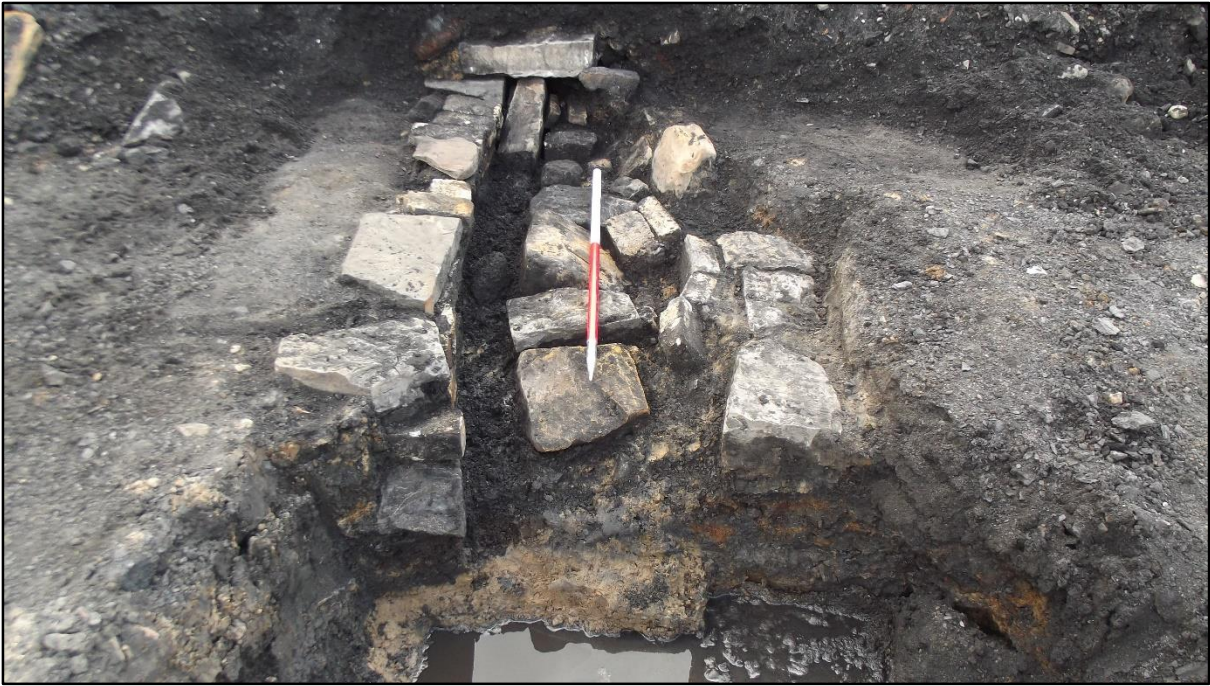
Plate 10. Stone drain 2203. The function and date of this drain remains unknown although its form suggests that it may relate to either Phase 1 or 2.

Several stone capped channels or drains, the most intact of which was drain 2203, were recorded on the uphill, south west curve of the canal, possibly to drain into that feature. Drain 2203 (Plate 10) was oriented south west to north east and had a surviving length of 5.4m. There was a suggestion that the drain branched into a second channel, also emptying into the canal but the whole feature was so damaged, the exact relationship was unclear. These features may have been adapted later to take account of the insertion of the culvert.

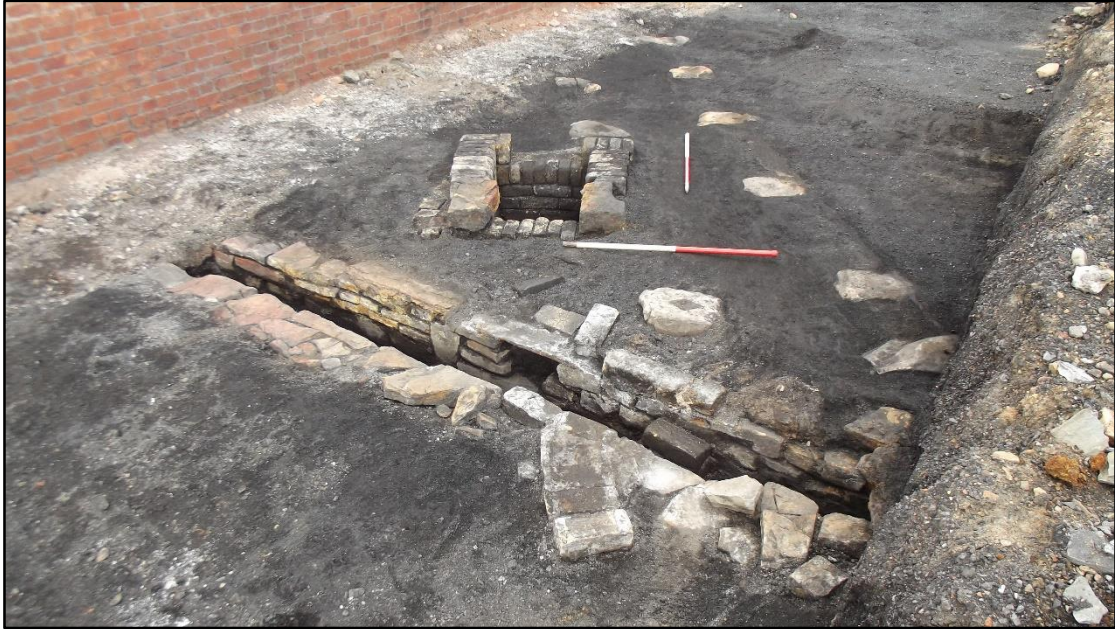
Plate 11. Probable Phase 1 and 2 features located beneath the footprint of the 1882 north Coppée oven coke bench. The earliest feature is the set of tramway sleepers (2296) which has been cut by the later insertion of a stone drain (2301) and brick built chamber 2297). The construction cut (2300) for the Coppée ovens is clearly visible in the upper left quadrant. View to north.

Small sections of the original coke yard survived in a truncated form beneath elements of the Coppée coking plant. These remains consisted of a compressed coal surface into which had been set some stone sleepers, together with stone built drains and at least one rectangular brick chamber. The drain and chamber system may well have helped supply water for quenching the hot coke produced in the coke heaps that were probably located here.

The earliest feature within the group was a set of nine stone sleepers (group 2296) which had been used as the bedding for a tramway track. The stones were of Pennant sandstone and all had the remains of an iron pin for mounting the rail. Measuring pin to pin, the blocks had been set 1.01m apart in two rows, six surviving for the south track and three for the north. This resulted in a gauge of approximately 3 Feet 3 inches, rather narrower than the standard 4-foot gauge used for the Penydarren tramway that crossed the bridge at Pont-y-Cafnau (built 1793) but fairly standard for those used in industrial settings from the early 1800s onward. The ghost impression of tracks (Plate 12) survived in the compressed coal surface into which the sleepers had been set (coal deposit 2306). The pattern of sleepers had been interrupted by the insertion of a stone lined box drain or culvert (drain 2301) and a rectangular brick built chamber (2297).

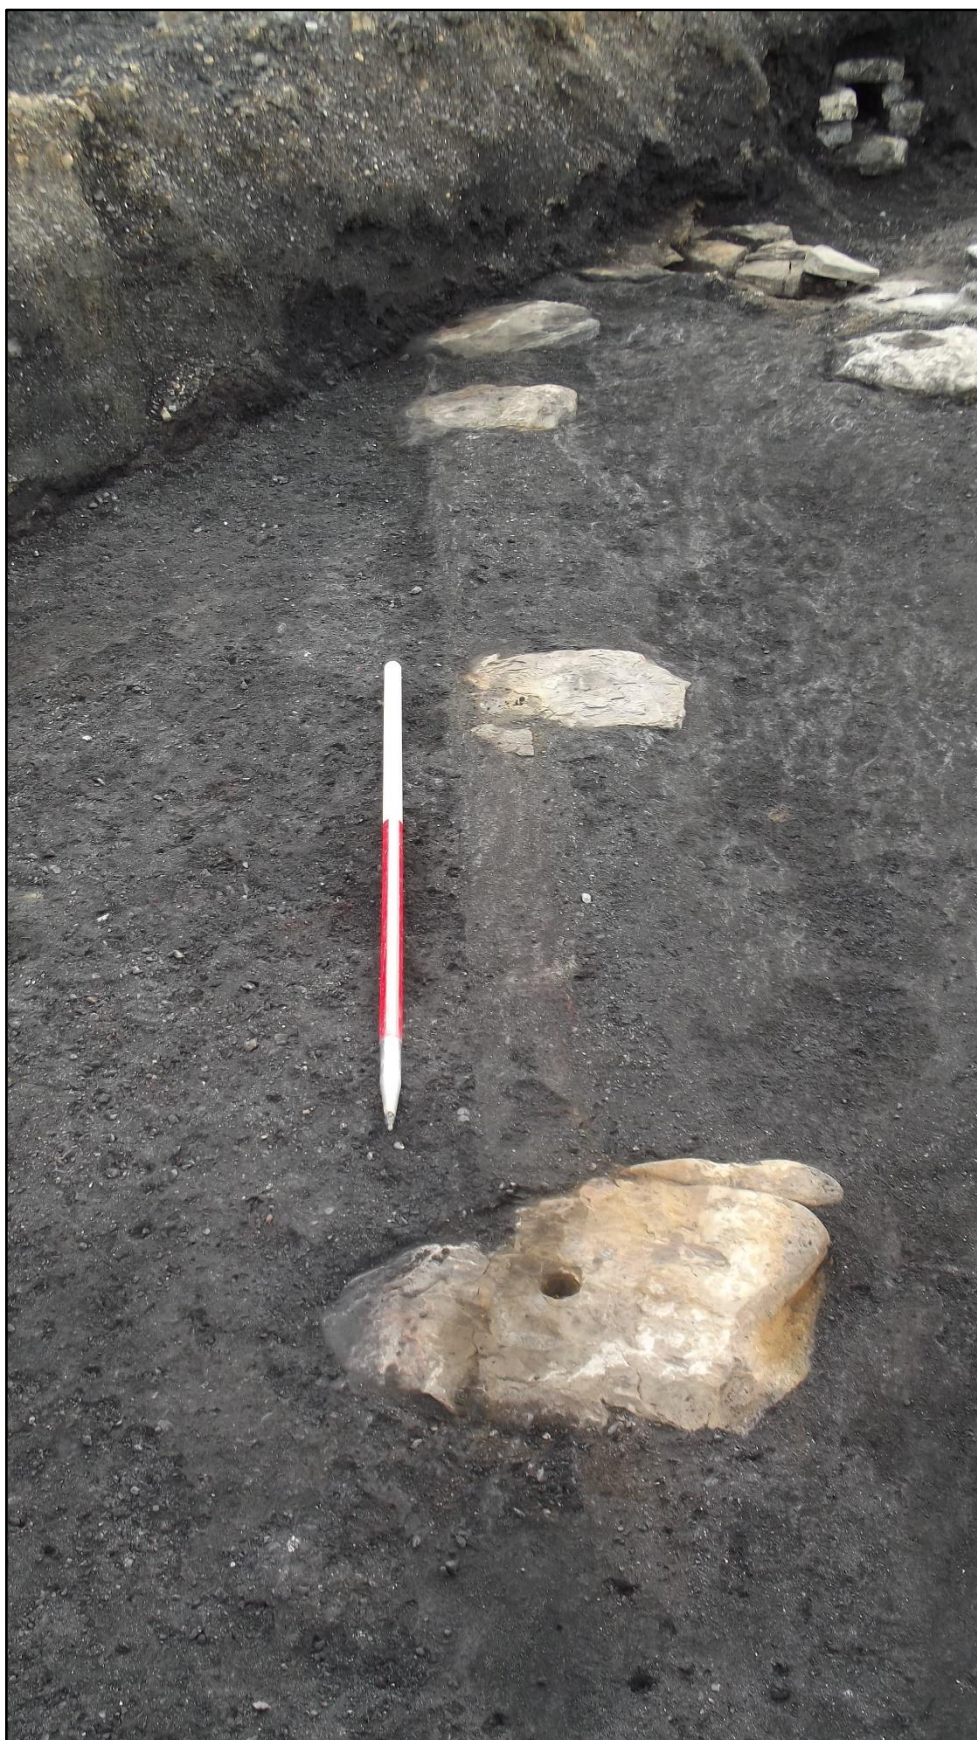
Plate 12. Ghost of the rail that once ran over the south of stone sleeper group 2296. View to south west.

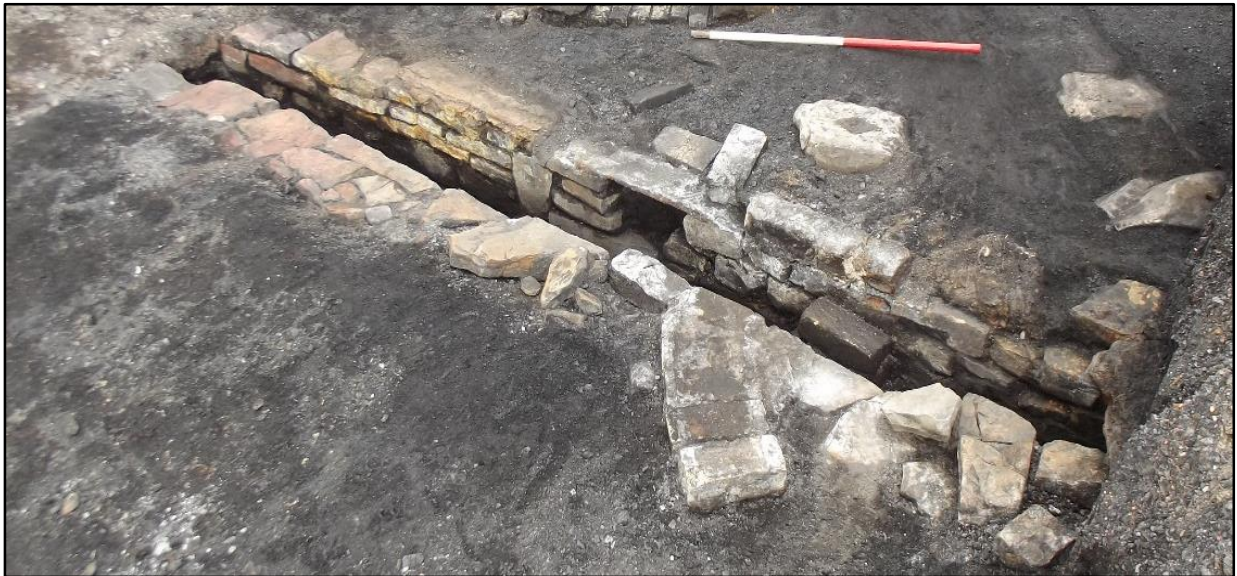
Plate 13. Box drain 2301 showing the iron lintel covering the drainage channel into rectangular chamber 2297. Secondary drain 2302, which probably Fed the box drain, can be seen curving at the bottom of the image. View to north east.

The linear stone box drain (2301) oriented north/south was exposed for a length of 4m (Plate 13) and had originally been filled with a silty, coal dust like deposit (2308). Whilst the overall construction was 1m wide, set into coal dust surface 2306, the internal channel was a square section measuring 310mm by 310mm. The drain was made from Pennant sandstone although there was no obvious bonding material, which may have washed out. The remains of a curving secondary drain 2302, located at a higher elevation and apparently feeding the box drain, were noted. An iron lintel had been set into the east wall of the box drain to support the mouth of a channel that fed into the rectangular brick chamber (2297) located 1.2m to the east.

Box drain 2301 had been deliberately blocked by the insertion of a number of yellow refractory bricks and a spread of compressed coal dust (2303). The purpose of the blocking is unclear but it may have been an attempt to prevent backflow towards the south from the secondary drain area.

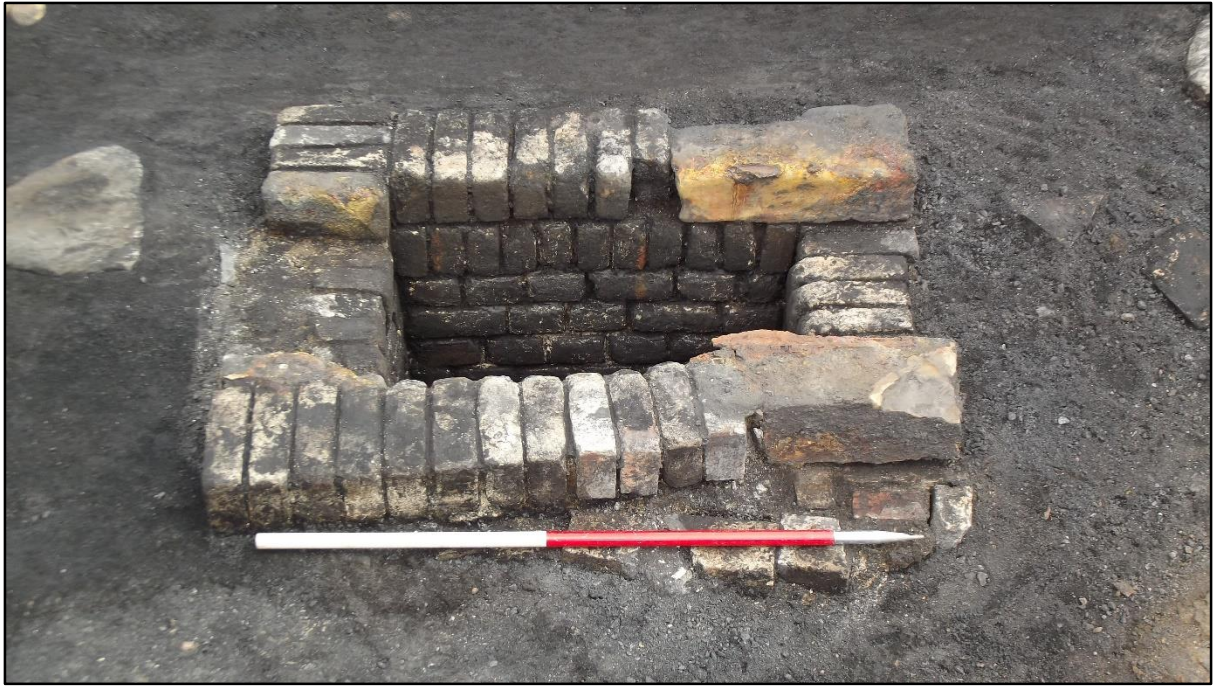
Plate 14. Brick chamber 2297. Note the raised edges and distinctive curving in the bricks forming the right hand (south western) side of the chamber. This suggests that this side was open when in use. The dislodging of the lower wall in the image was historical wear and tear caused during its lifetime. View to south east.

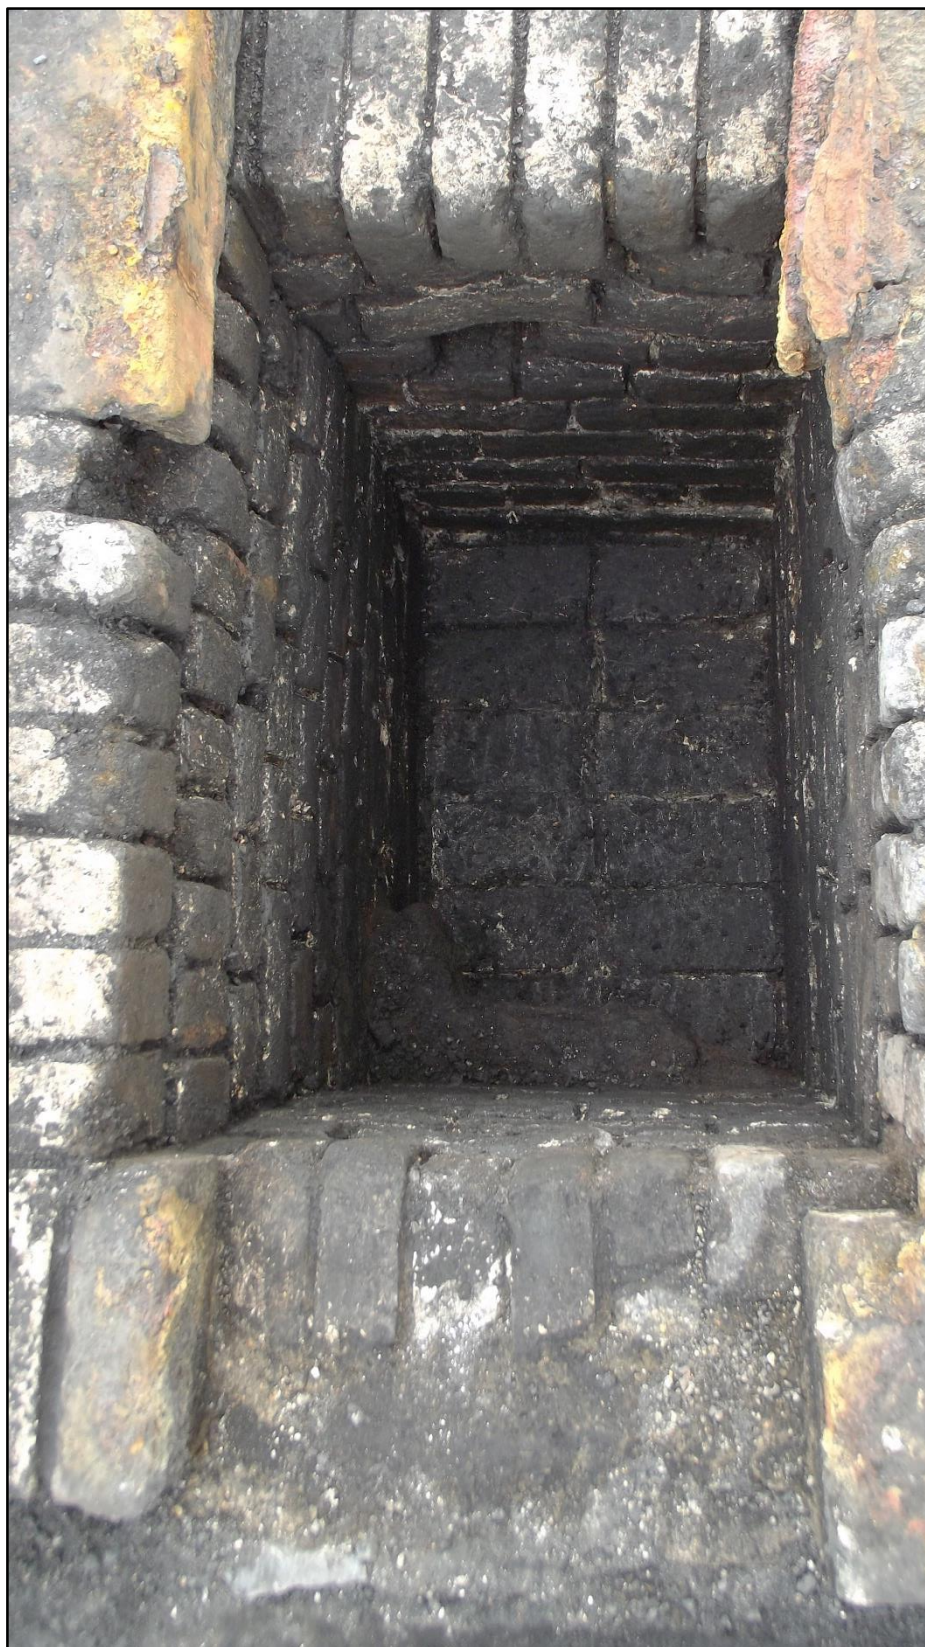
Plate 15. Interior of brick chamber 2297 showing the drain in the south west face and the floor.

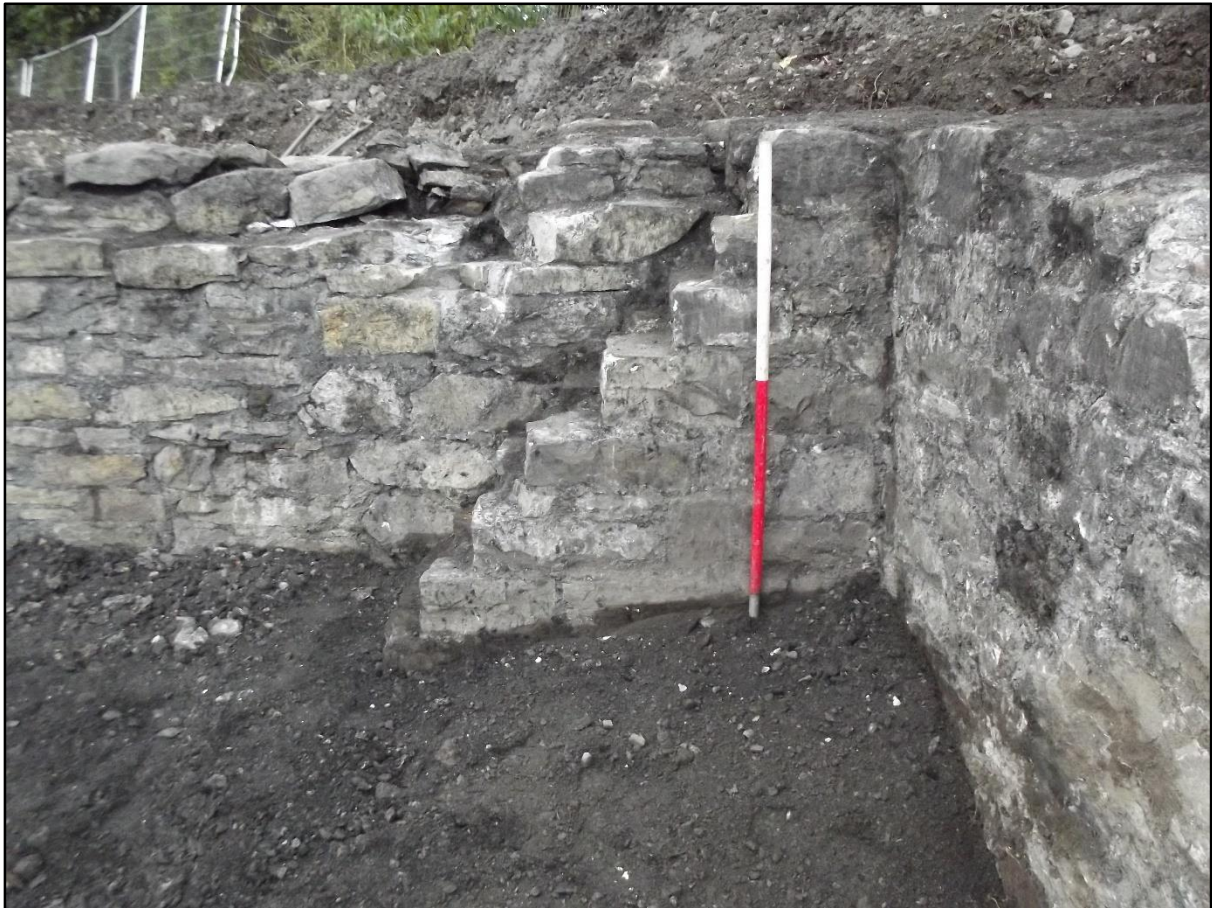
Plate 17. Smithy area, 'L' shaped structure showing the steps and the inner return of the 'L' shape. View to north.

The blocks had been shaped but were unworked and had been laid in somewhat irregular coursing, surviving in places up to an exposed height of 1.2m although the wall was certainly higher. A set of eight stone steps (Plate 17) had been constructed at the inner angle of the ‘L’ but there would originally have been more as the top of the wall had been truncated. The steps were a later addition, butting up to the wall but not bonded and the outer face of the stairs was angled, either to add stability or, less probably, to act as a buttress. The highest quality stonework incorporated in the wall was associated with the short length of the ‘L’ shape (Plate 18). Some care had been taken to select and work stones into quoins to produce neat 90 degree angles at the corners but the rationale for the markedly greater effort taken at this point is

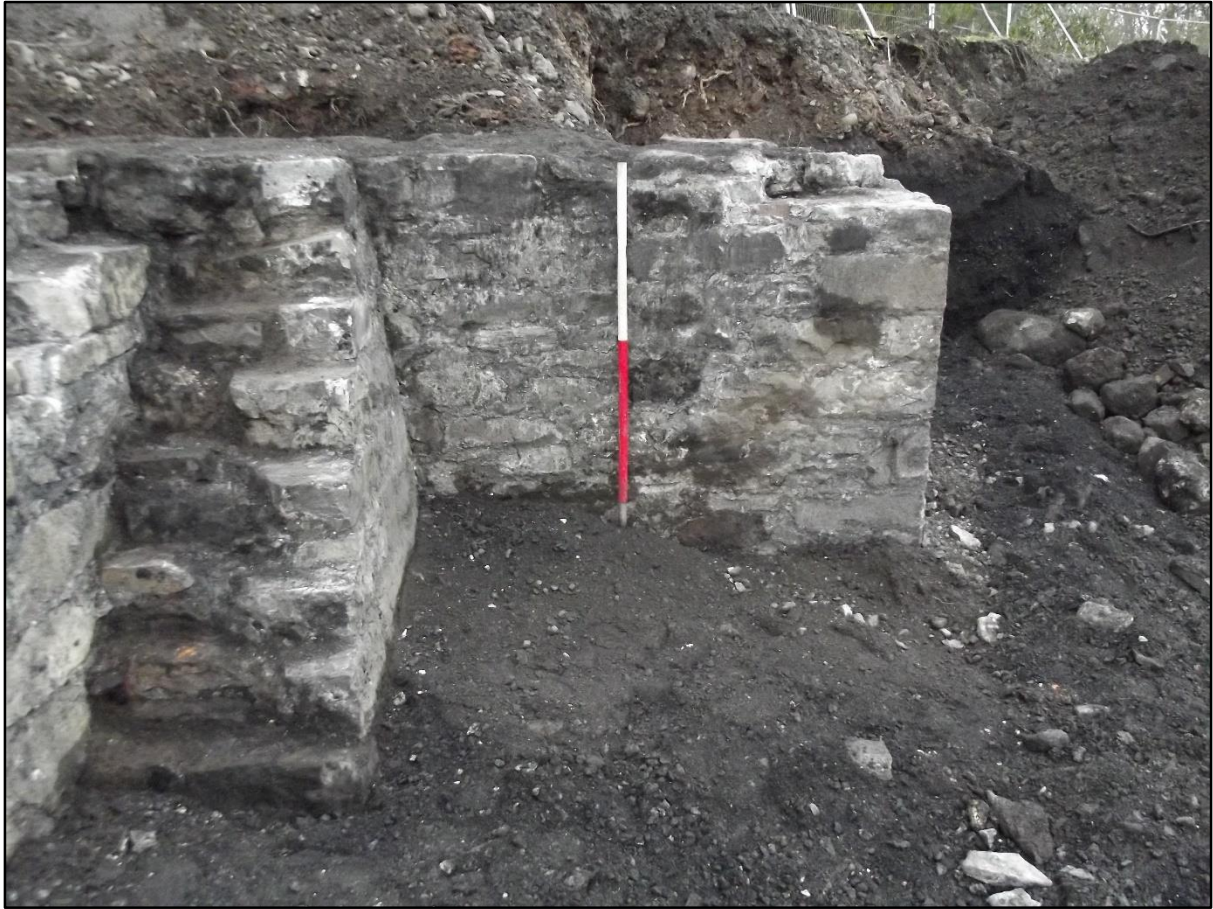
Plate 18. Smithy area, L shaped structure, showing the batter on the steps and the better quality stone quoins to the right of the image. View to east.

There are no obviously corresponding structures indicated on cartographic sources that help in the interpretation of the above wall. A conventional lime kiln is likely to have had a more solid construction and indeed the estate map shows it as a solid looking square structure. However, the construction and appearance of the wall has more in common with that of the canal than other structures within the site and it is likely that in date, at least, it has its origins in Phase 1 or Phase 2 of operations at Cyfarthfa.

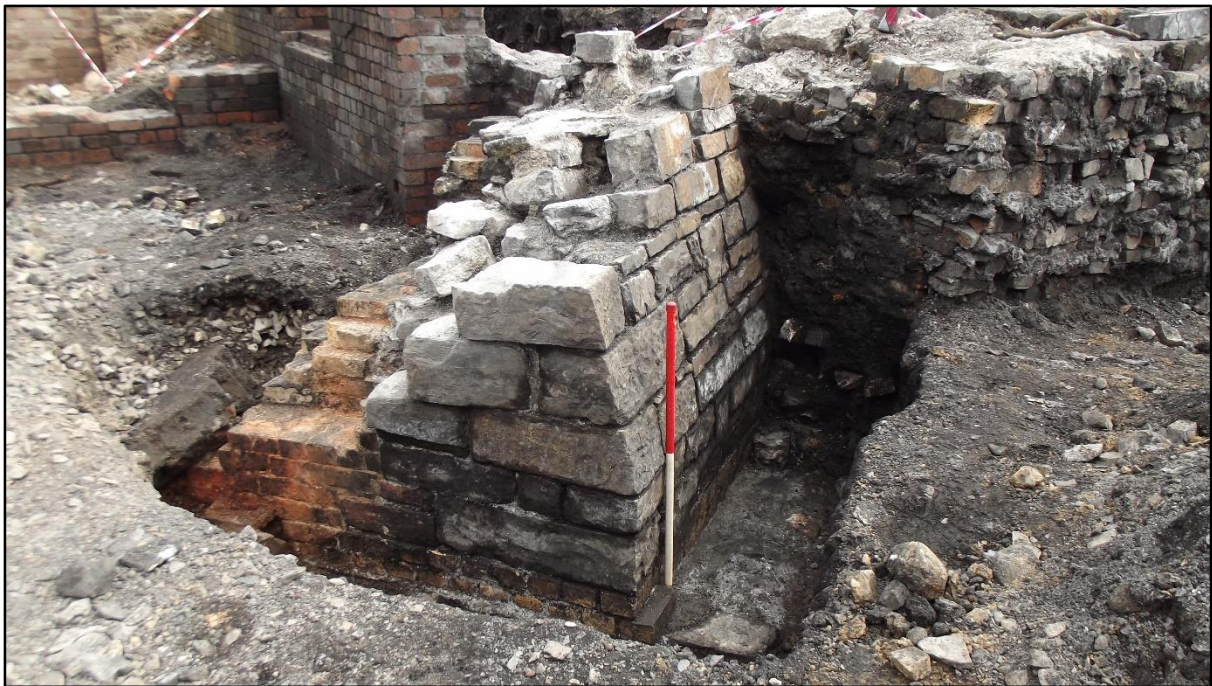
Plate 19. Battered gable end of the surviving element of the Thomas ovens. Note excellent quality of the dressed stonework.

The most substantial recorded part of the Thomas ovens to survive was a section of the south west gable end of a battery of ovens, made from pennant sandstone (2243). This exterior wall had a length of 3m north to south, a width of 1.15m and survived to a height of 1.7m. It had been constructed of large, squared stone blocks, with the one surviving corner possessing stressed quoins with a hammer dressing to the stonework. The wall had a batter on the south west elevation whilst being flush on the opposite side (Plates 19 and 21), a characteristic which is visible in a drawing of a Thomas oven in John Percy's work. The stones had been laid on a foundation of two courses of yellow refractory brick and the north (interior) elevation of the wall consisted of brick which was keyed into the stone wall to a height of at least 0.4m. The whole structure was bonded with a soft textured, light grey/white lime mortar elevation. The bricks of the interior elevation were vitrified, indicating the presence of high heat. A 'D' shaped iron fitting (Plate 20) had been built into the foundation course 1.45m from the corner and appeared to have been positioned in the centre line of the dividing wall between each interior floor. A number of identical fittings were found in the same position along the exposed length of the ovens and they were almost certainly used as stays to support upright door fittings, none of which were recovered.

The actual reason the gable end was retained is something of a mystery but it may have acted as a buttress for elements of the later Coppée ovens.

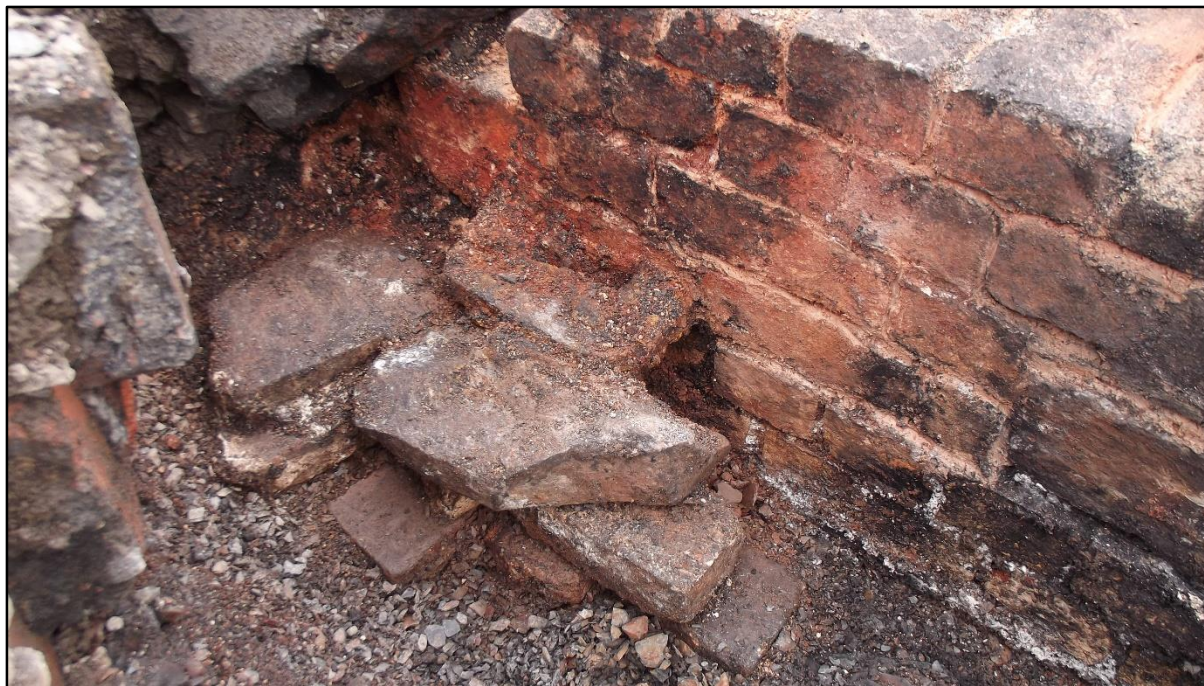
Plate 20. Close up of the 'D' shaped stay associated with the door fittings on the Thomas ovens.

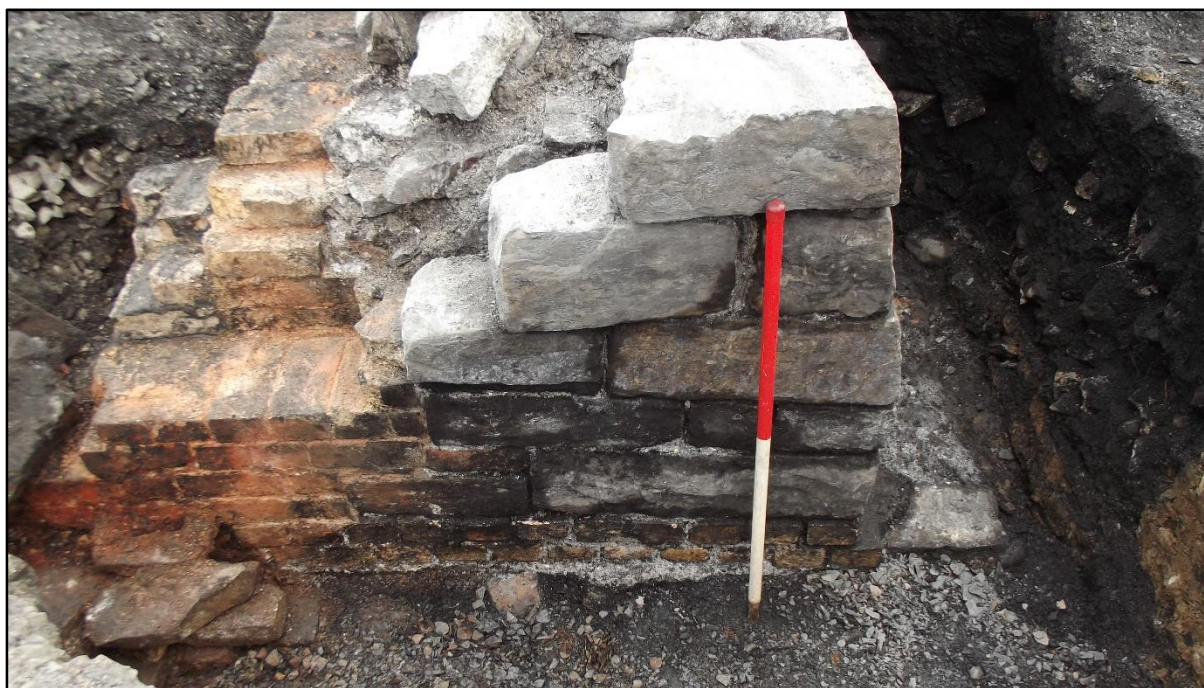
Plate 21. View of the surviving corner of the Thomas oven
