Cyfarthfa Coke Works (The Old Thorn Lighting Works) Merthyr Tydfil

Excavation report and analysis

October 2017

GGAT report no. 2017/051
Project no. P1844
National Grid Reference:
SO 03708 06785

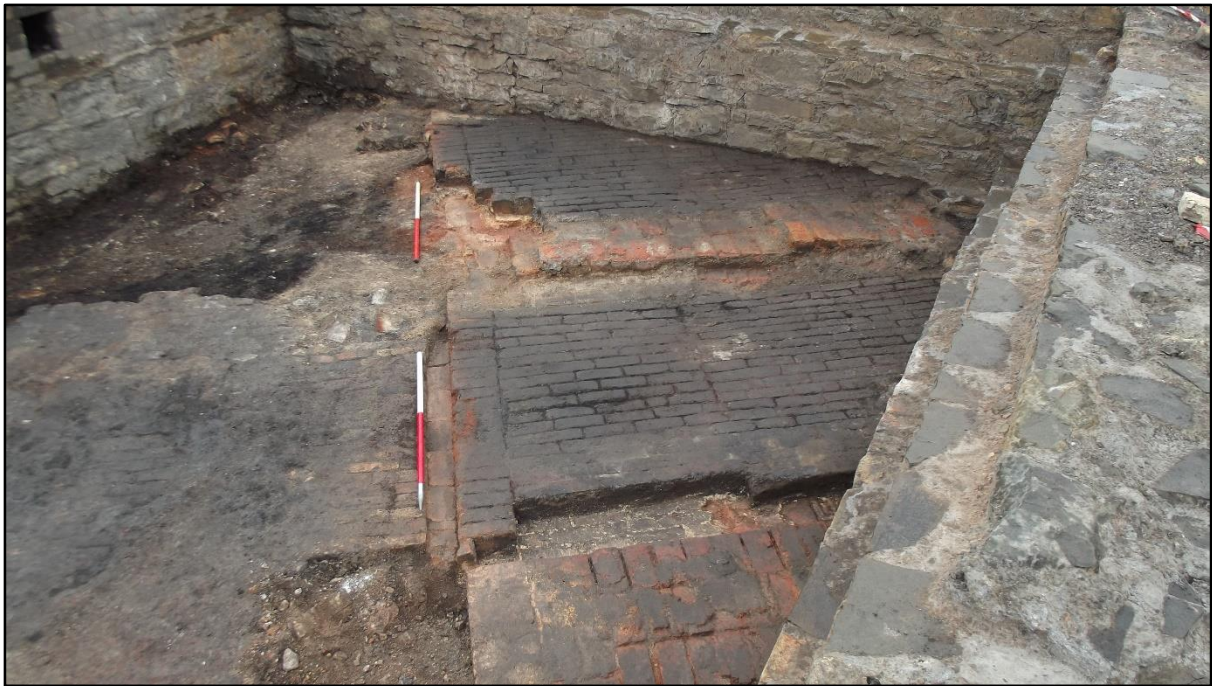
Plate 22. View to the south west of the internal floor surfaces of the Thomas ovens. The internal divisions are marked by the absence of bricks whilst the coking bench is the damaged brick surface to the left of the ranging rods. Slot 2366, a recess for the coke oven doors can be seen immediately right of the ranging rods. The upstanding walls are the remains of the later Coppée oven which was constructed in the 1880s.

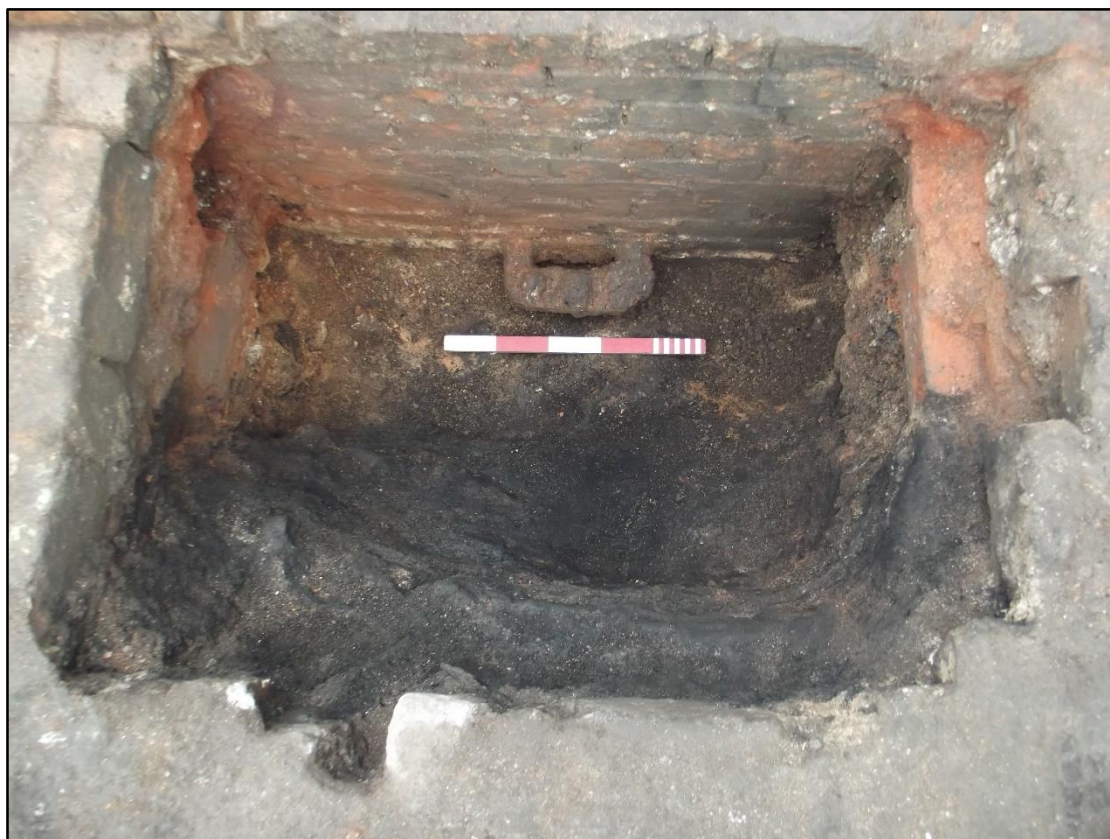
Plate 23. Receiver pit 2361 for part of the Thomas oven door mechanism. Note the iron stay, identical to those on the north side of the ovens.

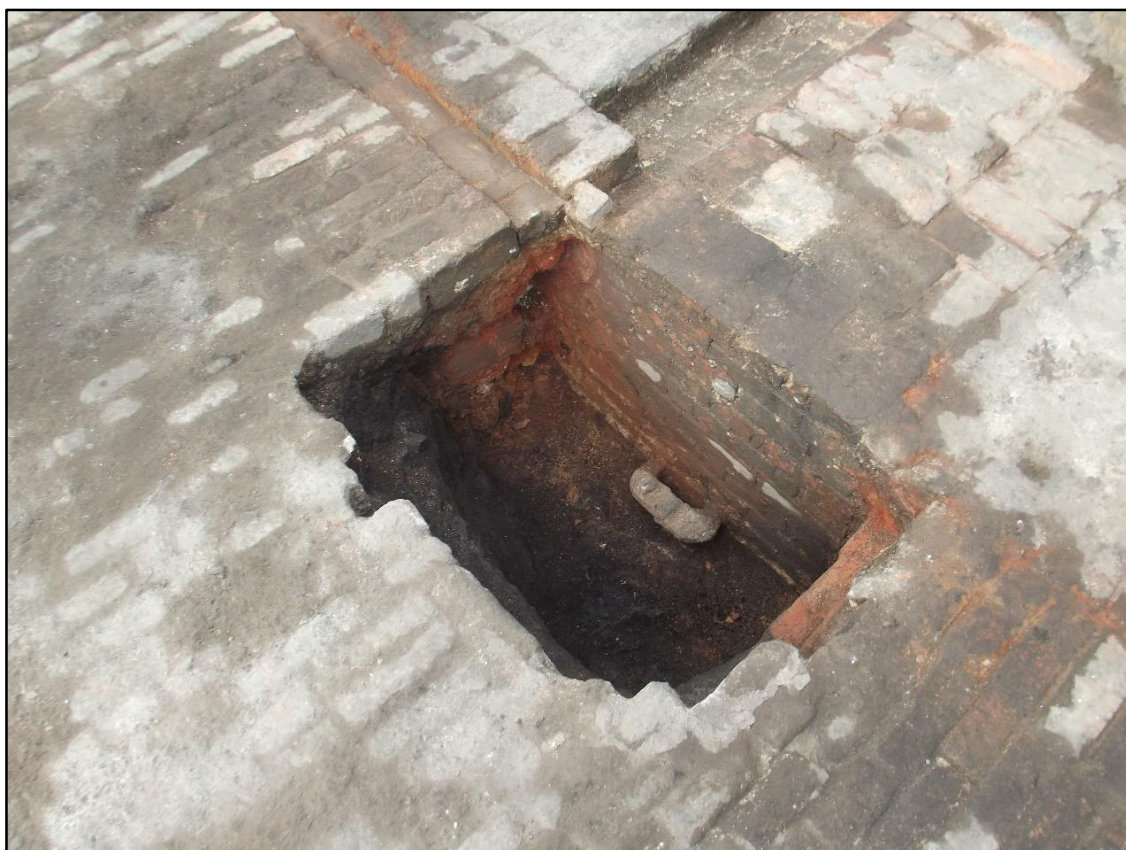
Plate 24. Receiver pit for door mechanism showing slot 2366 for the door. View to west

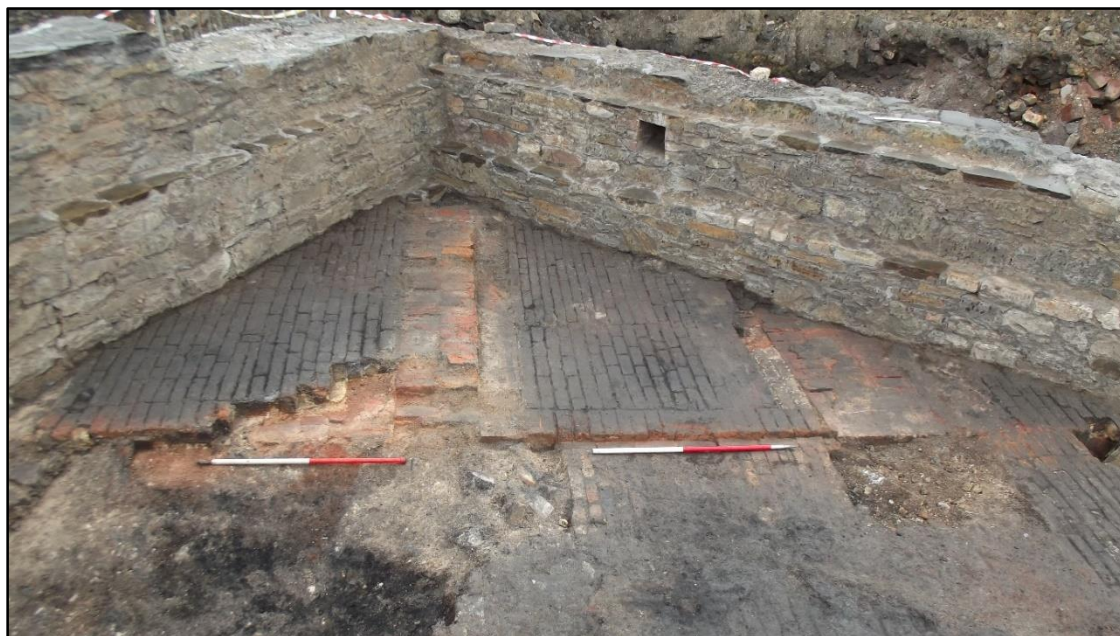
Plate 25. View to the north west of the interior of the Thomas ovens.

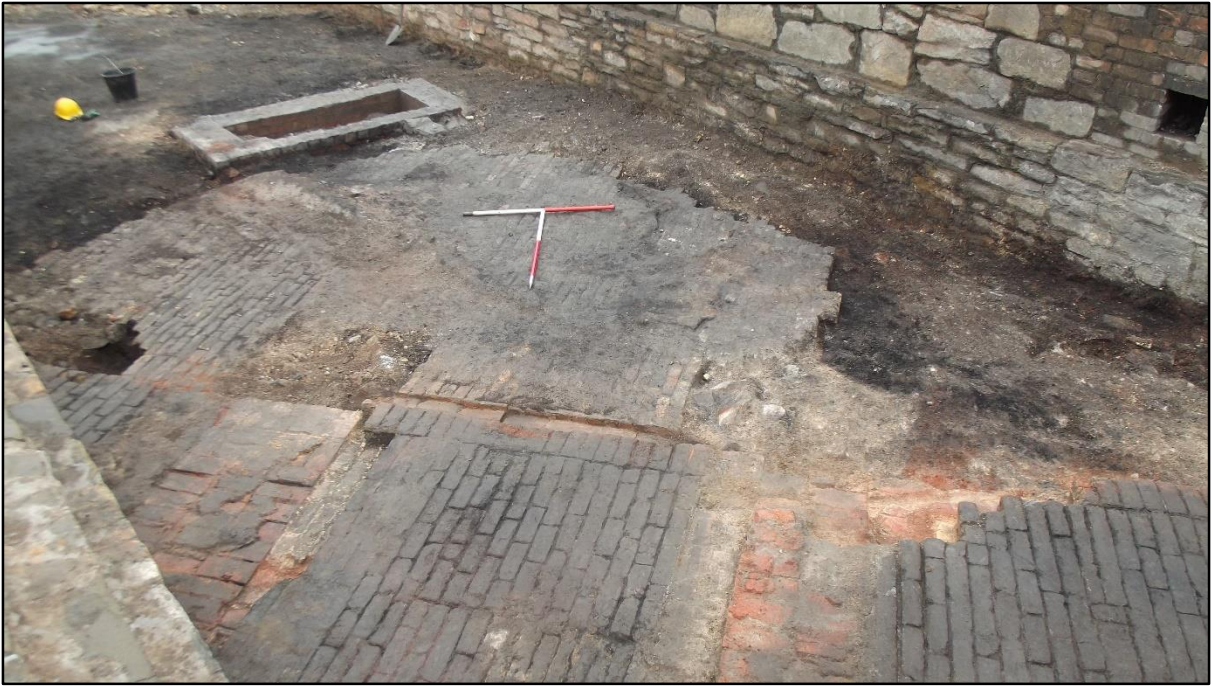
Plate 26. Interior floors of the Thomas ovens and coke bench showing the relationship with later brick chamber 2341. View to east.

Three individual, separate floors to the ovens were uncovered (2369 to 2371) (Plate 22, Figure 6). Each had been constructed of brick laid stretcher pattern and bonded with a coal rich lime mortar. These floors appear to have survived as they were buried within the footprint of the later Coppée ovens and although highly truncated, it was clear that they were originally rectangular in plan. The width of each floor was slightly inconsistent, 2369 being 1.78m

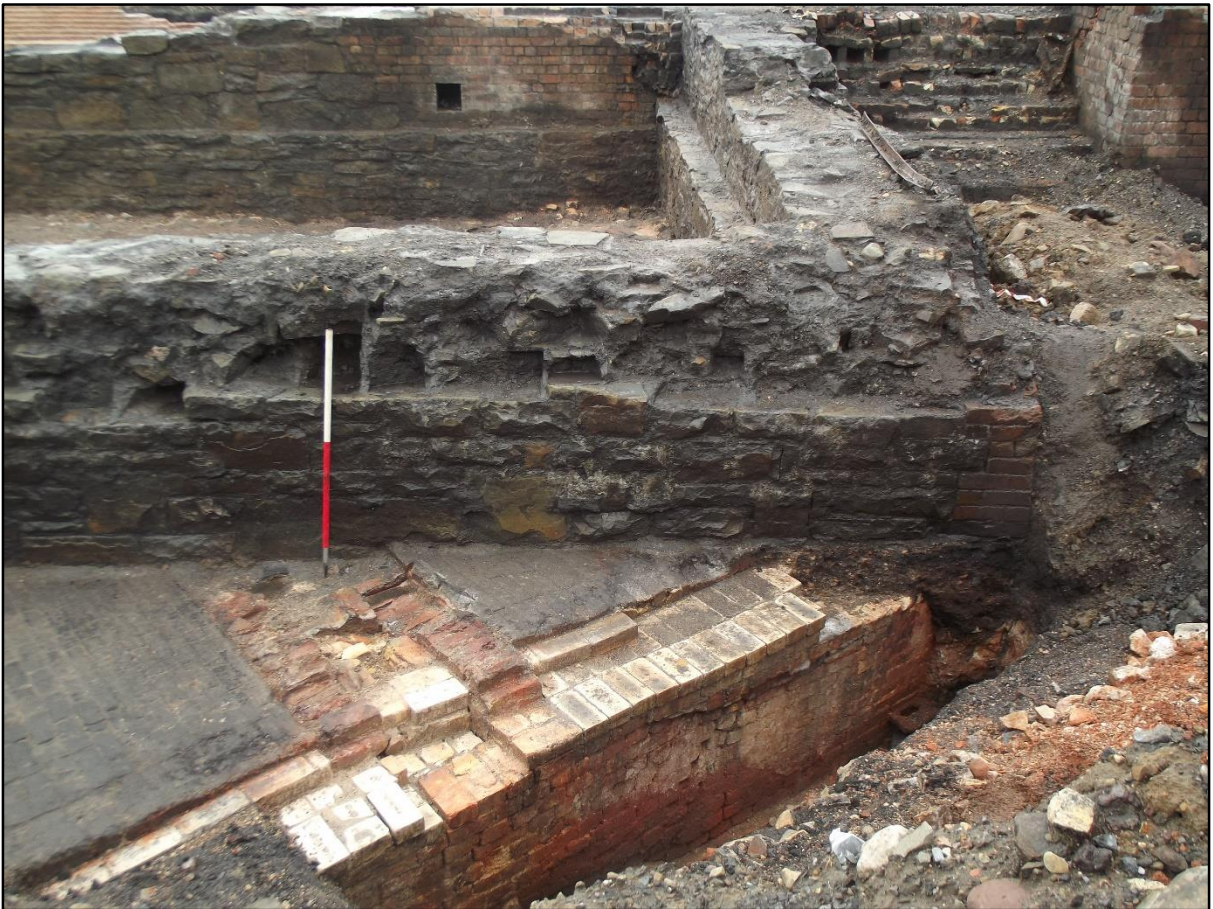
Plate 27. North side of the Thomas ovens beneath the later Coppée coke ovens. View to south.

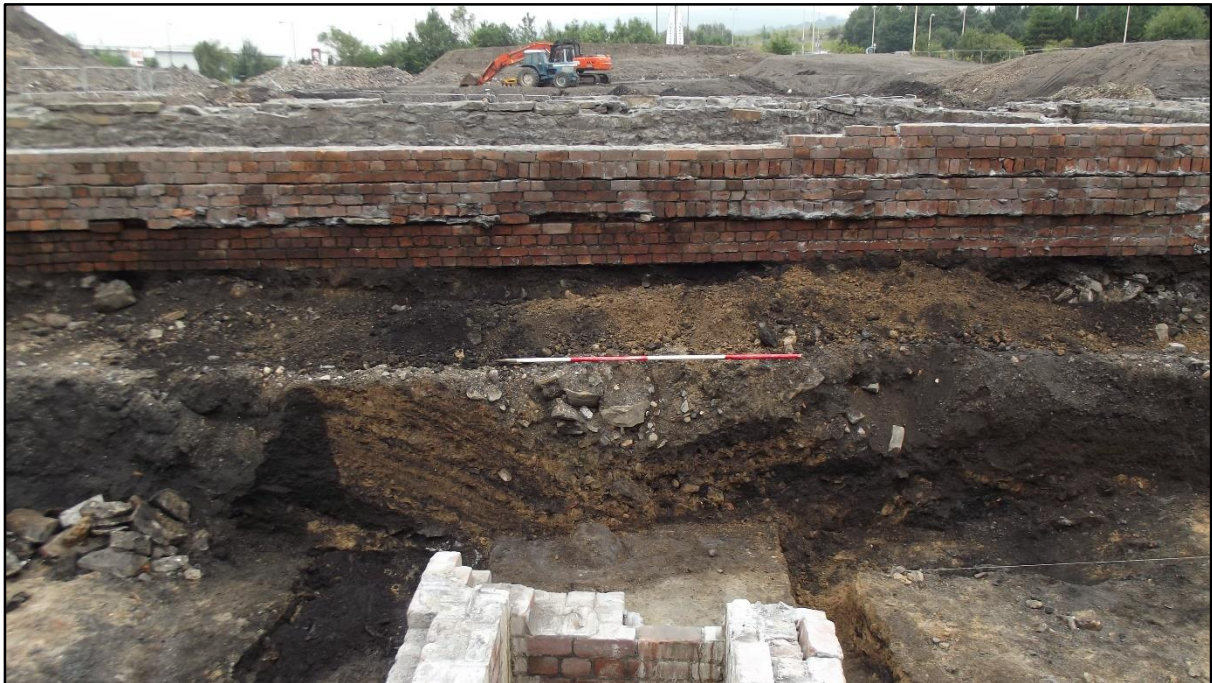
Plate 28. Cut 2310 and inspection chamber 2309. These features were cut into a coal dust surface which appears to have built up over the phase one levels and may be an indicator of the original level of the phase two marshalling yard. View to south east.

Very few remains associated with the Phase 2 coke yard appeared to survive, as later development had all but obscured any features. It is evident from cartographic sources that there was an extensive rail network into the yard, the remains of which certainly survived into the early 20th century. Unfortunately, nothing of this network was noted during the excavation, with the exception of the comparatively small area of earlier stone sleepers discussed under the first phase activity, and the assumption must be that all traces were removed during de-commissioning of the works. The compressed coal working surface into which the Phase 1 tram road tracks and other features were inserted appears to have been subsequently buried by a build-up of more coal and coal dust. The evidence for this comes from the cut that was made for the insertion of a pair of inspection chambers (2341 and 2309 contained by cut 2310) that appear to relate to phase 4 and may be associated with the Thorn Electrical works. Cut 2310 was made into a deep deposit of coal dust and was clearly visible in section (Plate 28).

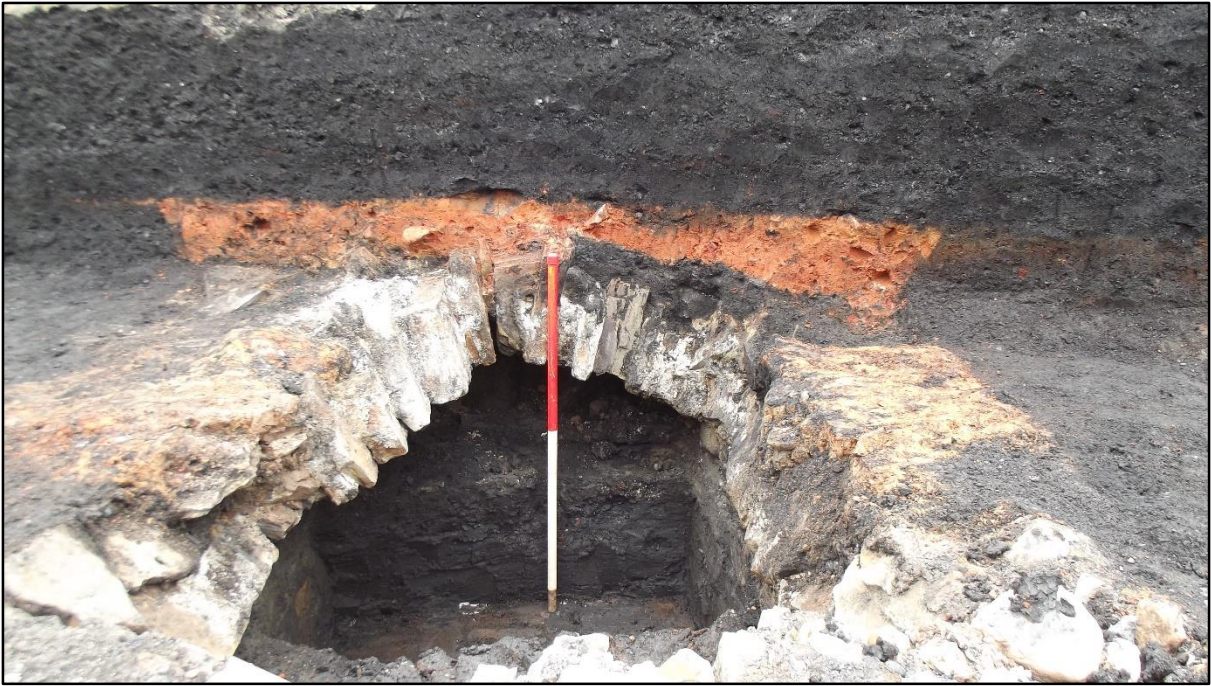
Plate 29. Coke yard area, culvert group 2295 showing the highly distinctive orange clay (deposit 2347) used to seal the culvert. Considerable quantities of coal dust (deposit 2306) must have been present at the time the feature was constructed. View to south.

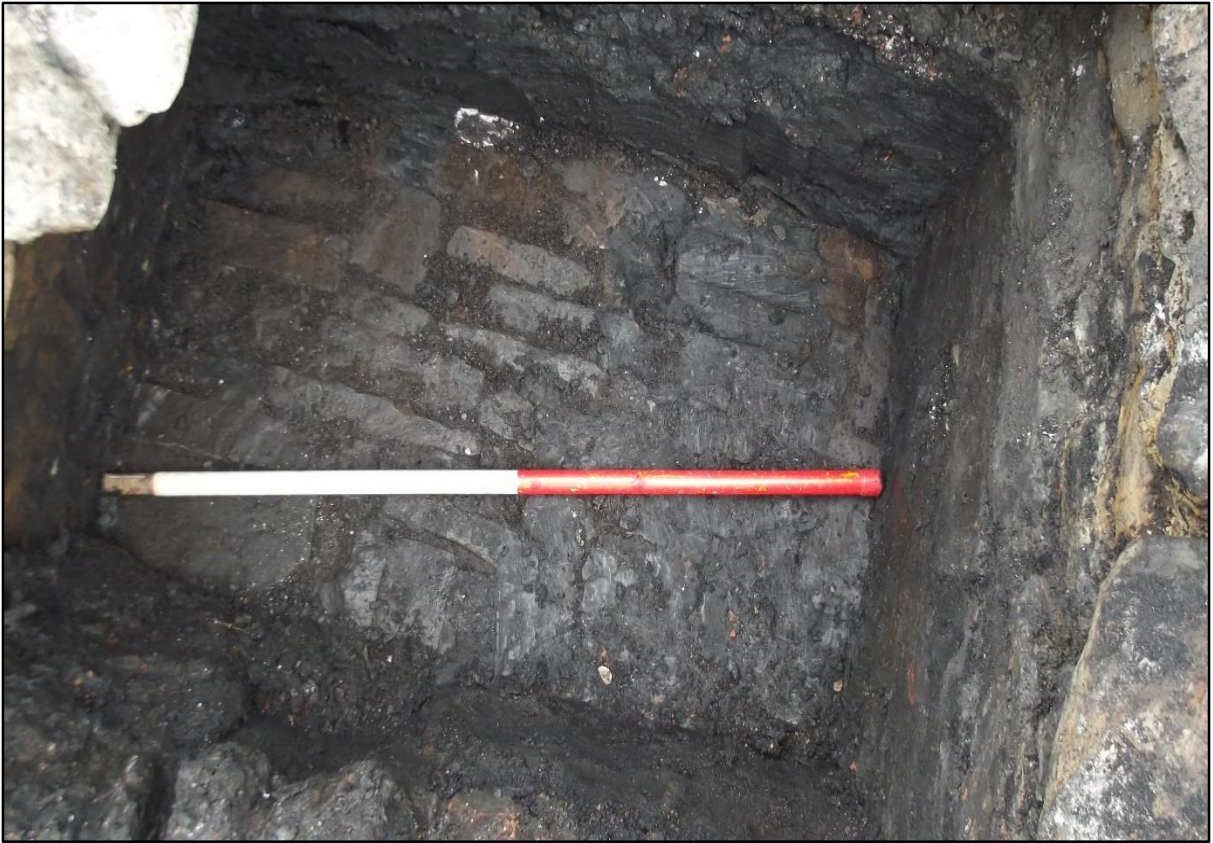
Plate 30. Coke yard area, stone floor of culvert 2295. Note the traces of clay on the upper stone courses.

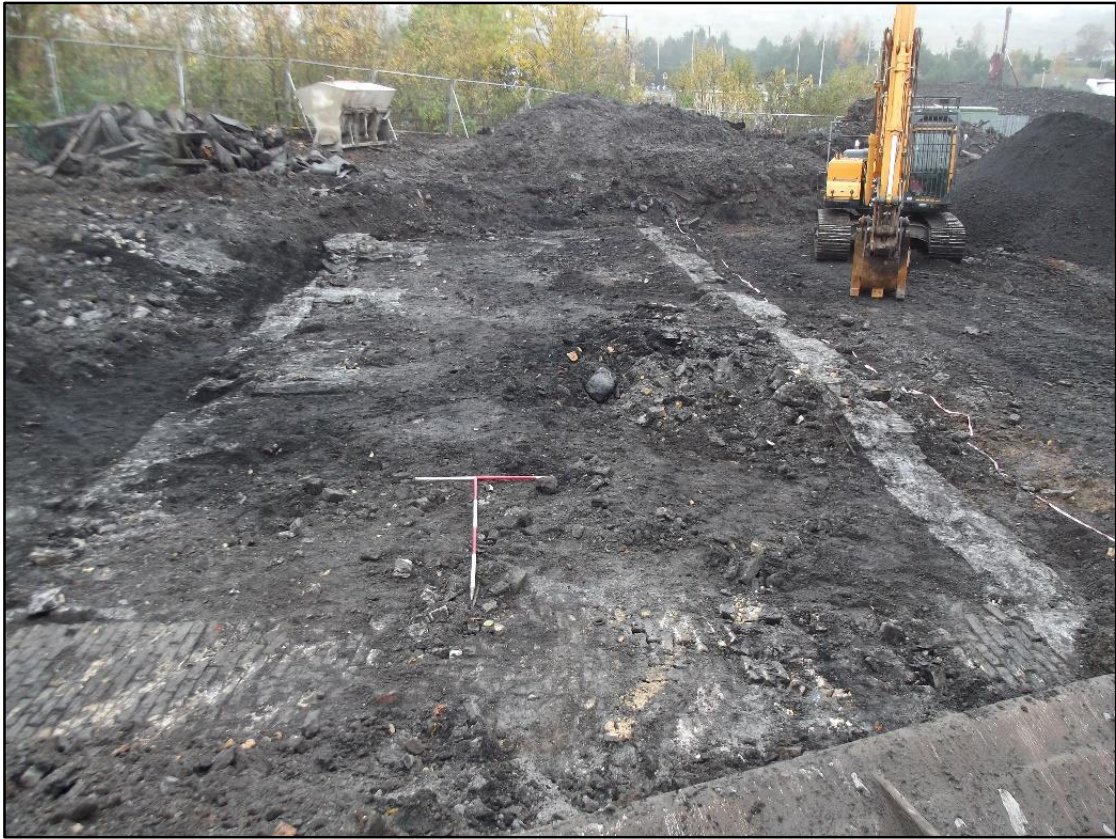
Plate 32. Remains of the smithy/forge building as exposed, view to south west.

The smithy building was partly exposed for a length of 16.8m during the development work in order to assess the extent of its survival and to record the remains prior to re-burial. The excavation revealed that only the lowest portions of the foundation walls survived, together with the highly truncated remains of three hearth bases, which had been built against the inside of the south east wall. The building had a width of 6.6m. There was no evidence of internal division within the building with the exception of a rectangular area of brick floor at the north east end of the building (Plates 32 and 33), which would approximate to the area of the gable chimney and doorway noted on the photograph above. Curiously, there was no obvious foundation for a partition wall demarcating the brick floor from the remainder of the smithy and the nature of this internal division above the floor is unknown.

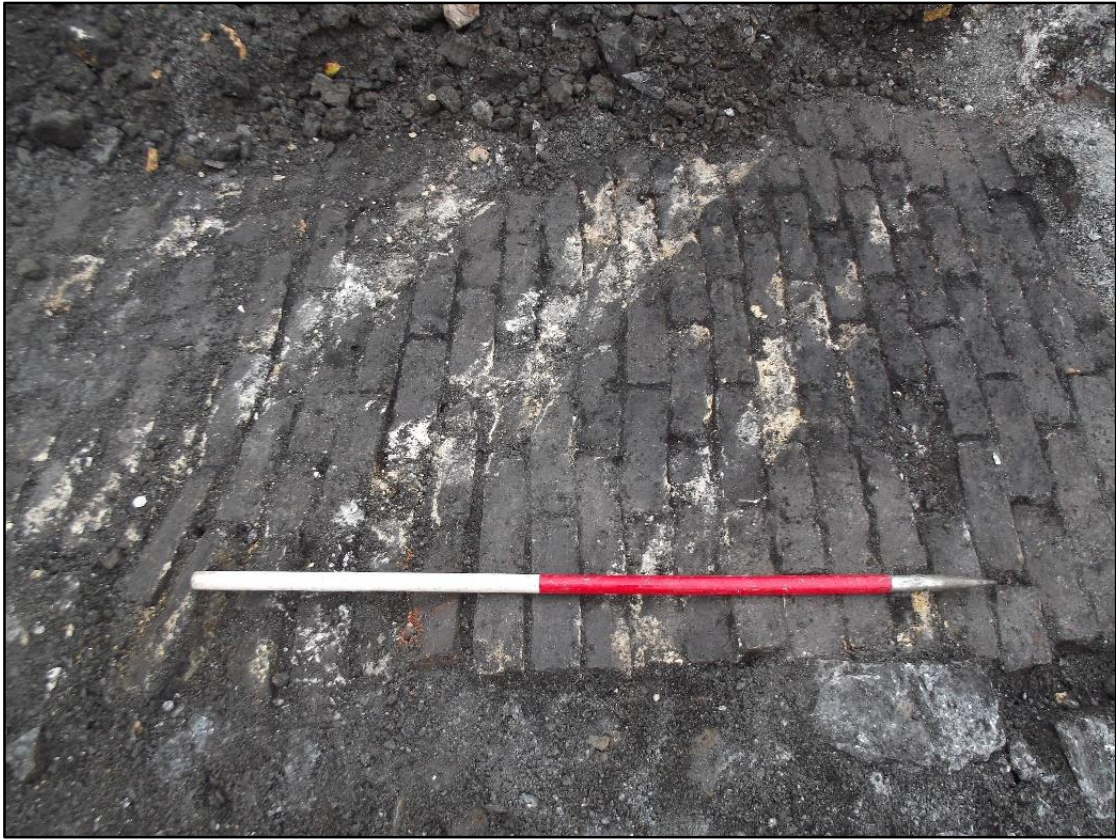
Plate 33. Brick floor surface forming the only internal division within the smithy/forge at the north east end of the building. View to north east.

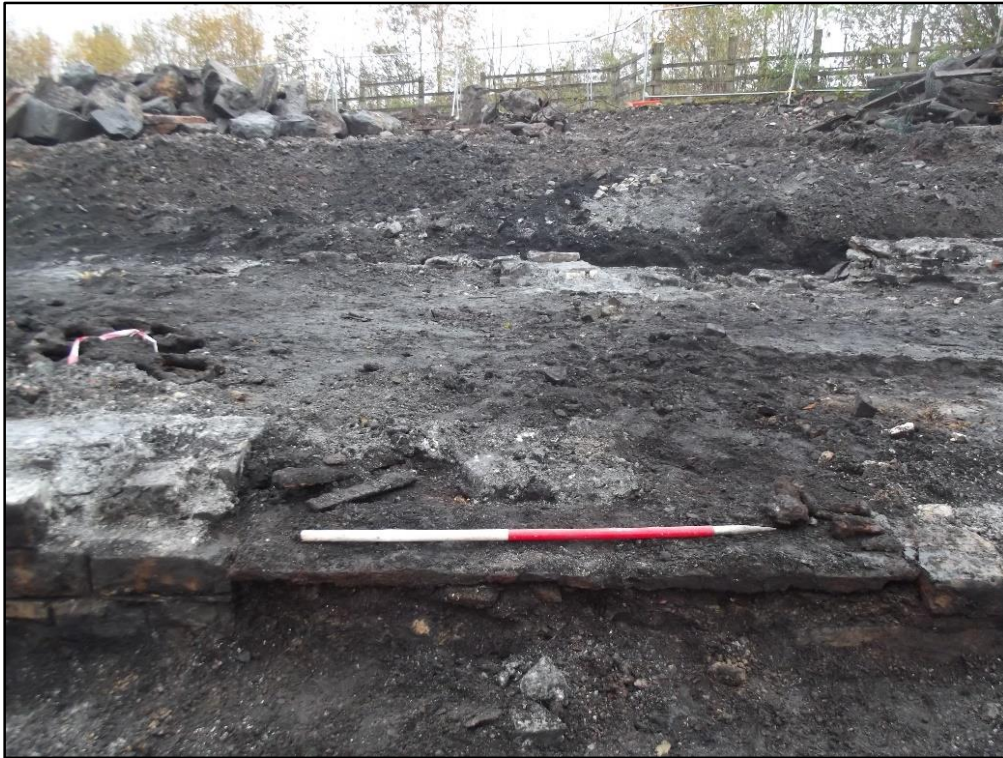
Plate 34. Iron plate forming a possible threshold into the smithy/forge. This was the only obvious entrance into the building although more undoubtedly existed. View to east.

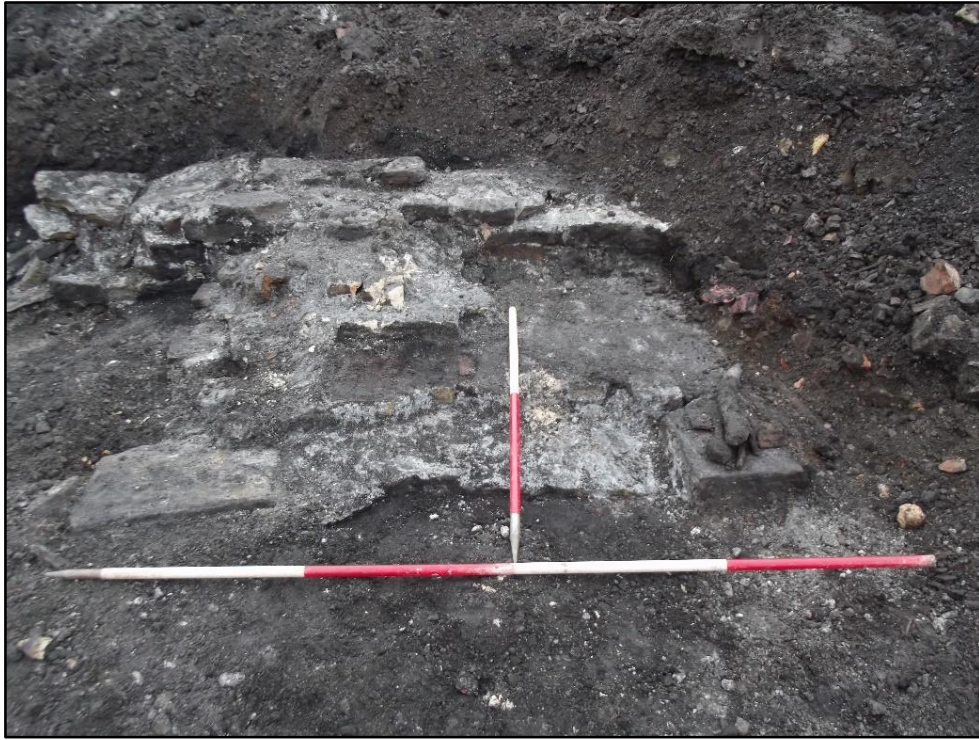
Plate 35. Remains of the best preserved hearth base. Along with two others, this is all that remains of the smithing stations that would have been in operation every day at the Cyfarthfa works. View to east.

Each of the hearths was constructed similarly, of stone bonded with light grey lime mortar. Brick had occasionally been incorporated in places but the overall effect was to produce a rectangular hearth, 2m wide and 1m deep, built against the inside of the south east elevation of the smithy wall, though not bonded to it. Each of the hearths was separated from its neighbour by a distance of 2.5m. The corners and sides of the hearths incorporated squared off blocks of stone, with the remainder having a much more irregular appearance and using liberal quantities of mortar (Plate 35). The only evidence of fittings was associated with the north east hearth, in the form of a 1m x 0.6m iron plate laid flat adjacent to the north east side of the hearth. The actual function of this plate is unknown. The original appearance of the hearths is speculative but based on similar, surviving examples, each is likely to have been equipped with a hood to remove fumes and smoke, and it is the chimneys for these hoods that are visible in the photograph mentioned above (Plate 31).

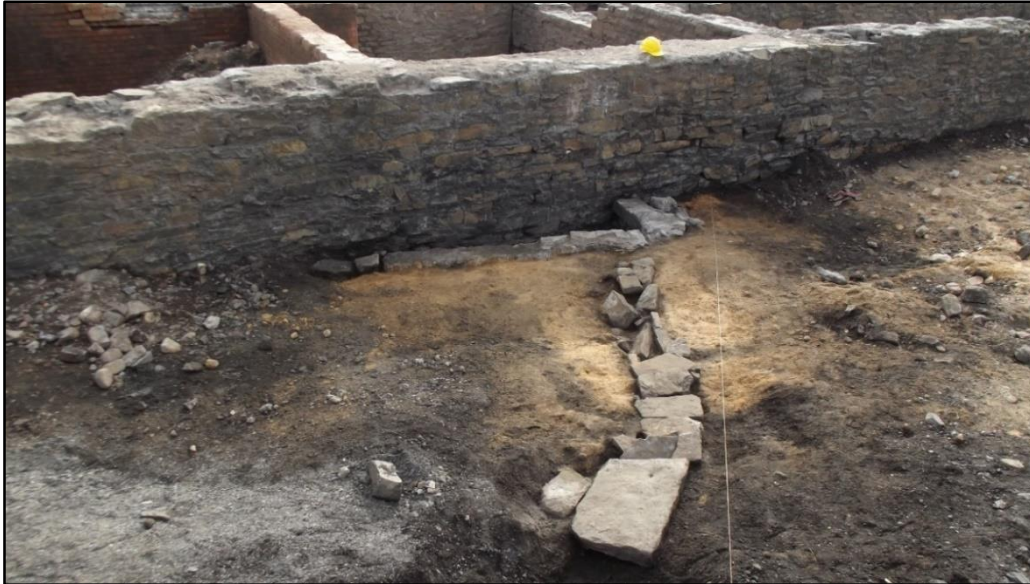
Plate 36. Walls 2249 and 2250 which had been cut by the construction of storage bunker wall 2213 for the coke works. Note also box drain 2248 which terminated at the corner of the structure.

The corner of a structure (2249 and 2250) and a stone capped drain (2248) were noted lying beneath the walls of the northern range of storage bunkers (2213) (Plates 36 and 37).

Mr. Cope Pearce's sketch of the Cyfarthfa works dated to 1856 (see conclusion) depicts a rectangular structure that appears to be partitioned into at least six separate parts and it is possible that walls 2249 and 2250 are part of this building. They are shown as being more extensive on the earlier 1851 Board of Health map and are labelled as storage areas but it is clear that this area of the works was in a state of flux over this period.

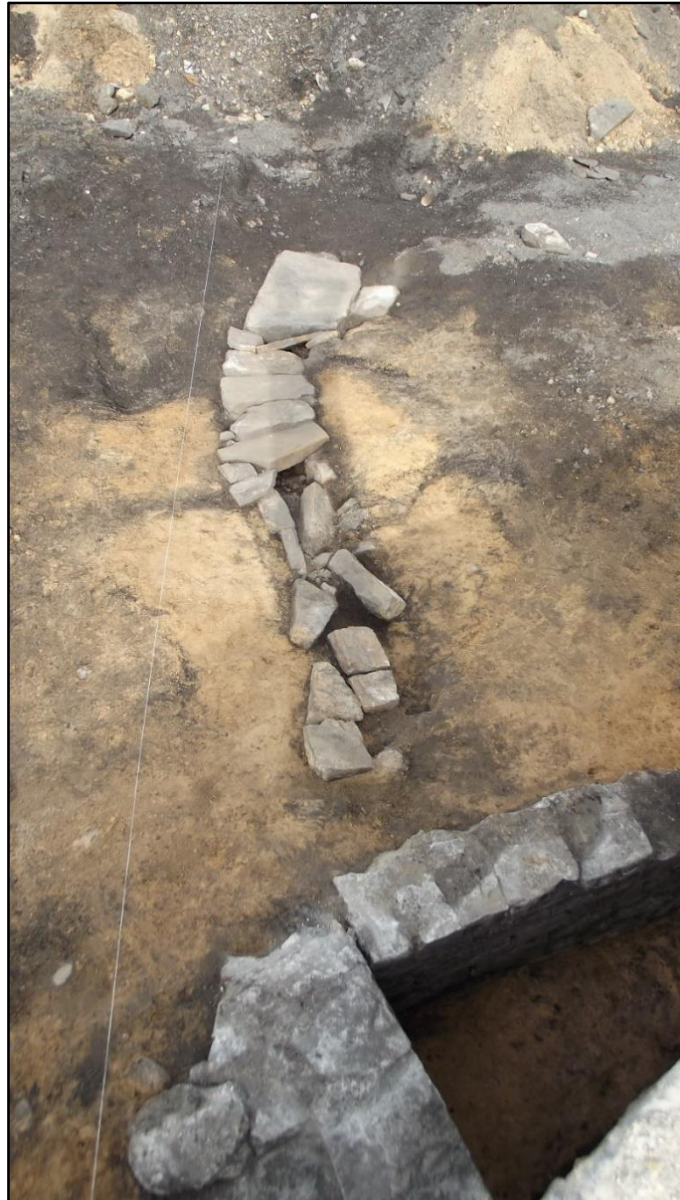
Plate 37. Stone capped drain 2248 may have been cut by the construction of walls 2249 and 2250; the exact nature of the relationship was unclear. This view towards the north east shows the fair faced interior of the structure.

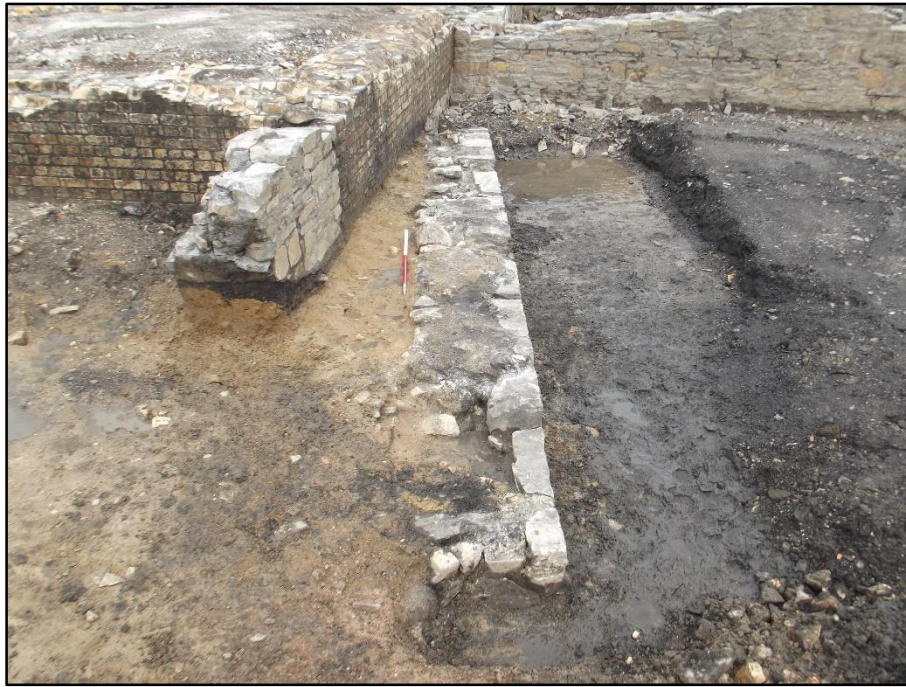
Plate 38. Phase 2 wall 2130, truncated by the construction of the 1882 washing and crushing plant. View to north west.

This truncated linear wall was of similar appearance to walls 2249 and 2250 although it was located further south and on a different alignment (north west to south east). The wall was 7.82m in length and survived to a height of 0.53m above the excavated ground level (Plate 38). It had been built of un-coursed pennant sandstone bonded with mid grey coal flecked lime

mortar and possibly some clay, resulting in a wall width of 0.77m. The wall is truncated both north and south by insertion of the Coppée coke ovens and crusher, indicating that the wall originally dated to before 1882. However, nothing more can be said regarding this feature other than it may relate to the series of storage buildings noted on the Board of Health map of Merthyr Tydfil and Cope's annotated plan of the works, both dating to the 1850s, as discussed above.

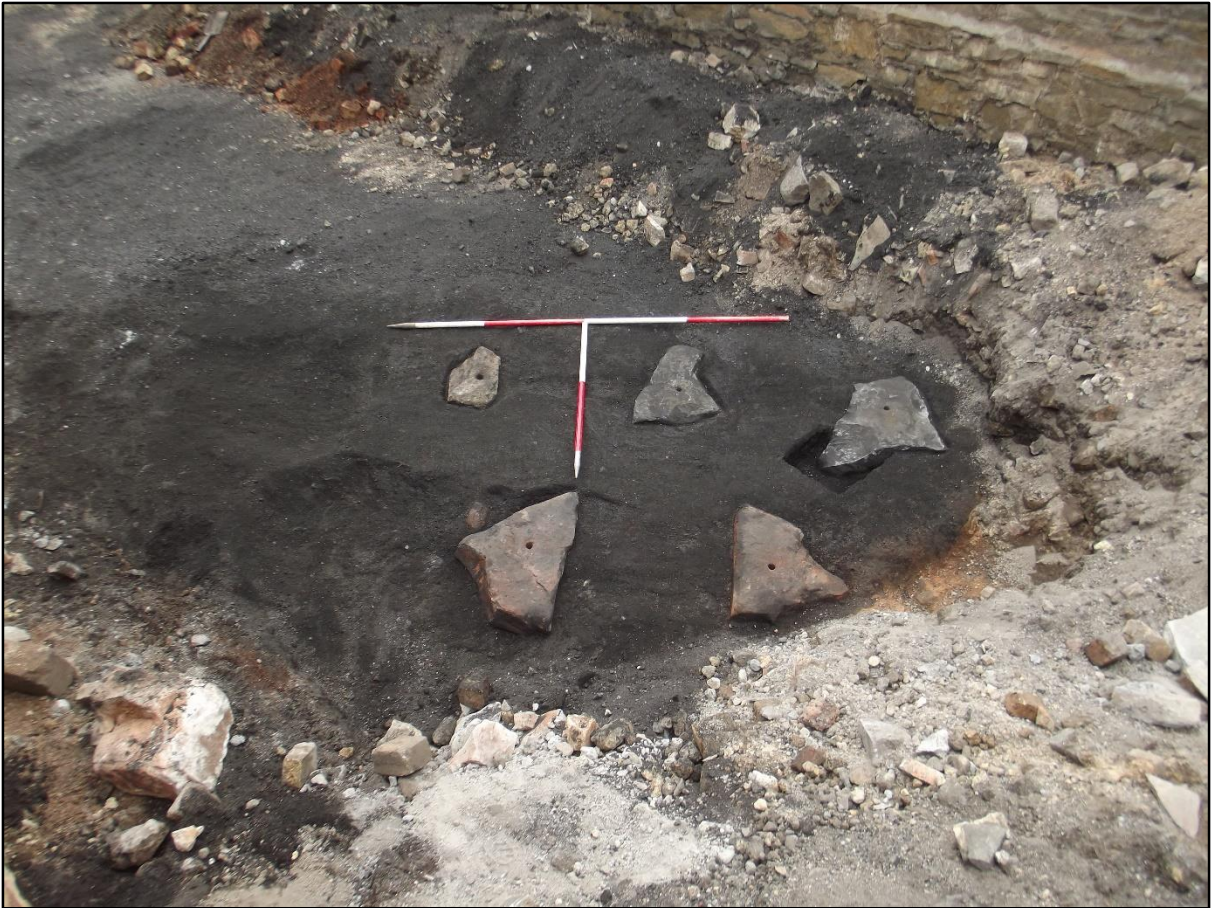
Plate 39. North Coke rammer wall area, the remains of a Phase 2 tramway (sleeper group 2384) which had survived beneath the fill of the rammer wall. View to north west.

A series of five stone tramway sleeper stones were located within the footprint to the north Coppée coke oven rammer wall (2323 to 2326). The sleepers were aligned north east/south west in two parallel lines (three and two stones respectively Plate 39). The stones were of pennant sandstone set into a compressed coal dust surface (2399) and were spaced apart sufficiently to create a gauge of 1.18m (3ft 7 inches). Each of the highly irregular blocks had a single circular hole drilled to presumably accept a retaining pin for the rail system. No iron staining was visible on any of the blocks and no other remains associated with the tramway appeared to have survived.

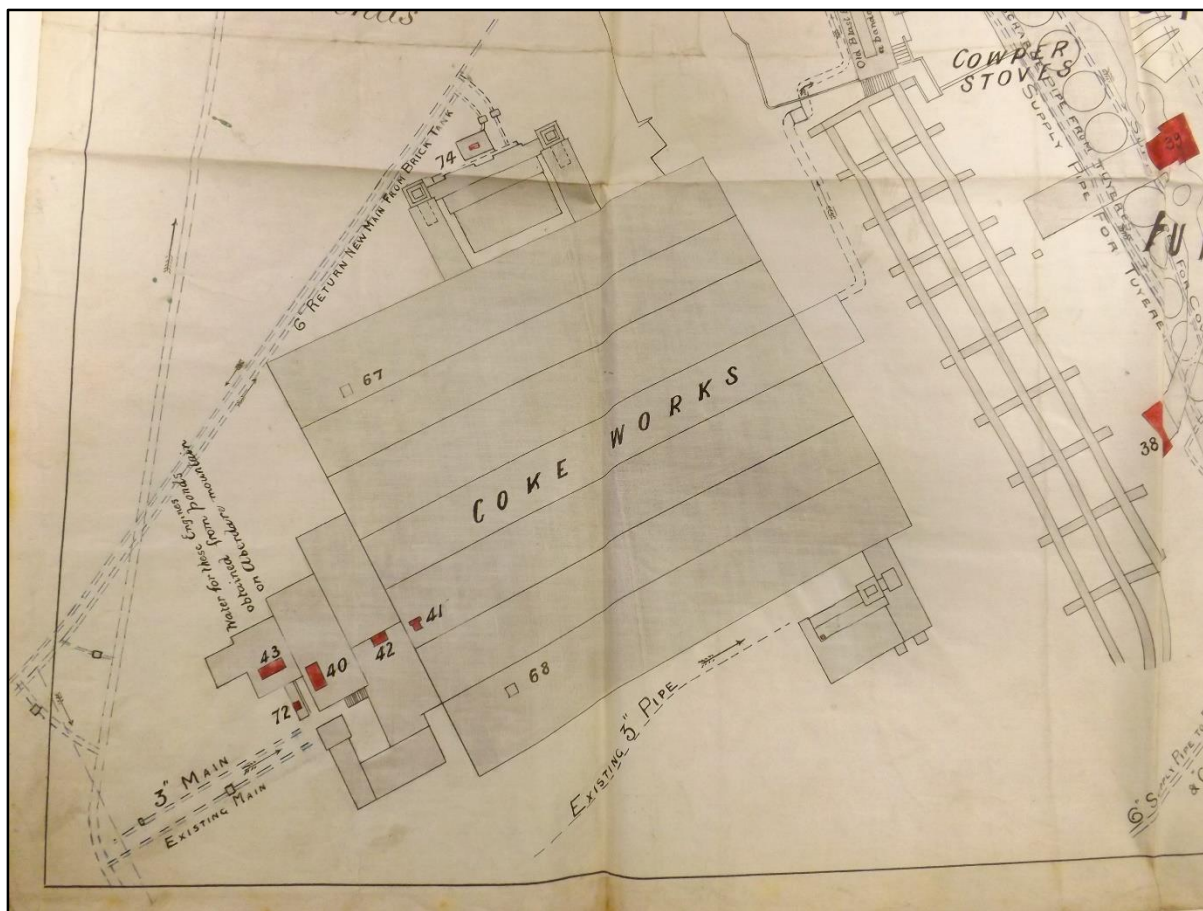
Plate 41. Annotated map of the Cyfarthfa coke works dated 23rd February 1892. This shows the Coppée coke oven complex in its original form (Phase 3a), prior to the addition of the Sheppard Washer in 1894/5. The red features are the locations of individual steam engines (Glamorgan Archives DG/F/9/10).

The first phase crusher, centred on the Carr's Disintegrator, is depicted on an annotated map of the works prepared by the Chief Engineer in February 1892 (Plate 41). This shows the layout of the washery and crusher buildings as well as the coke oven complex. The purpose of the map was primarily to indicate the location of various steam engines and their water supplies rather than to detail the layout of the plant itself. The building housing the crusher is labelled 43 and described in the accompanying schedule as a 'coal crushing rolls engine'. As the contract for the later addition of the Sheppard Washer specified the retention of the disintegrator, elements of the first phase should be visible and indeed it appears they are distinguishable by the use of different coloured brick, evident in the excavated remains.

wearing surface. The chute was 4.45m long as exposed, with the angle being more acute than the western one in order to accommodate the elevation drop in a shorter distance. The purpose of the narrower construction is unclear but it is possible that it may have permitted access to the base of the chute to clear obstacles or effect repairs. Alternatively, the gap may have been to allow passage of pulleys or other items of plant; the location is close to that for the coal crusher roll engine (engine 43 depicted on the above map of 1892 (Plate 41) although little relating to the engine was noted.

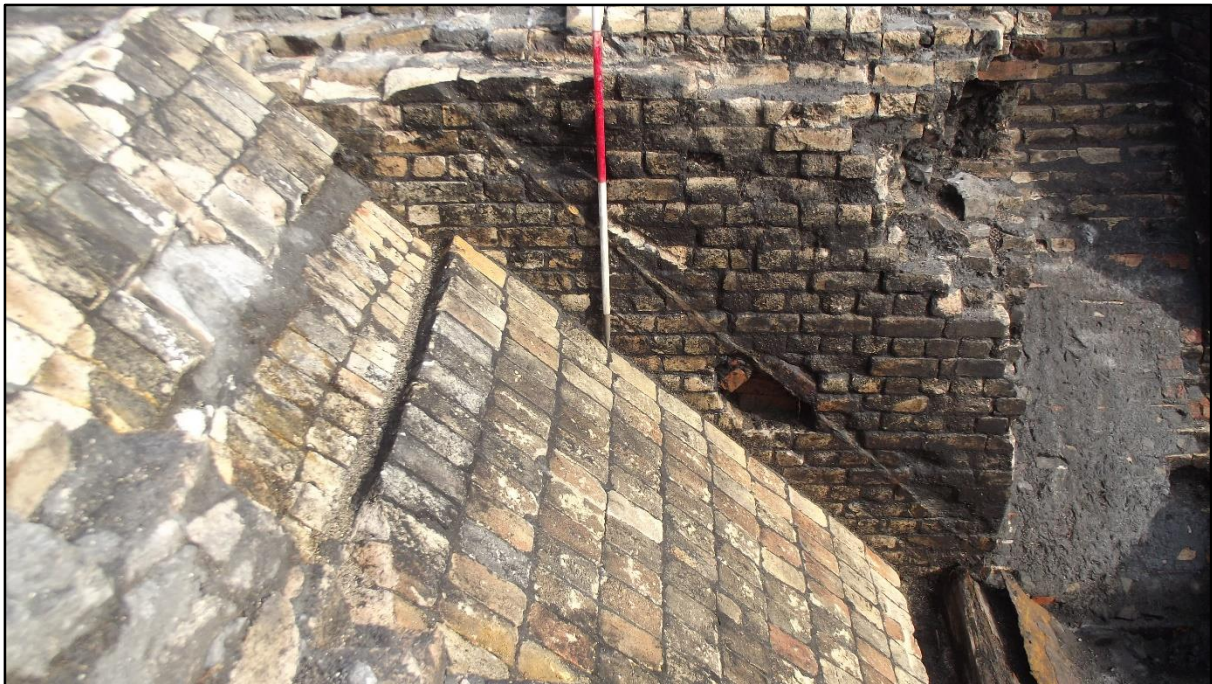
Plate 42. The western elevator chute 2063 for the Carr's disintegrator. Note the parallel lines on the far wall marking the position of the iron sheets that formed the actual wearing surface of the elevator. This sheeting was intact at a lower level, as seen at the bottom right of the photograph. View to north.

The main, western chute had originally been provided with a series of timber beams set into the brick, onto which iron sheeting was nailed or screwed, in order to provide a smooth wearing surface. This system was damaged but still present at the lower level of the chute (Plate 42).

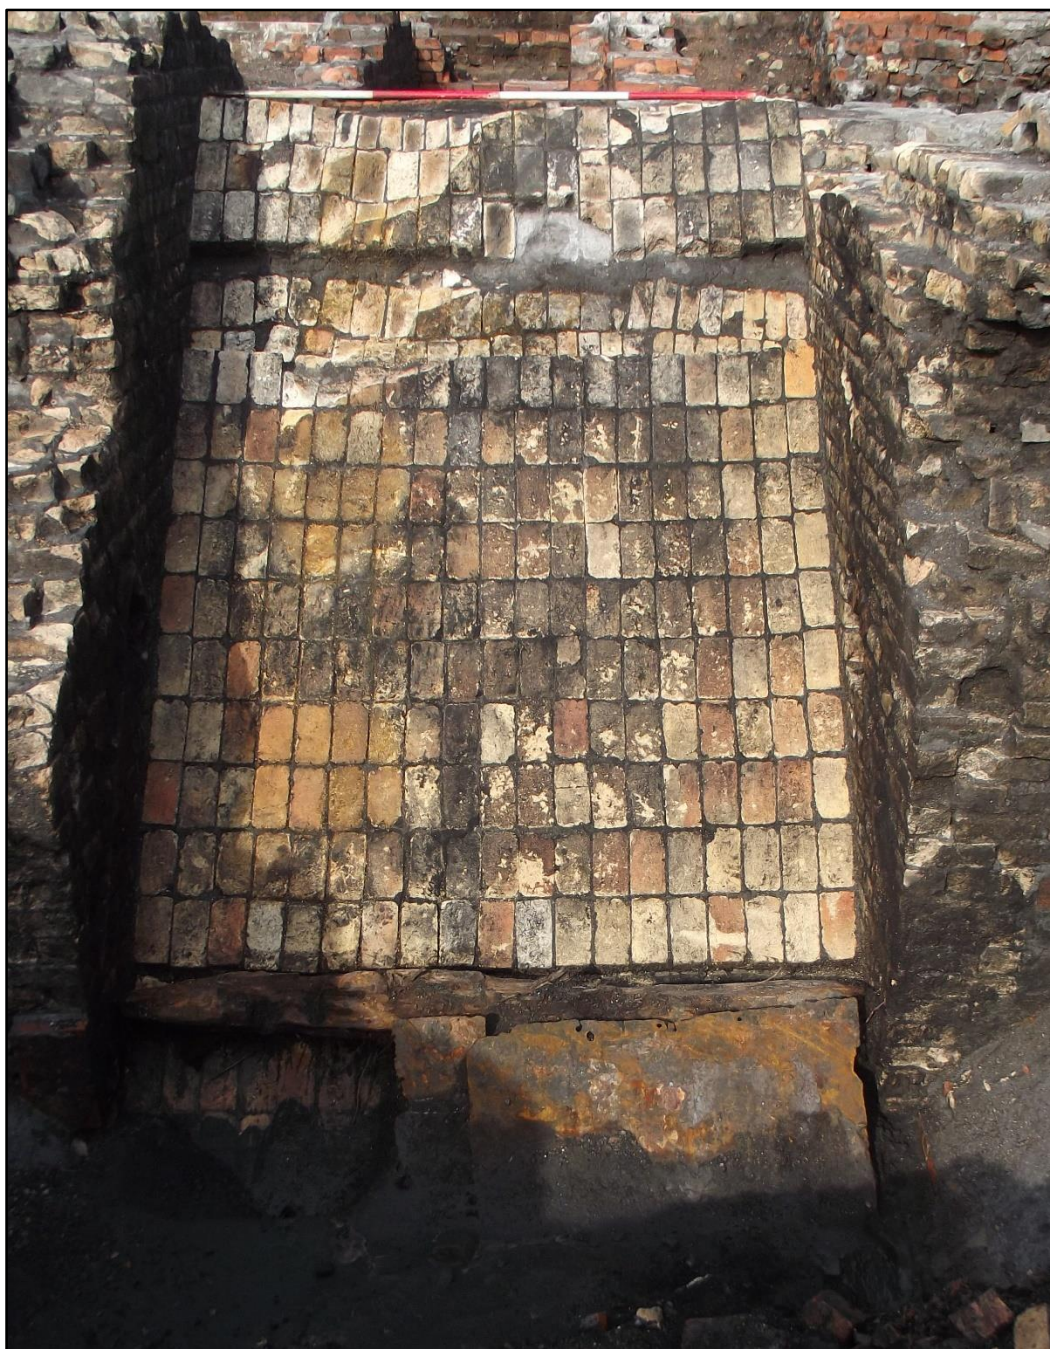
Plate 43. The western chute 2063 for the Carr's disintegrator elevator. View to west.

Plate 42. The western elevator chute 2063 for the Carr's disintegrator. Note the parallel lines on the far wall marking the position of the iron sheets that formed the actual wearing surface of the elevator. This sheeting was intact at a lower level, as seen at the bottom right of the photograph. View to north.....	73
Plate 43. The western chute 2063 for the Carr's disintegrator elevator. View to west. ..	75
Plate 44. The north chute (2064) of the Carr's disintegrator elevator pit. View to north.	77
Plate 45. The southern (2054) chute for the disintegrator elevator pit. Note the reversed 'L' shape which contrasts with the full width of the other two chutes. View to south. ...	78

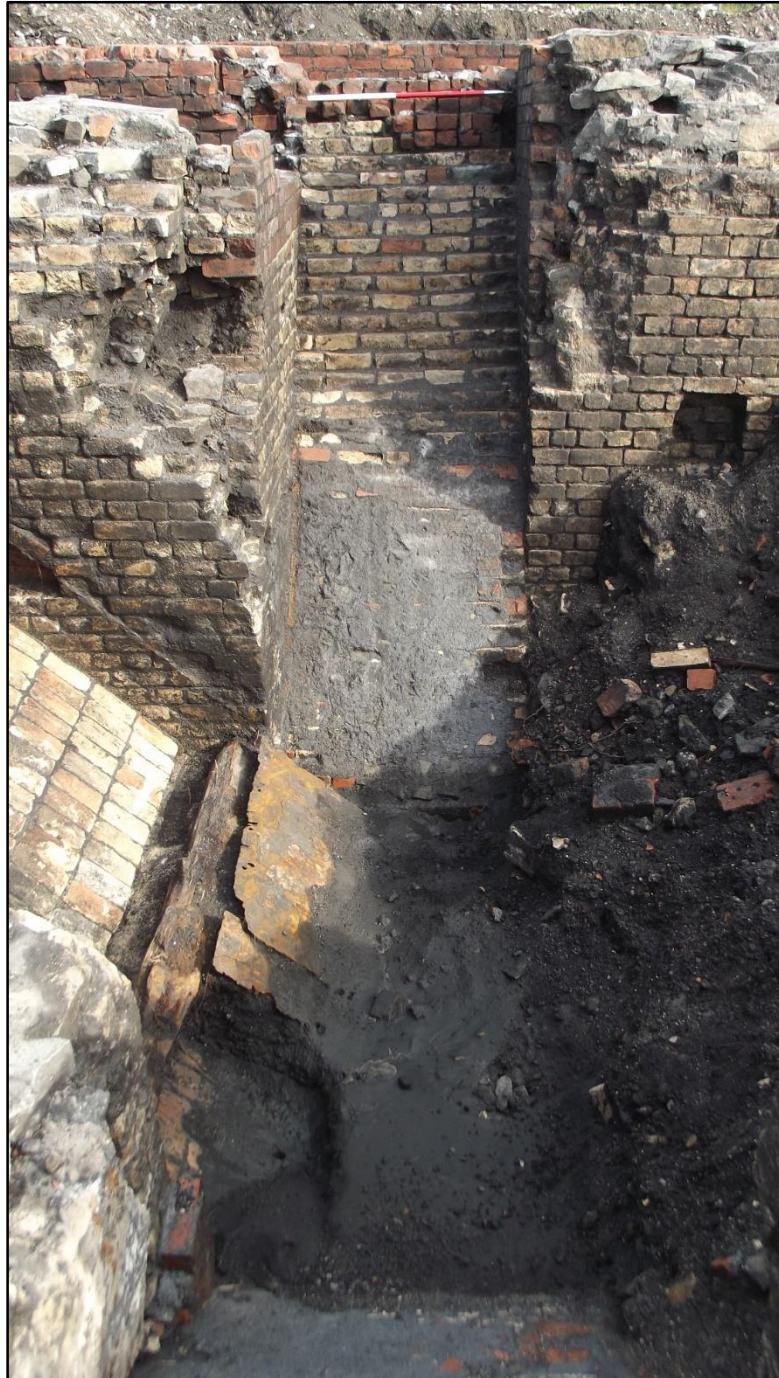
Plate 44. The north chute (2064) of the Carr's disintegrator elevator pit. View to north.
