Cyfarthfa Coke Works (The Old Thorn Lighting Works) Merthyr Tydfil

Excavation report and analysis

October 2017

GGAT report no. 2017/051
Project no. P1844
National Grid Reference:
SO 03708 06785

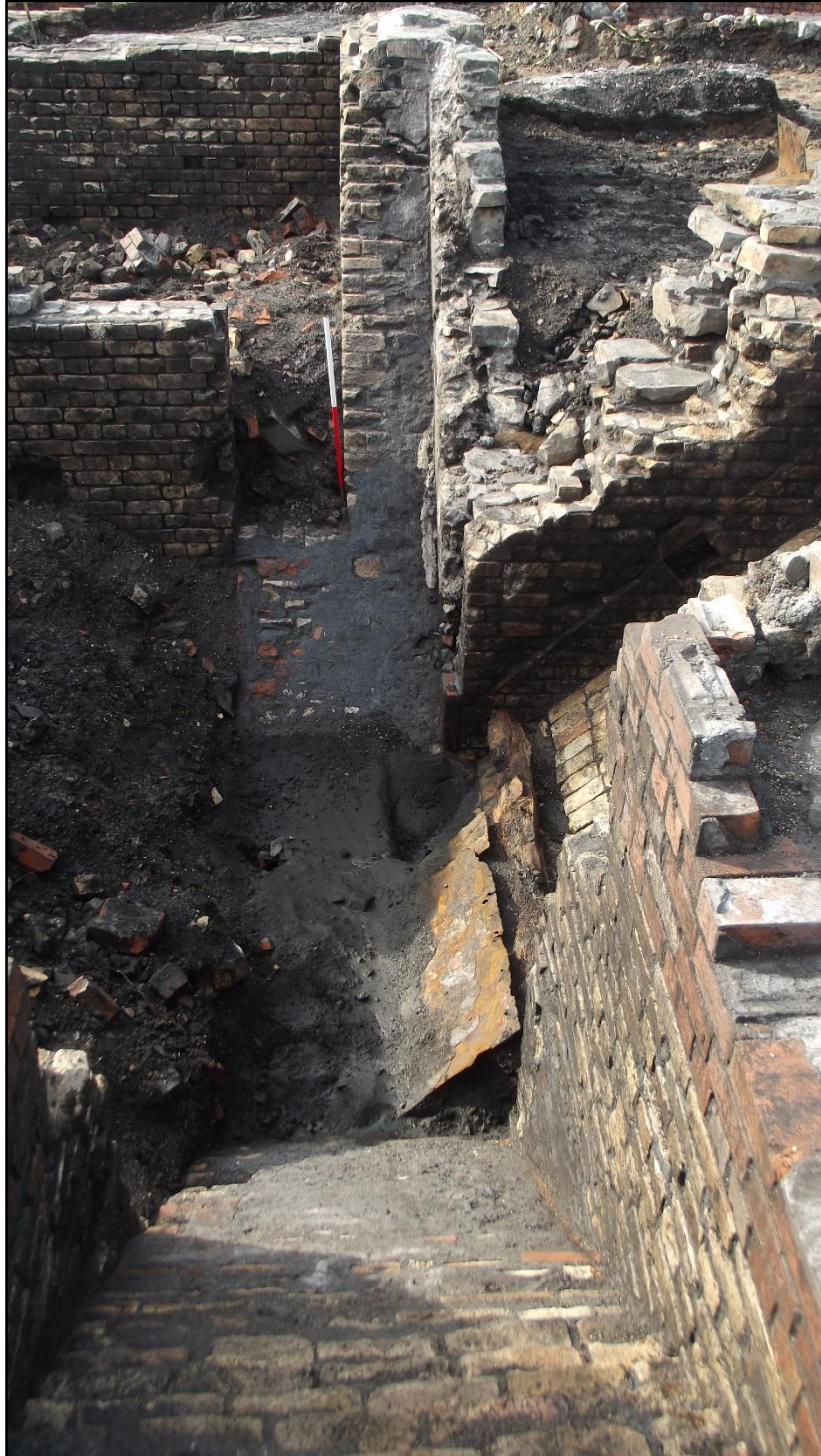
Plate 45. The southern (2054) chute for the disintegrator elevator pit. Note the reversed 'L' shape which contrasts with the full width of the other two chutes. View to south.

A third chute was located in the south of the disintegrator elevator pit; chute 2065 was the most unusual of the three, being relatively narrow (0.63m at the minimum) at the upper level and widening out to 1.17m towards the base of the excavated depth. This arrangement produced an 'L' shaped surface to the chute, readily apparent in the photographs (Plate 45).

The construction of the southern chute was similar to the northern one *i.e.* it had been built of largely yellow refractory bricks rendered with a hard grey lime mortar to produce a smooth

wearing surface. The chute was 4.45m long as exposed, with the angle being more acute than the western one in order to accommodate the elevation drop in a shorter distance. The purpose of the narrower construction is unclear but it is possible that it may have permitted access to the base of the chute to clear obstacles or effect repairs. Alternatively, the gap may have been to allow passage of pulleys or other items of plant; the location is close to that for the coal crusher roll engine (engine 43 depicted on the above map of 1892 (Plate 41) although little relating to the engine was noted.

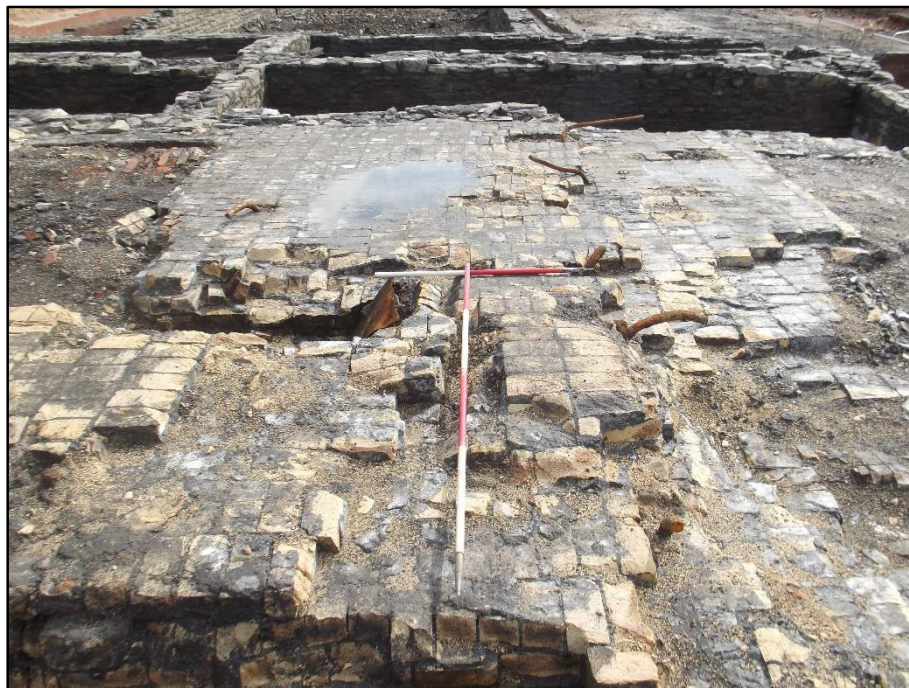
Plate 46. Foundation and mounting pins for the disintegrator and elevator engine. View to north east.

A substantial brick build foundation for an engine was located adjacent to the area formerly occupied by the Carr's disintegrator (Plate 46). This foundation was solidly built of yellow refractory brick and measured 3.89m in length by 4.94m in width, being at least 3.5m in height and probably significantly larger when the unexcavated portion was taken into account. The feature contained the remains of six iron mounting pins aligned north west to south east as well as a slot lined with sheet iron which dropped into the foundation for an unknown length. This foundation is believed to have supported engine 40, as depicted on the 1892 map; this engine is described as the disintegrator and elevator engine and is positioned conveniently in between both the storage bunker and crusher areas. It is possible that the slot in the foundation was to permit the passage of line shaft belting or similar means of transmitting the motive power generated by the engine.

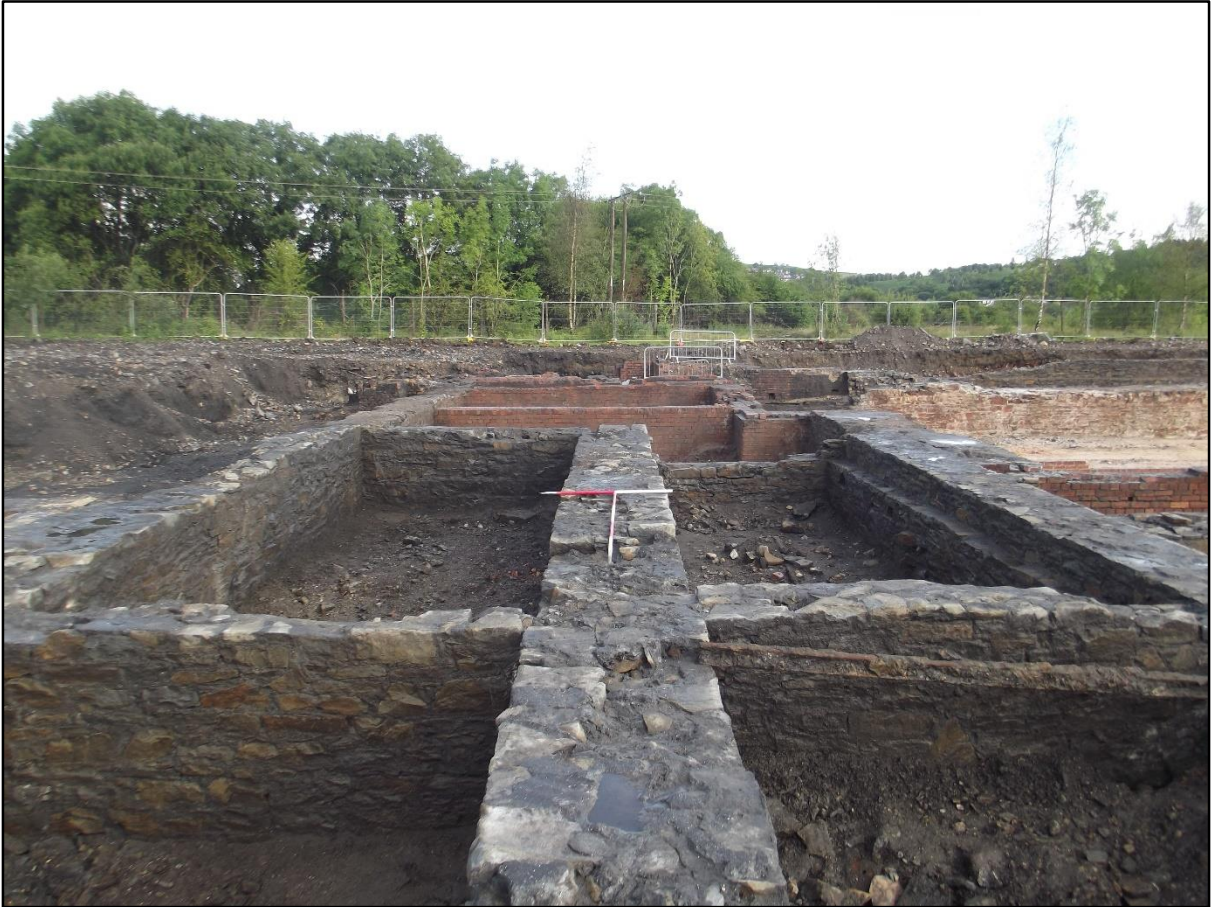
Plate 47. Phase 3a storage bunkers showing the internal division into four. Note the Phase 3b extension to the bunkers as the red brick walls in the distance. View to north.

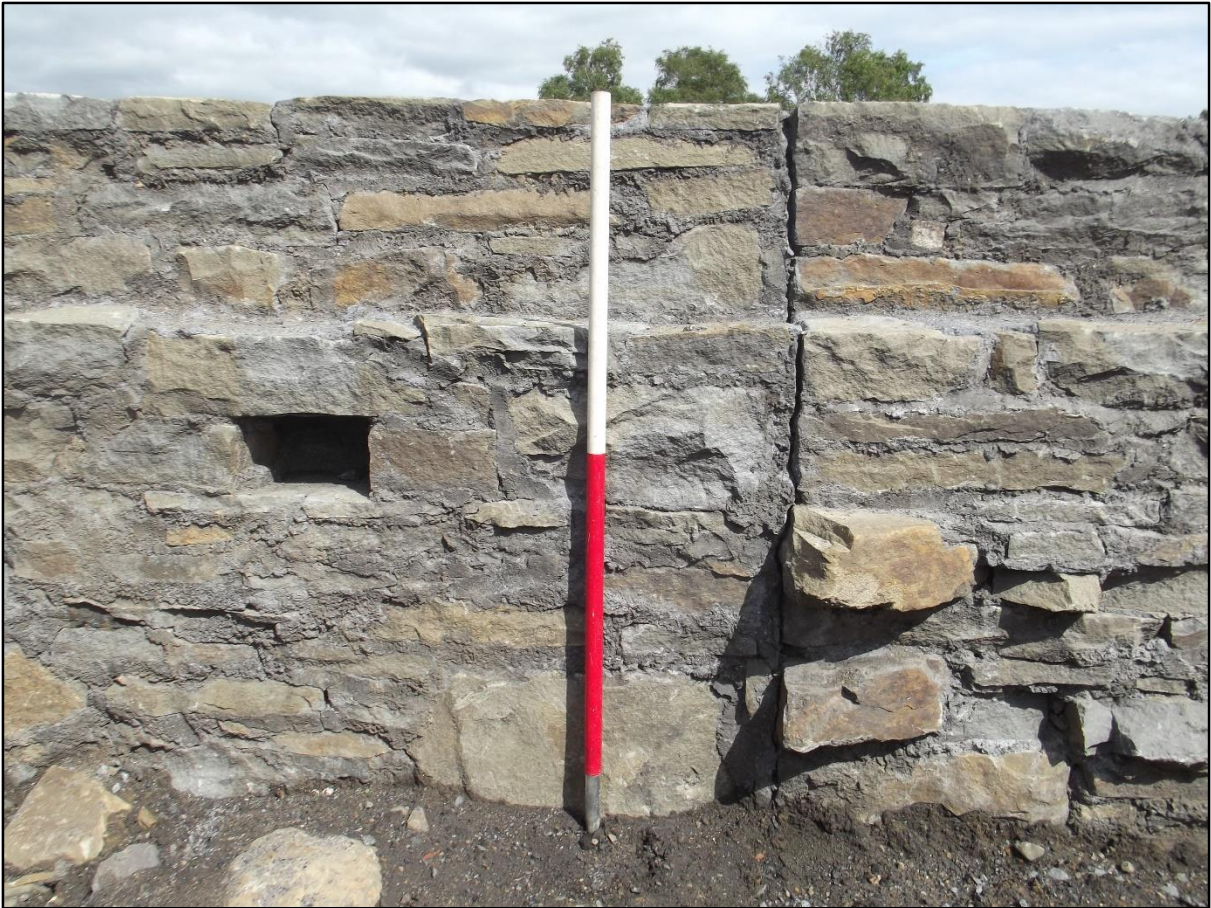
Plate 48. Phase 3a coal storage bunker group 2172. Abutment of walls 2176 (left) and 2181 (right). View to east. The slot (recess 2192) in wall 2176 is believed to be a beam slot to support a floor level, working in conjunction with the step in the walls visible in the photograph.

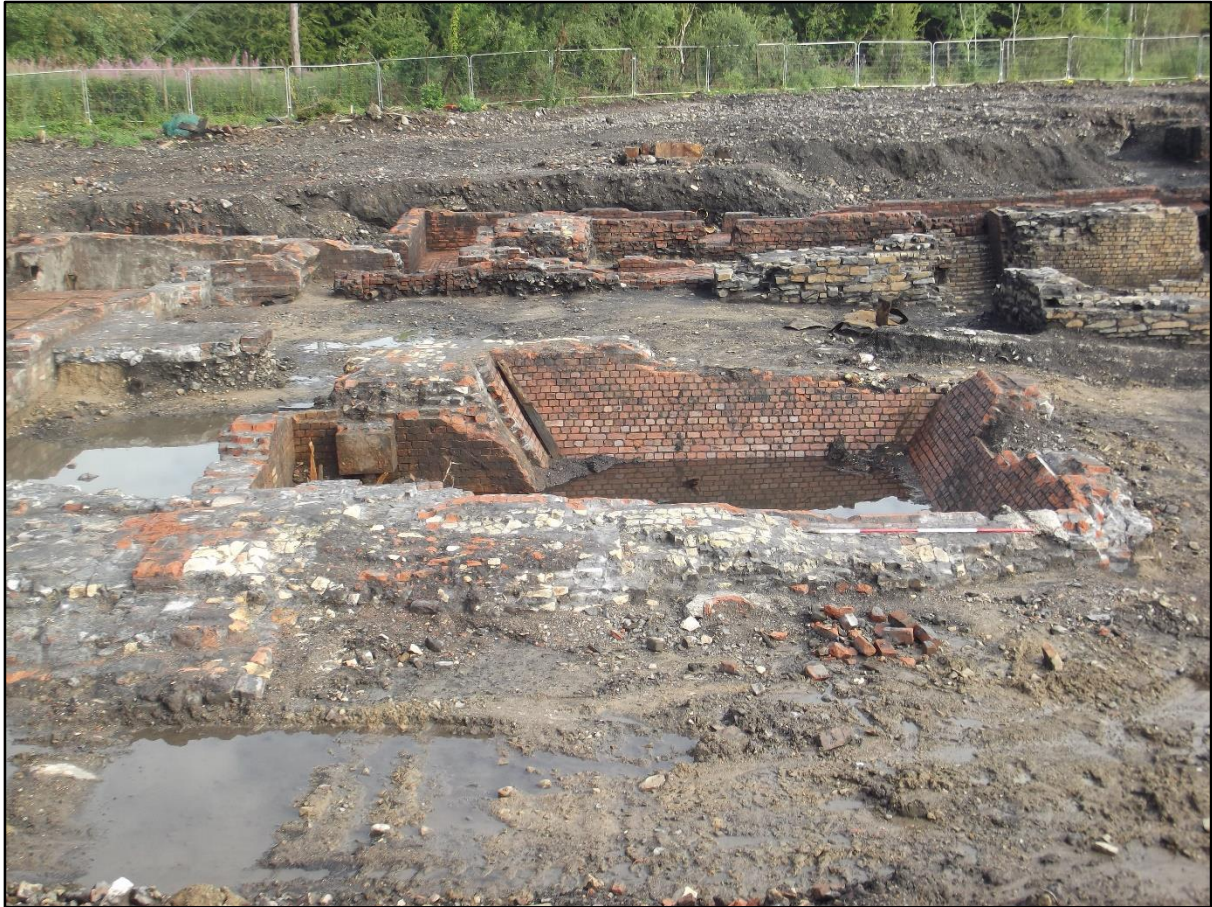
Plate 49. General view of the remains of the hopper (Group 2055) for the Sheppard coal washer, view to north

This feature consisted of an inverted brick chamber of pyramidal shape (Group 2055, Plates 49 to 51) and was the means by which coal began its journey through the washery.

The whole of the surviving element of the hopper was square in plan, with sides measuring between 5.65m and 5.71m long. The west wall of the hopper contained an engineered recess, slightly rectangular in plan, measuring 3m by 2.7m. Two brick and iron supports had been constructed either side of this recess, each being 0.61m long and 0.36m deep. These supports consisted of heavy cast iron boxes, filled with brick and were intended to take the great weight of the east elevation of the building that housed the washery plant, as it spanned the hopper. Originally, a double set of railway tracks spanned the hopper, permitting coal trucks to drop their cargoes into the space beneath. The coal was then scooped up in a chain bucket lift system, for transport to a rotating drum that would loosen and roughly size the coal and thence to the

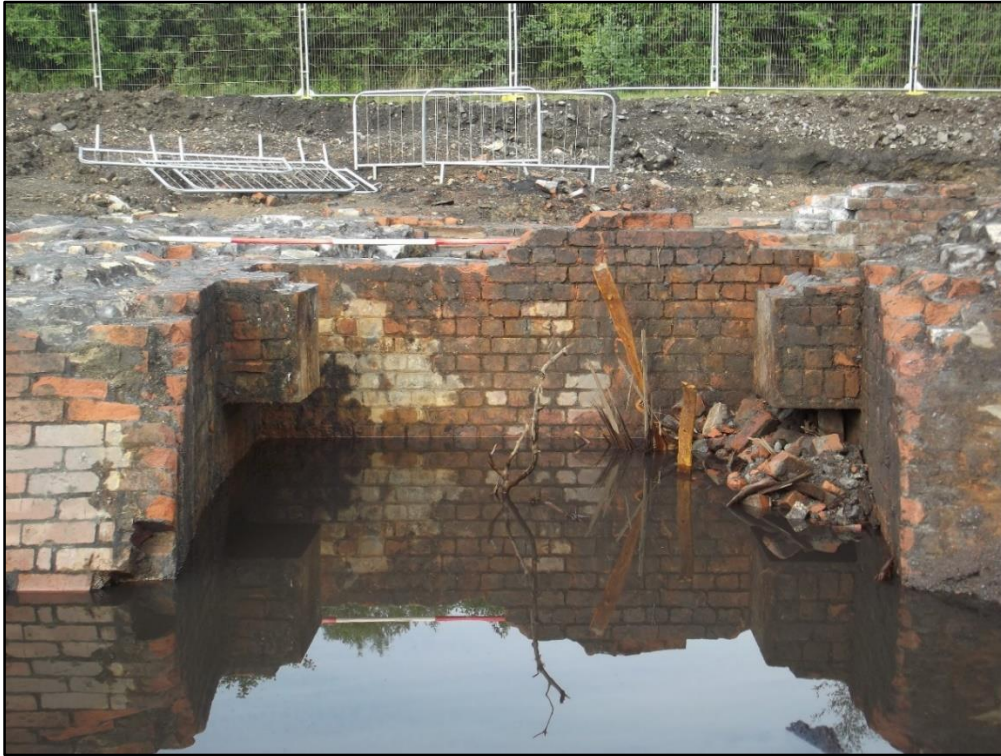
Plate 50. Recess in hopper 2055 showing the iron and brick wall supports on either side. View to west.

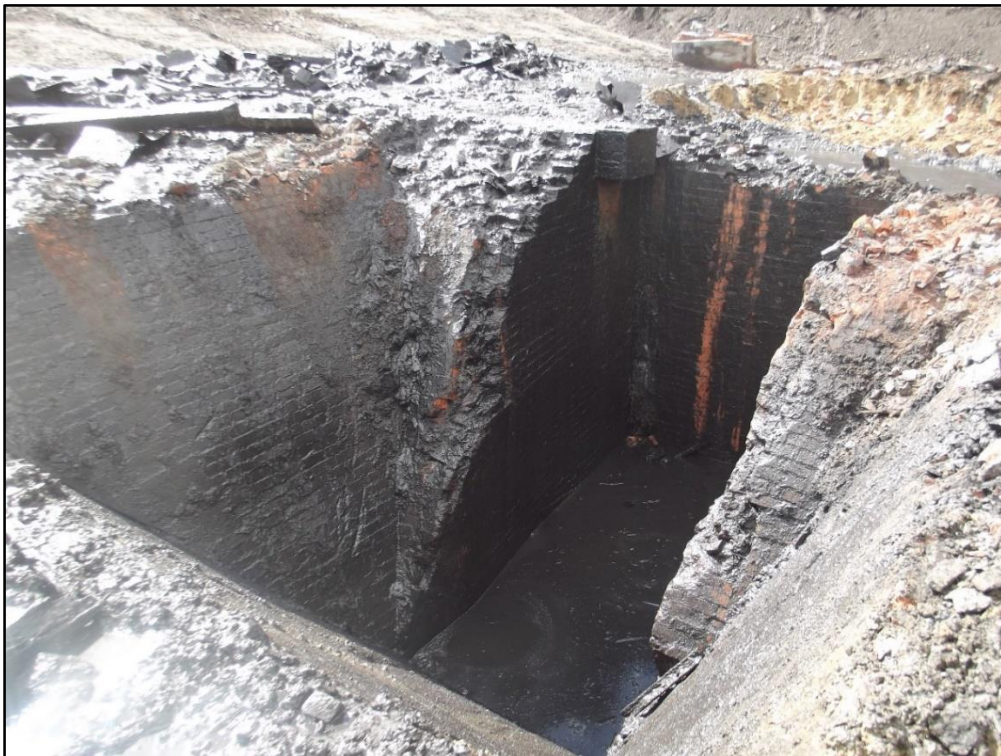
Plate 51. Hopper 2055 following clearance of the water and debris that it had contained. This feature is exactly as depicted in a drawing contained in The Engineer of 12th December 1895. The rectangular chamber housed part of the chain bucket system.

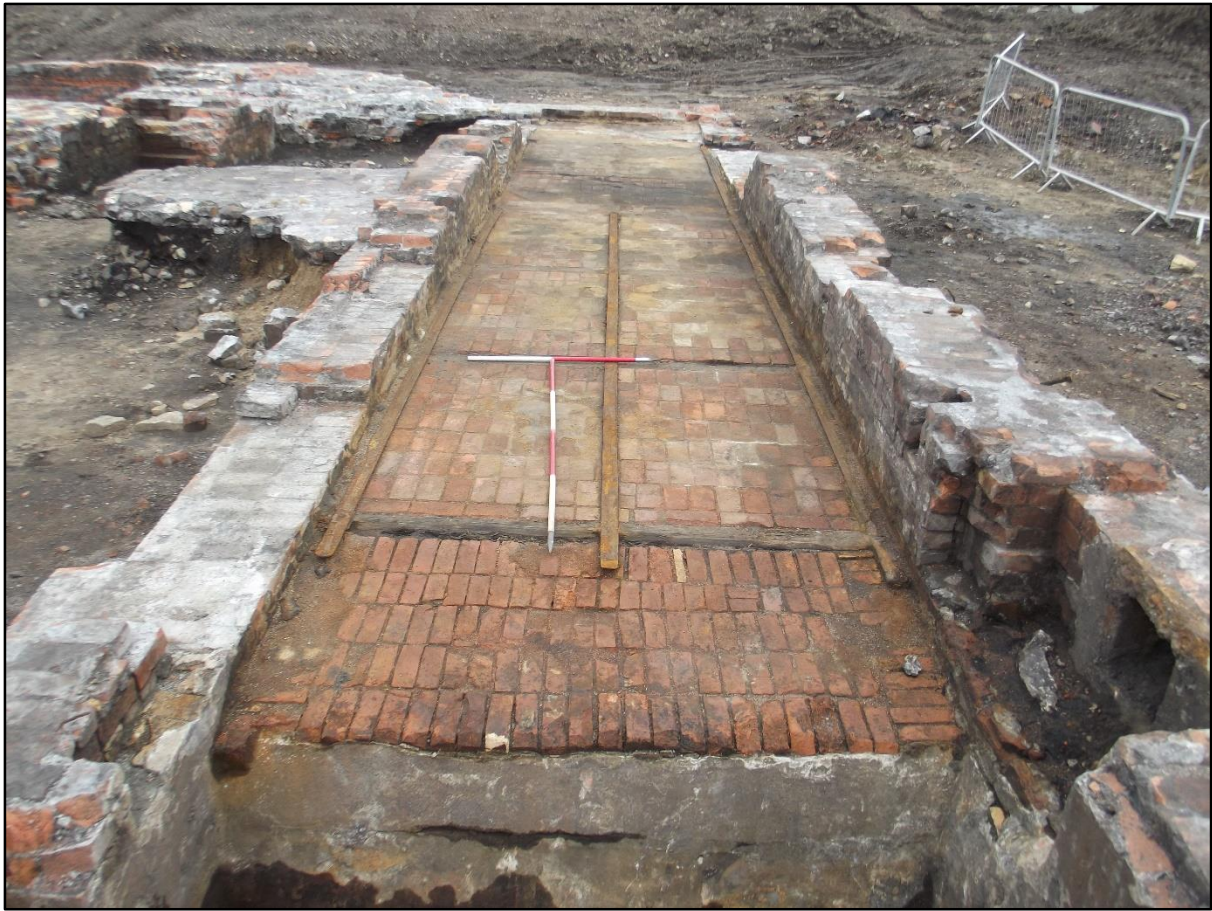
Plate 52. Base of the remains of the settling chamber. View to south

The remains of the settling chamber (Group 2051) consisted of a red brick floor, 14.01m long and 2.2m wide, flanked by two parallel red brick walls (Plate 52). The floor was divided into seven separate sections, each divided by a timber beam measuring a standard 0.15m x 0.24m (Contexts 2112 to 2117) at floor level that spanned the width of the chamber. The location of each beam corresponded to a recess in the flanking walls which probably related to structural elements of the scraper system. The length of the floor equates exactly to the 45 feet mentioned

in the 1895 article for the length of the chamber. Three iron strips were found overlaying the sleepers, running along the length of the chamber, one at either edge and one down the centre; none of the strips were intact and it is thought that other sections must once have run the entire length of the chamber, possibly serving as spacers between the brickwork and plant or even as a wearing surface for the scraper mechanism, although there was no sign of undue wear and tear on either the floor surface, beams or iron strips (Plate 53).

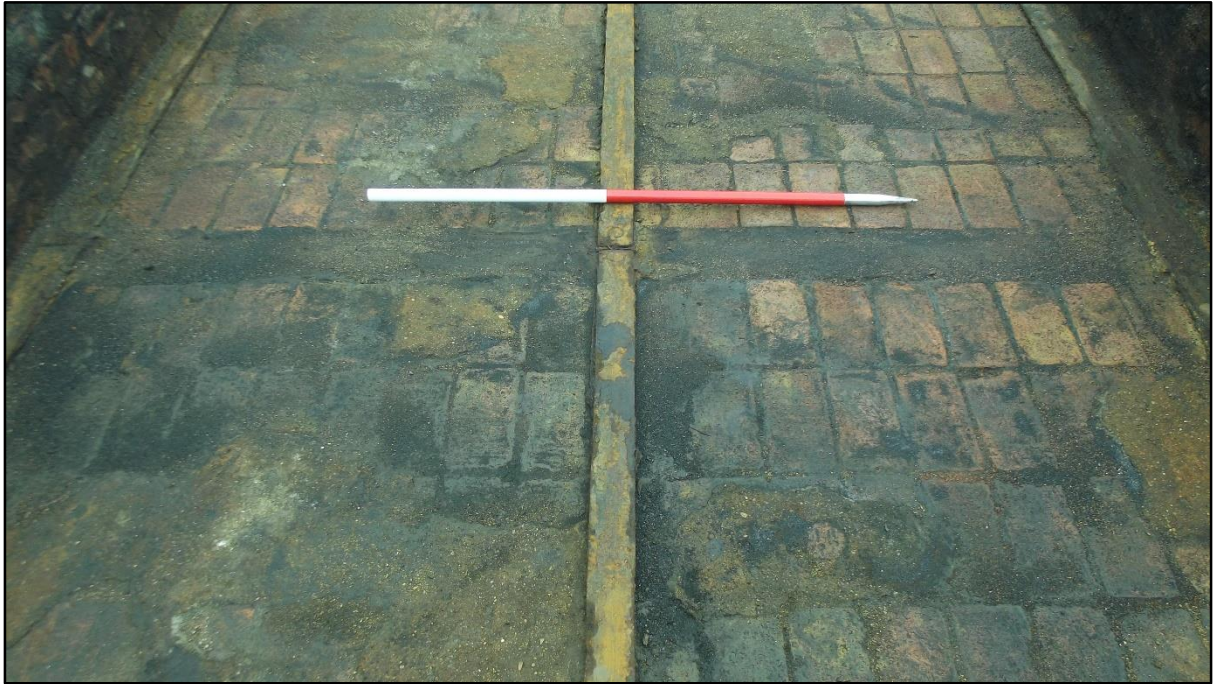
Plate 53. Closer view of the iron strips on the base of the settling chamber. They had been secured to the timber sleepers by round flathead nails. Scale is 1m.

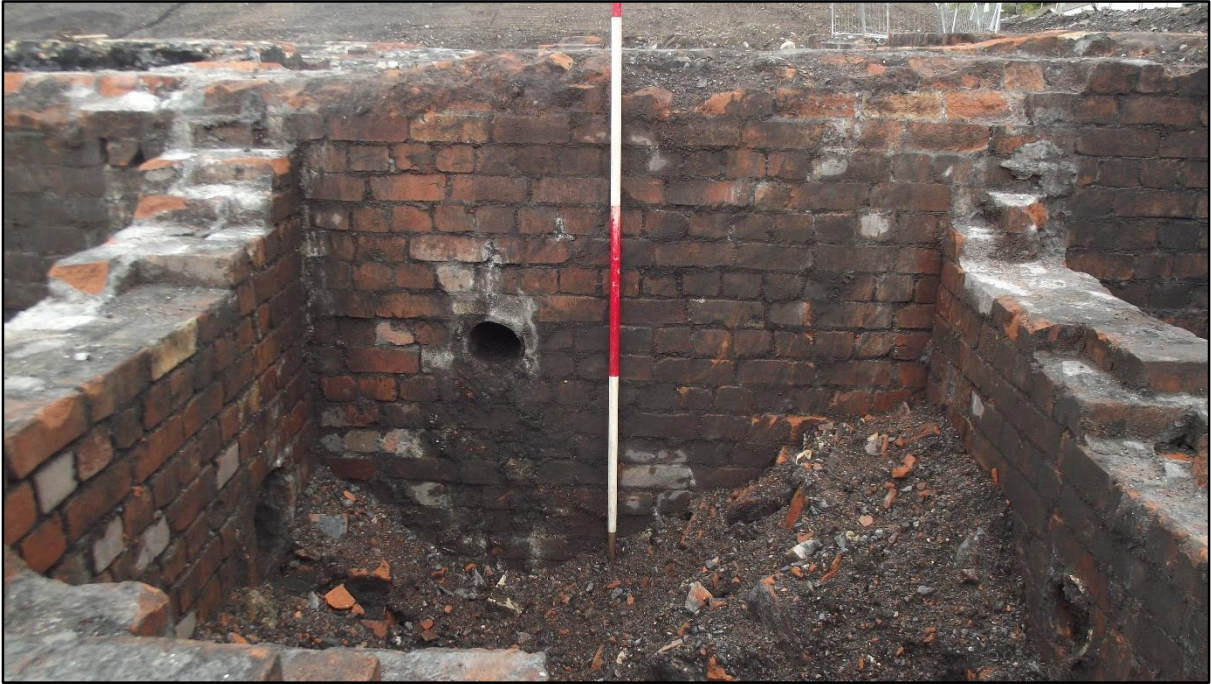
Plate 54. Sheppard washer chamber 2038, view of the interior, looking south. The chamber contained three pipes, the one from elevator pit 2049, and two others, set lower which are likely to have emptied the chamber. The fill of the chamber (2039) was not excavated due to the presence of asbestos.

A series of truncated red brick walls and floors located immediately west of the settling chamber marks the former location of the Sheppard Feldspar washer. These features (floors 2047 and 2047 and walls 2041 and 2042) are all that remain of the mechanism used to initially wash the coal prior to it moving to the settling chamber. This section of the plant had largely been destroyed, although iron pipes 2125, 2043 and 2040 are probably the remains of high pressure steam pipes used to power the Feldspar washer and possibly to provide the water required (Plates 54 and 55).

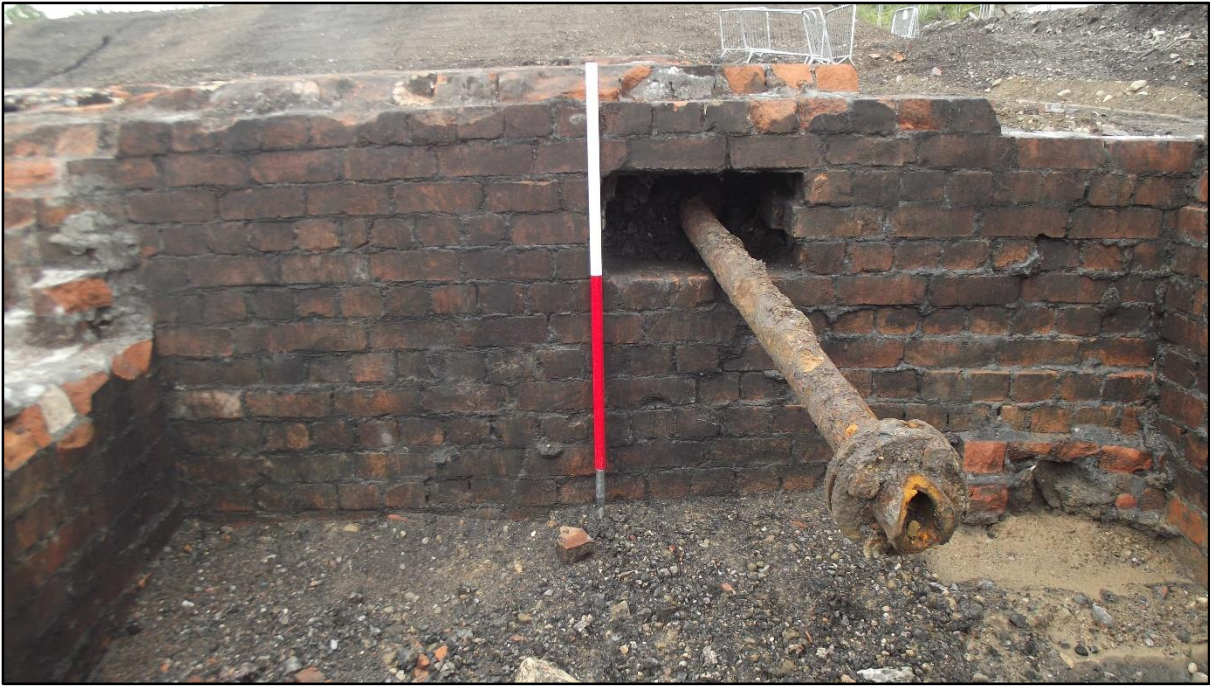
Plate 55. High pressure steam or water pipe 2044. This pipe probably helped to supply power or water for the Sheppard Feldspar washer located west of the settling tank and was one of the few remaining elements of it to have survived.

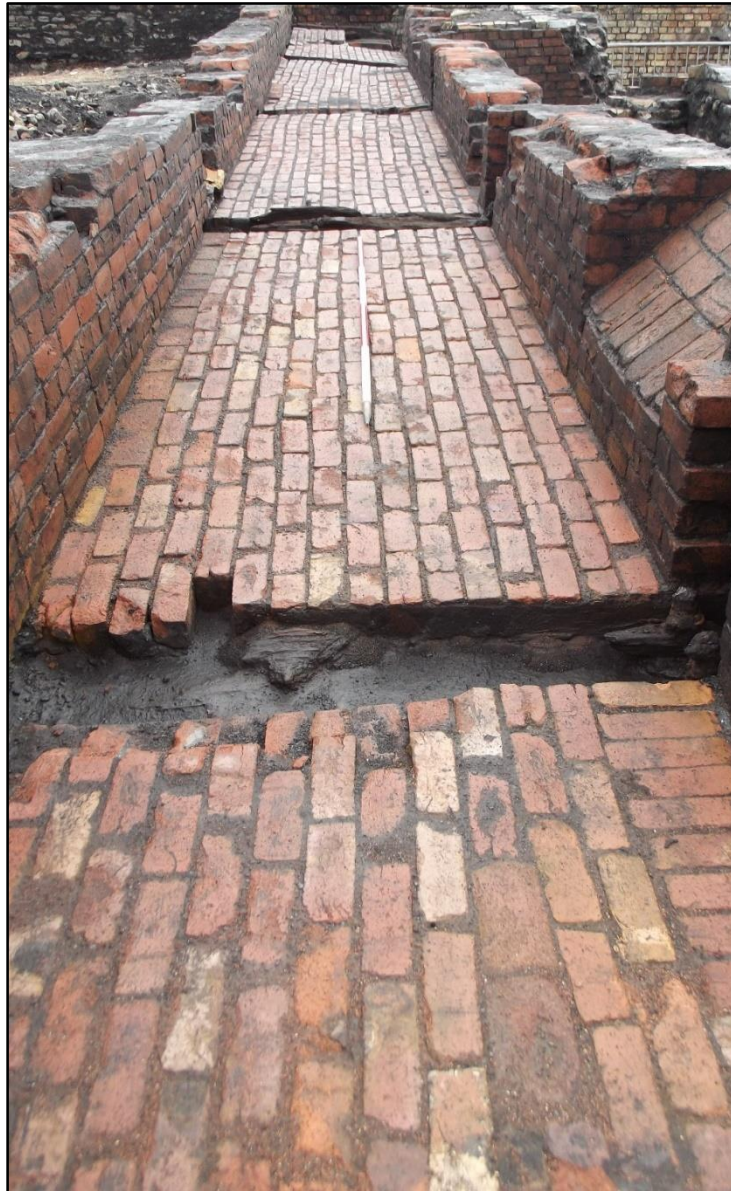
Plate 56. The north passage of Group 2059 (brick floor 2072) showing chute 2060 to the right. Note the sleeper locations and the slots built into the flanking walls that would have permitted easier replacement of the sleepers. Note how the pins are off-set to the right (south) side of the passage, possibly to allow limited access to the screw conveyor for clearing blockages and repairing the machinery (see also Plate 59). View to east.

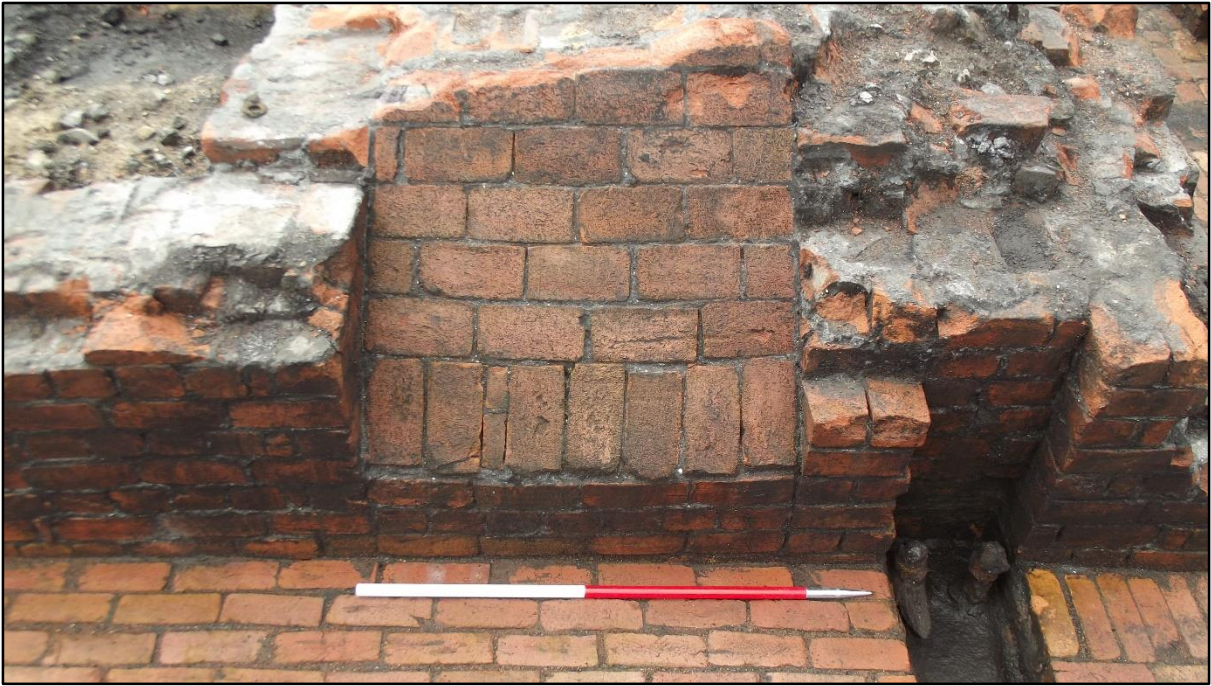
Plate 57. View of chute 2060 in the north passageway. Note the recess in the wall to the right of the chute to allow for insertion of a timber sleeper. Scale is 1m.

2060 was a brick base located between the east/west passages and which incorporated a 0.91m wide chute leading to the north passage from the area of the base (Plates 56 and 57). This chute corresponds to the position of one illustrated in the 1895 Engineer which appears to indicate that the elevator from pit 2049 raised the coal from the settling tank before distributing it to the conveyors contained by both the passages formed by Group 2059.

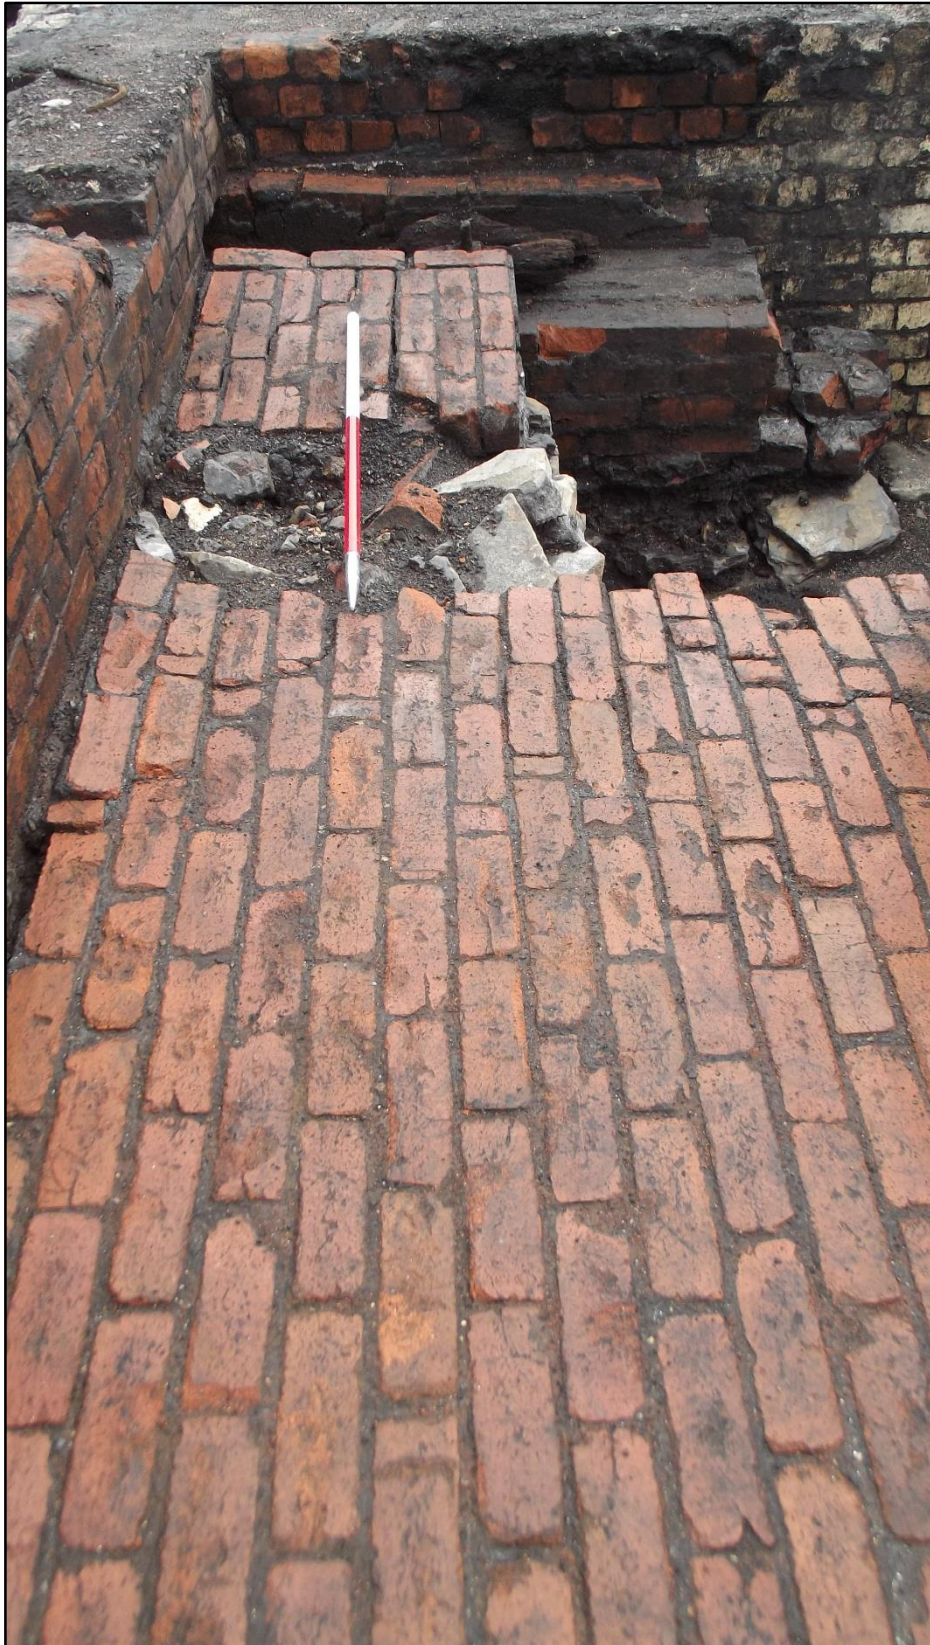
Plate 58. The damaged east end of the north passage showing the blocking in wall 2129 that dates to Phase 3b (1894/5) and which was done during installation of the Sheppard plant. View to east.

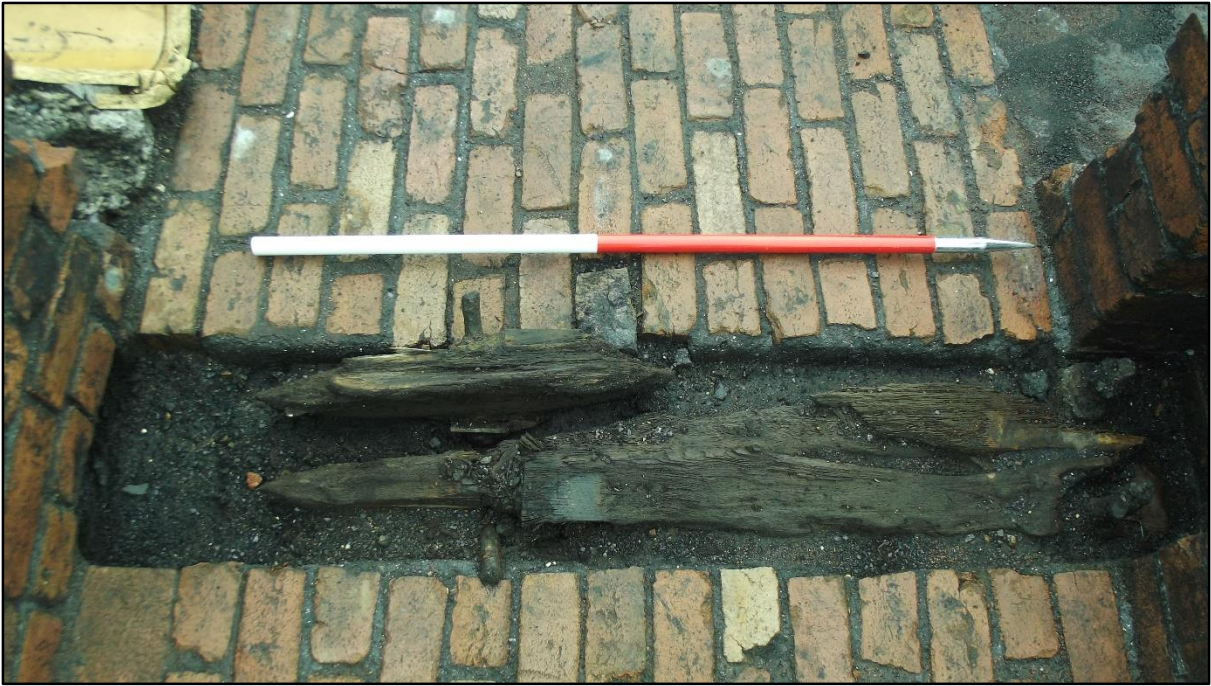
Plate 59. Remains of timber sleeper 2107 set within floor 2072. Scale is 1m. Note the shallow recess beneath the wall on the left of the photograph which permitted insertion of one side of the sleeper; the opposite end could then be dropped into place using the larger recess in the opposite wall.

The timber sleepers (2106 to 2110) set within the passage floors were broadly similar in form and dimension. Sleeper 2107, set into the brick floor of the passage (2072) was the most intact and will be described as being representative of the other examples. The remains of 2107 (Plate 58) were 1.25m long, 0.2m wide and 0.16m deep. The sleeper was furnished with four, screw threaded iron bolts close to each corner of the beam. The bolts had square heads and were fitted with square washers to aid securing. The bolts were arranged to be 0.86m apart at either end, and iron staining on the surviving timber suggested that the bolts were a method of securing machinery rather than part of a rail system. The arrangement of the bolts was off-set to the south of the centre of the passage, indicating that the screw conveyor was also offset. This is, in fact, how the arrangement is shown on the 1895 drawing, with the Archimedes screw being shown hugging the south wall of the north passage. It is quite likely that the resulting space on the opposite side would just about have permitted access for clearing blockages or repairing the conveyor.

Close examination of the slot for sleeper 2107 revealed the method for inserting the beam; the slot contained a recess beneath the north wall, wide and deep enough for one end of the sleeper to be pushed into it. The opposite end of the slot corresponded to one of the recesses engineered into the inner walls of the passage, which then allowed the sleeper to be dropped into place. This allowed the insertion of a sleeper which was wider than the passage itself, and which may have reduced movement of the conveyor caused by vibration.

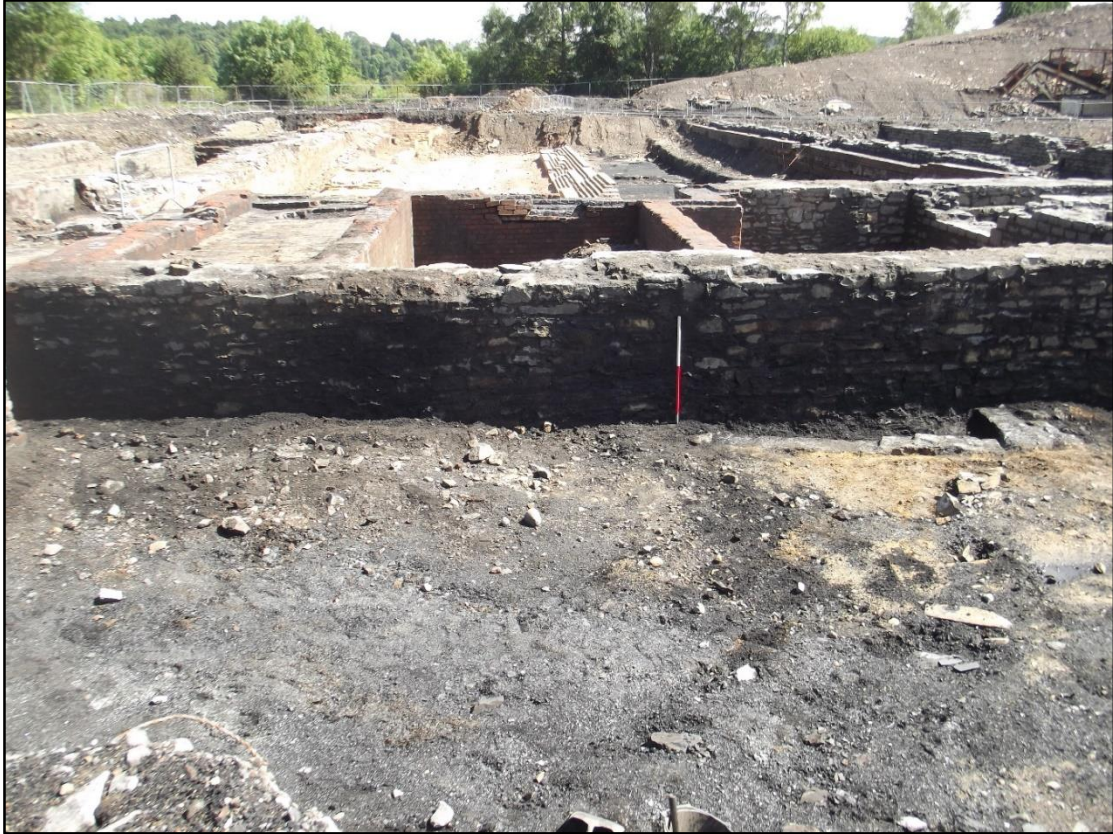
Plate 60. Western elevation of the Phase 3b of the coal storage bunker (wall 2213). Also visible are the brick wall partitions inside the structure to create the bunkers. View to east.

The first phase (Phase 3a) bunkers had subsequently been extended northwards by the addition of a new masonry and brick wall (2213) which had been divided internally by two large brick partition walls (2217 and 2218) to create three additional storage bunkers (Plates 60 and 61).

There is a strong possibility that this extension dates to 1894/5 (Phase 3b), as although some Pennant sandstone was used, the key elements were built of the same red brick as used in the Sheppard plant. This suggests that the new arrangements significantly increased production of processed coal, necessitating greater storage capacity.

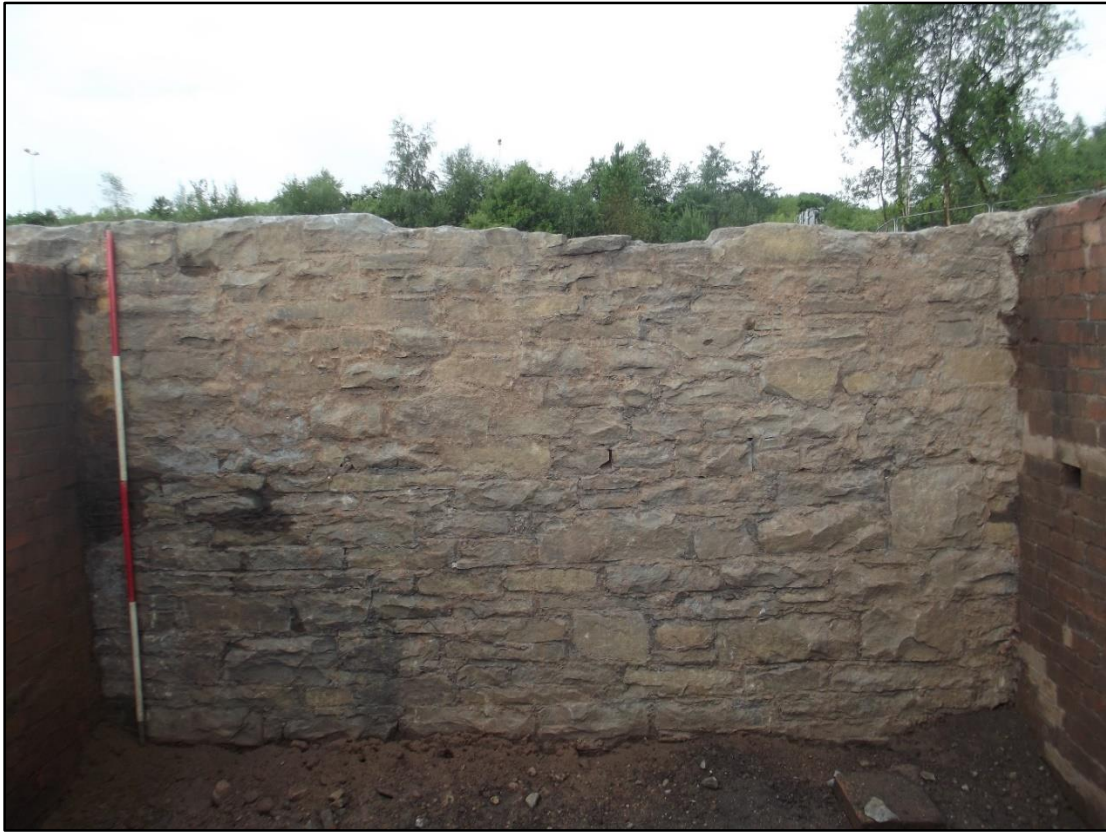
Plate 61. Phase 3b coal storage bunker. View of the eastern (internal) elevation of wall 2213. Brick partition walls 2217 (left) and 2218 (right) are also visible. Scale divisions are 0.5m.

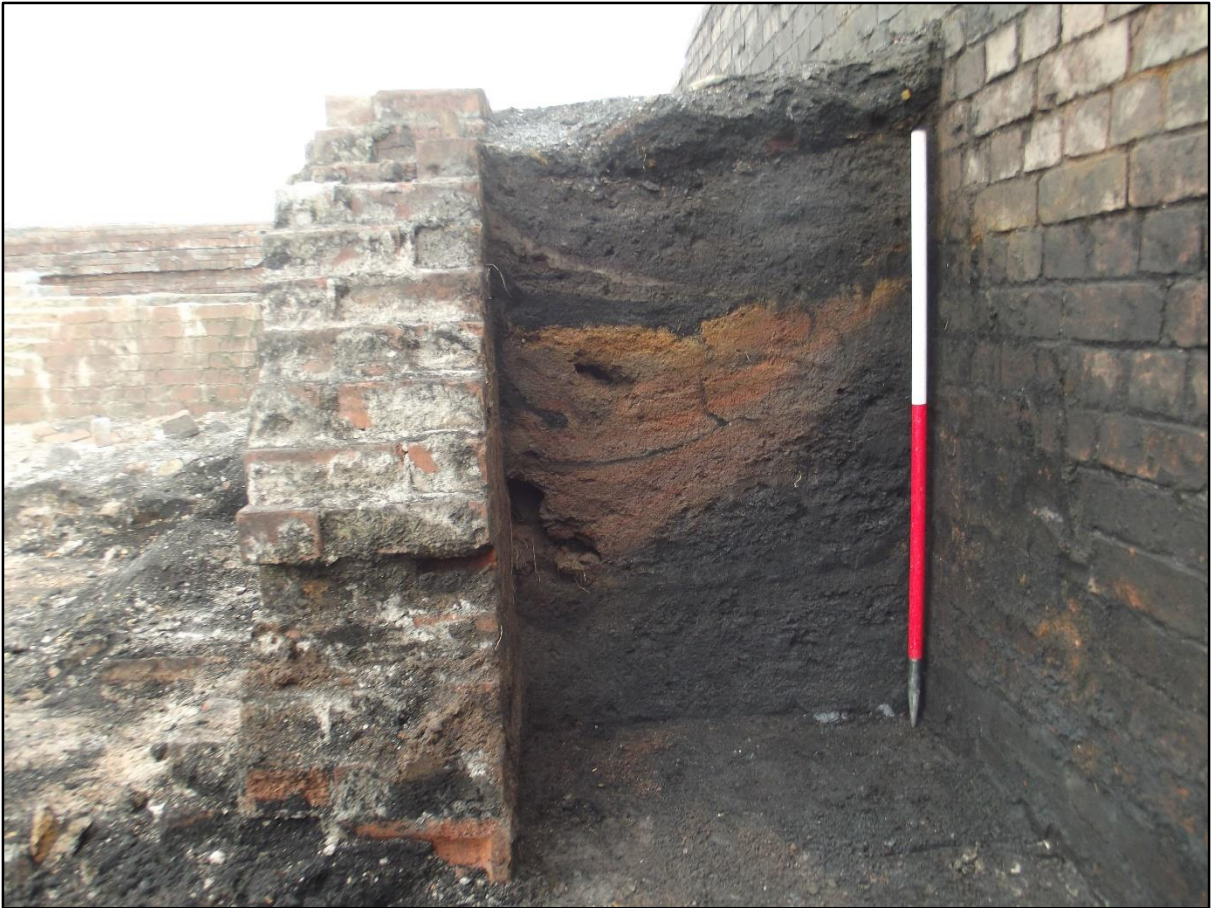
Plate 62. North Coppée oven battery. Insulation deposit 2313 sandwiched between the western end of the north coke oven battery (wall 2315 on the left) and the coal storage bunker (wall 2215 on right). Note the deposit has been heat affected. View to south.

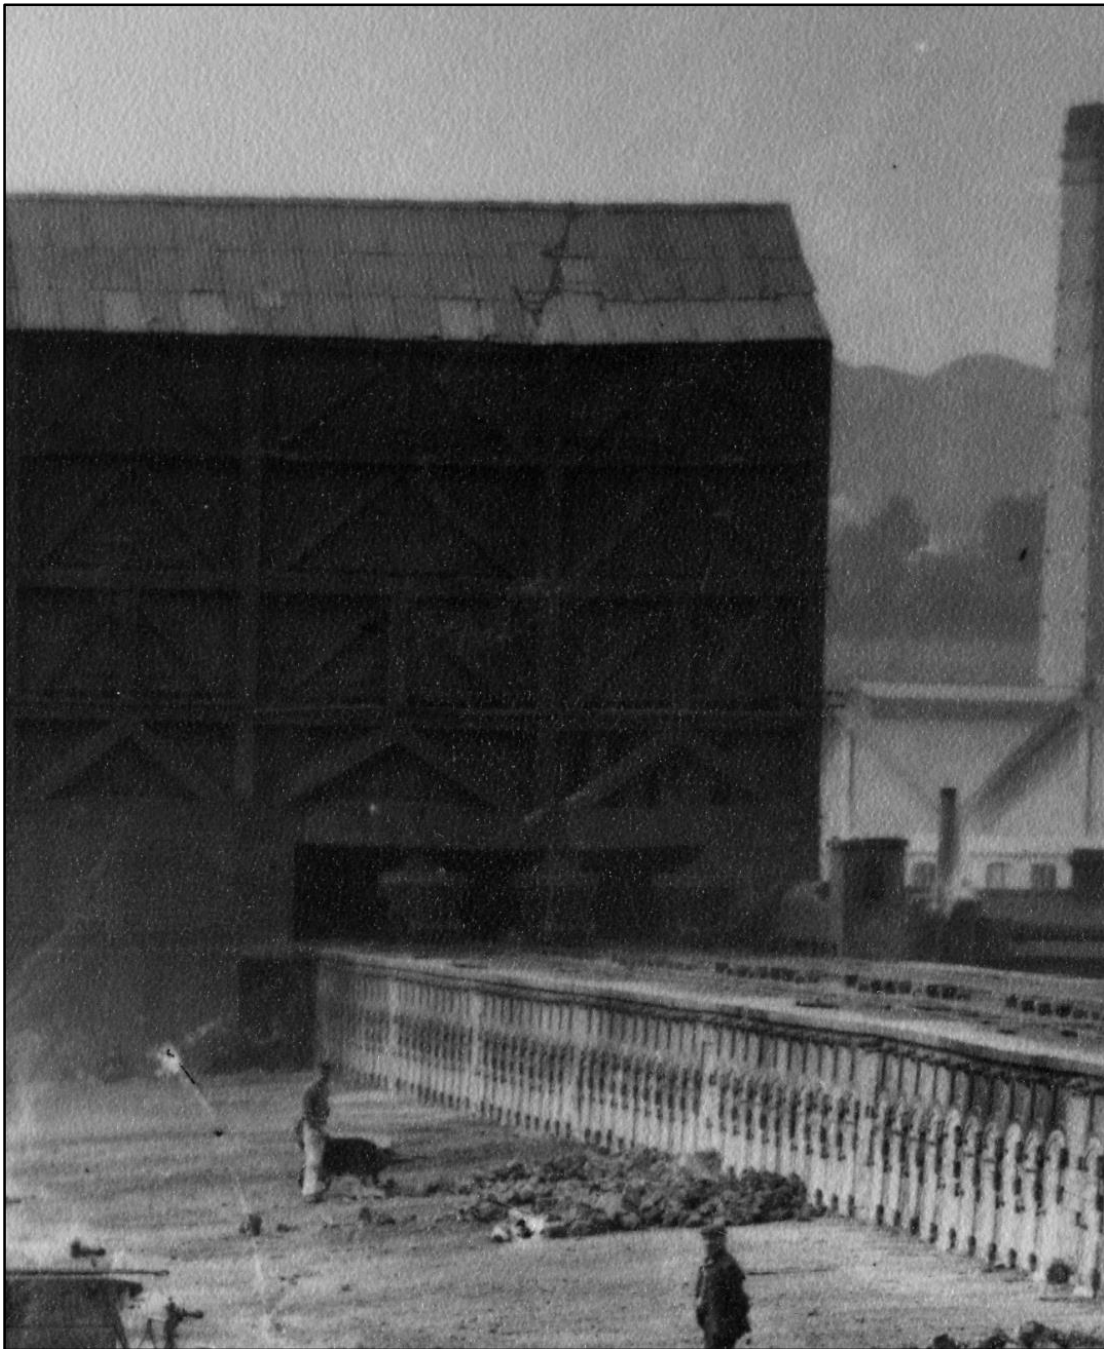
Plate 63. Close-up section of a photograph of the coke works from the 1890s showing three dandies on a trackway along the top of the north coke oven battery. Floor surfaces 2219 to 2221 are believed to relate to the very base of this transportation system, in the location of the recess in the building, which was used to transport processed coal from storage to the tops of the coke ovens. View to north west (Alan George)

The remains located at the north end of the coal bunkers consisted of a number of substantial, brick and masonry built floors and walls, (floors 2219 to 2221 and walls 2224 to 2226) which formed the remains of the base for the system of dandies which transported processed coal to the top of the coke ovens. The most intact of the floors was 2219, which was a rectangular floor of yellow refractory brick measuring 6m in length by 2.16m. The floor had been damaged during its lifetime, with signs of considerable wear to the upper surface of the bricks and signs of some subsidence (Plate 64) This floor is believed to be associated with trackway for one of the dandies although there was no evidence for the presence of the track itself. The exact nature of the arrangement is unknown but the location corresponds well to the recesses from which the dandies emerge on the 1890s photograph of the Coppée coke plant (Plate 63). The elevation of the floors (204.4m OD) is approximately 1m higher than the upper level of the coke bench water troughs, which are probably the features which are closest to a recognisable ground surface visible on the 1890s photograph. Although it is difficult to assess, the dandies and trackway running along the tops of the coke ovens visible in the photograph would appear to be higher than 1m above the coke bench and it is probable that brick floors 2219 to 2221 represent only the very base of the system.
