Cyfarthfa Coke Works (The Old Thorn Lighting Works) Merthyr Tydfil

Excavation report and analysis

October 2017

GGAT report no. 2017/051
Project no. P1844
National Grid Reference:
SO 03708 06785

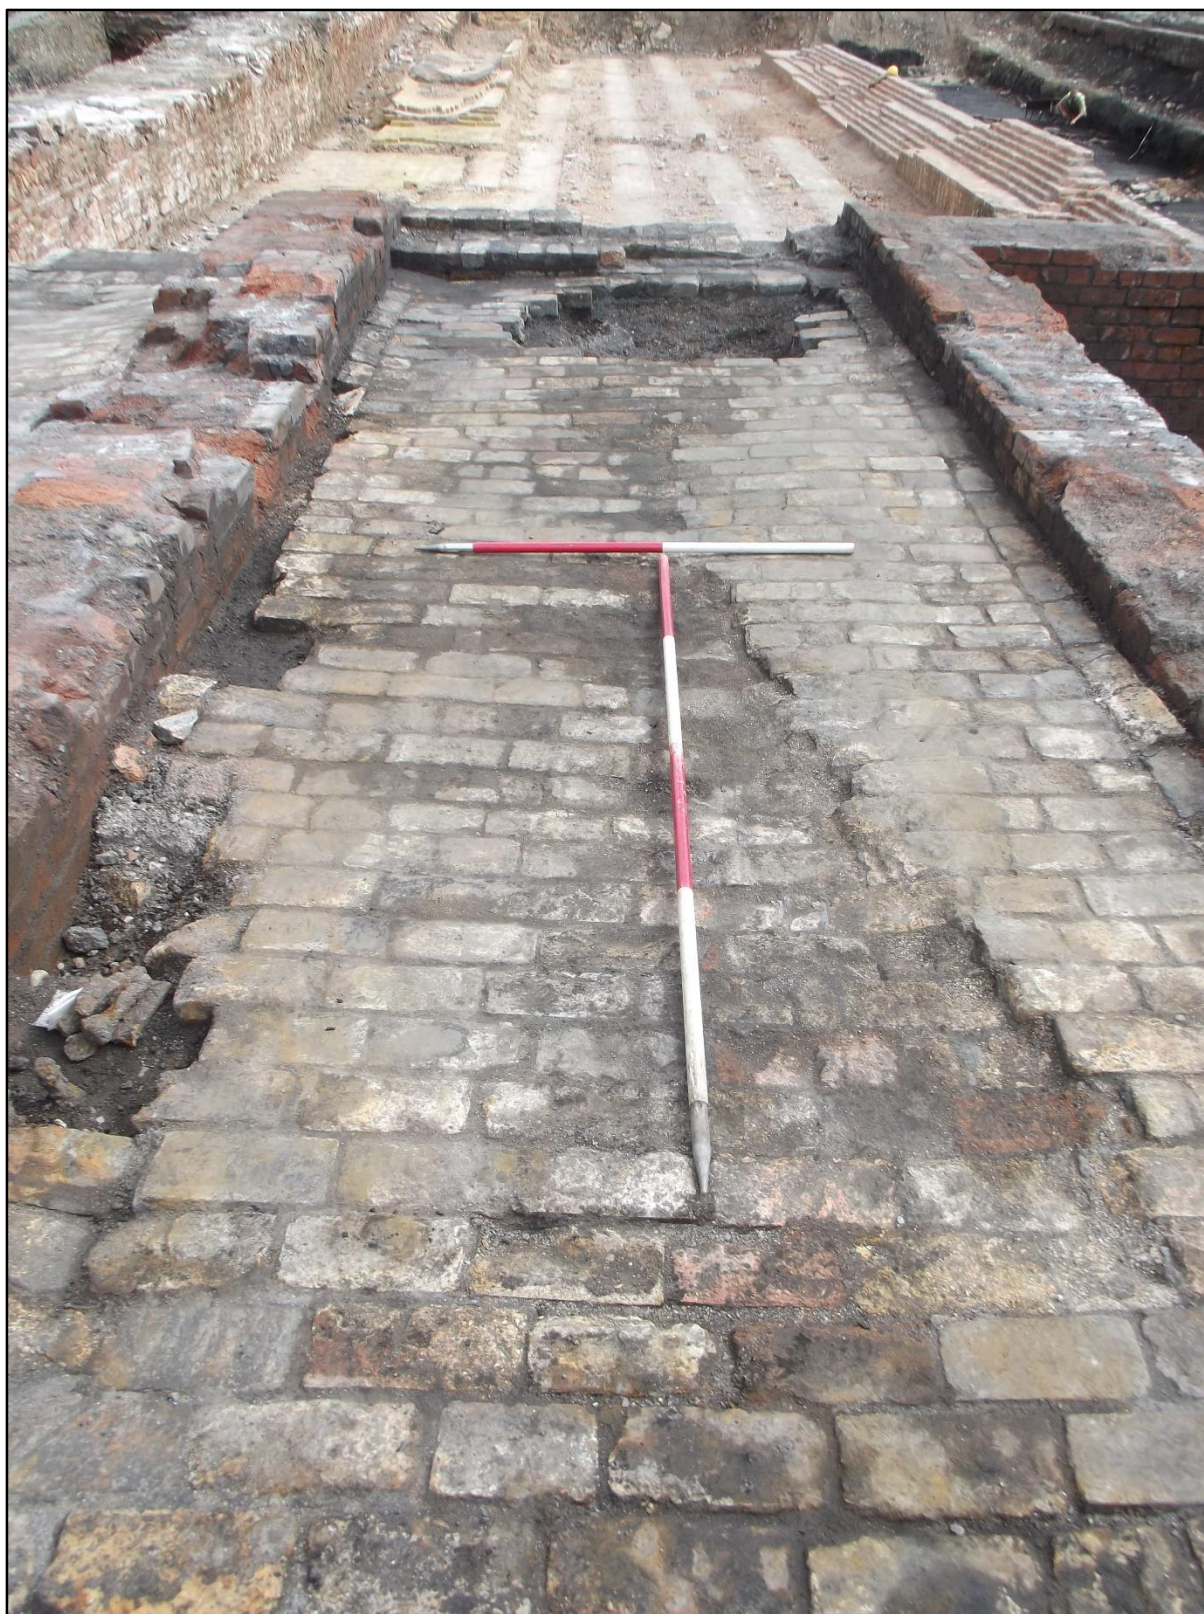
Plate 64. North Coppée coke oven battery. Floor surface 2219 looking east to the remains of the coke ovens. This floor is believed to be associated with the transportation system for moving processed coal to the top of the Coppée coke ovens. Note the extensive wear to the surface of the bricks.

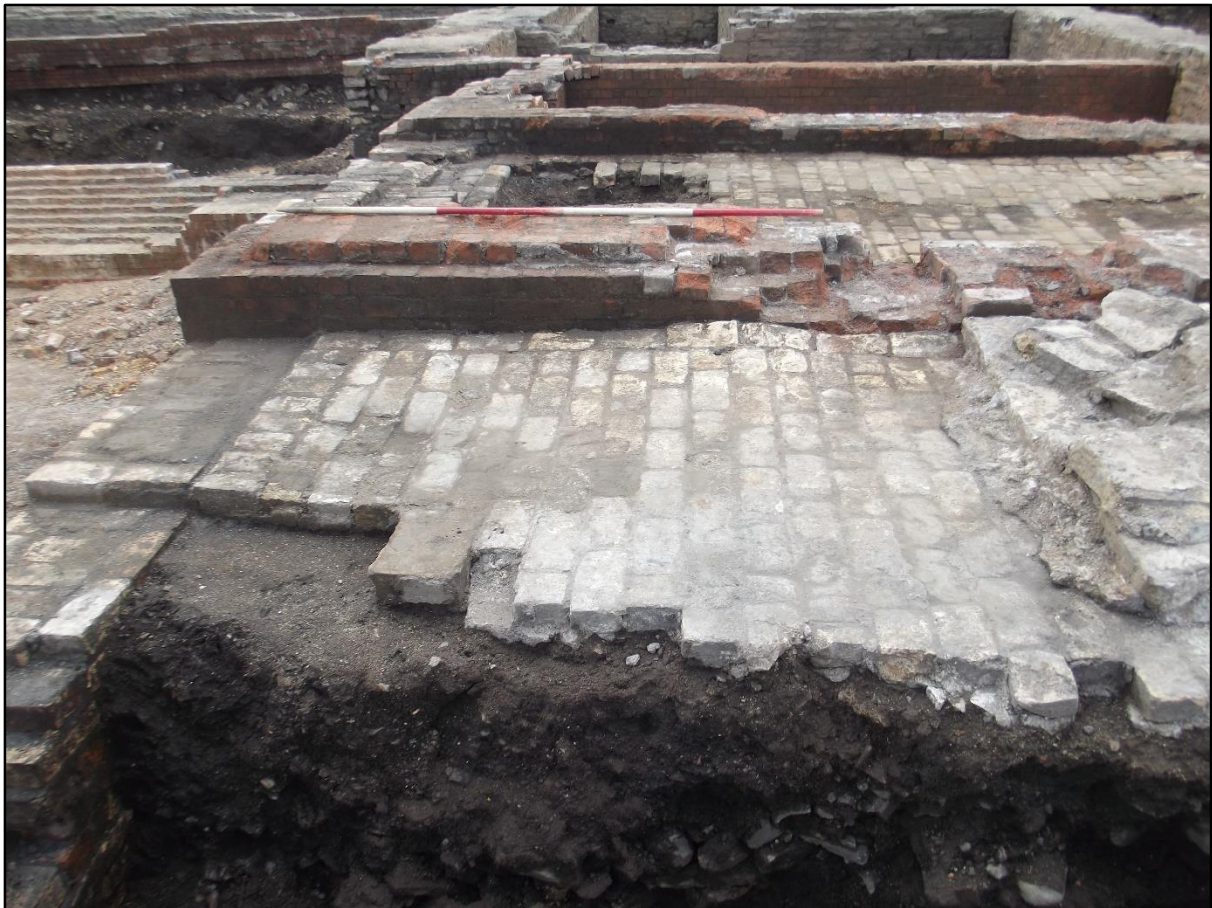
Plate 65. North Coppée coke oven battery, floor surface 2221 showing the cut for the modern pipe run (2228). Floor 2221 was almost certainly related to the transportation system for moving coal to the top of the coke ovens but the insertion of the masonry partition (wall 2229 on the right of the photograph) would have significantly affected the space available.

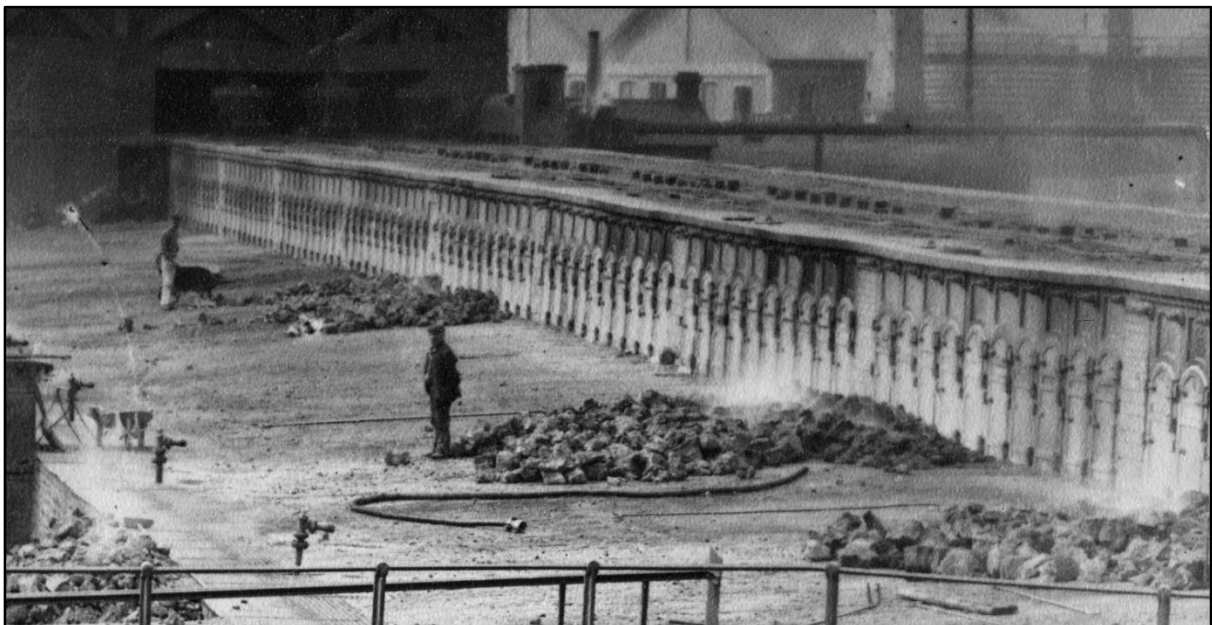
Plate 66. Detail from a photograph of the north coke oven battery in the 1890s (Alan George)

Details visible on the historic photograph showing both the north and south coke oven batteries show that the ovens were arranged in nine groups of ten, each group being separated by a brick partition (Plate 66). The frontage of each group presented a convex shape so that the whole battery would have had an undulating appearance. The reason for this undulation is unclear but it may have been to reinforce the frontage of the battery. The organisation into groups of ten probably aided operation of the ovens on a rolling cycle; different ovens reached the end of the coking process at different times and it probably made sense to have a group of ten at the same stage rather than have to keep track of individual ovens.

The ovens themselves were fed from what appears to be three, parallel sets of dandies that ran along tracks affixed to the top of the ovens. Each of the long, narrow ovens was fed from all three dandies, as this would allow even loading. It follows therefore that each oven would have had three loading hatches, and some of the possible covers for these were recovered during the excavation (see below).

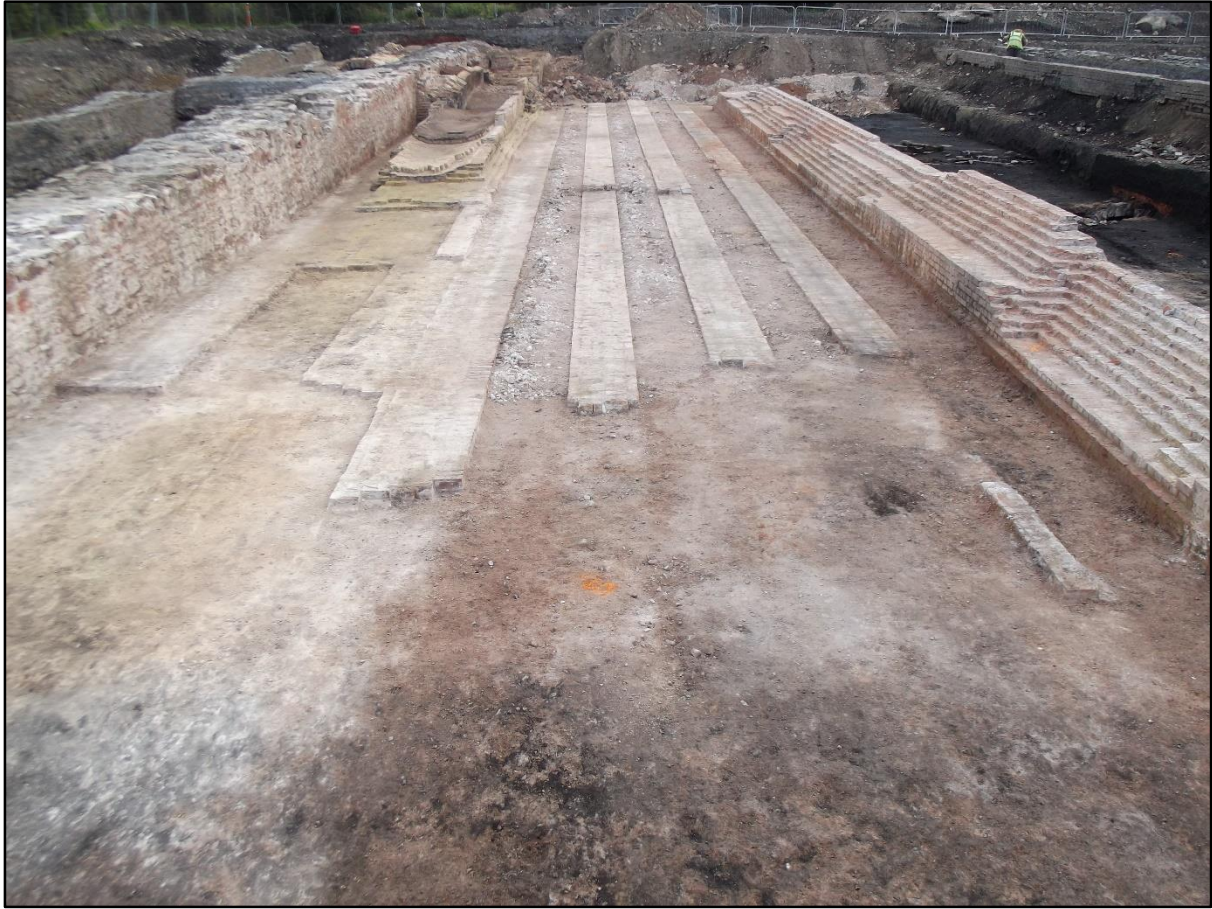
Plate 67. Remains of the strip foundations of the north battery of Coppée coke ovens. View to east. Wall 2314 is visible to the right of the photograph whilst wall 2324 is visible on the left. The space between is filled with a series of linear brick foundations, and the base of a single, large flue (2340 and 2343) is located adjacent to the left hand wall. View to north east.

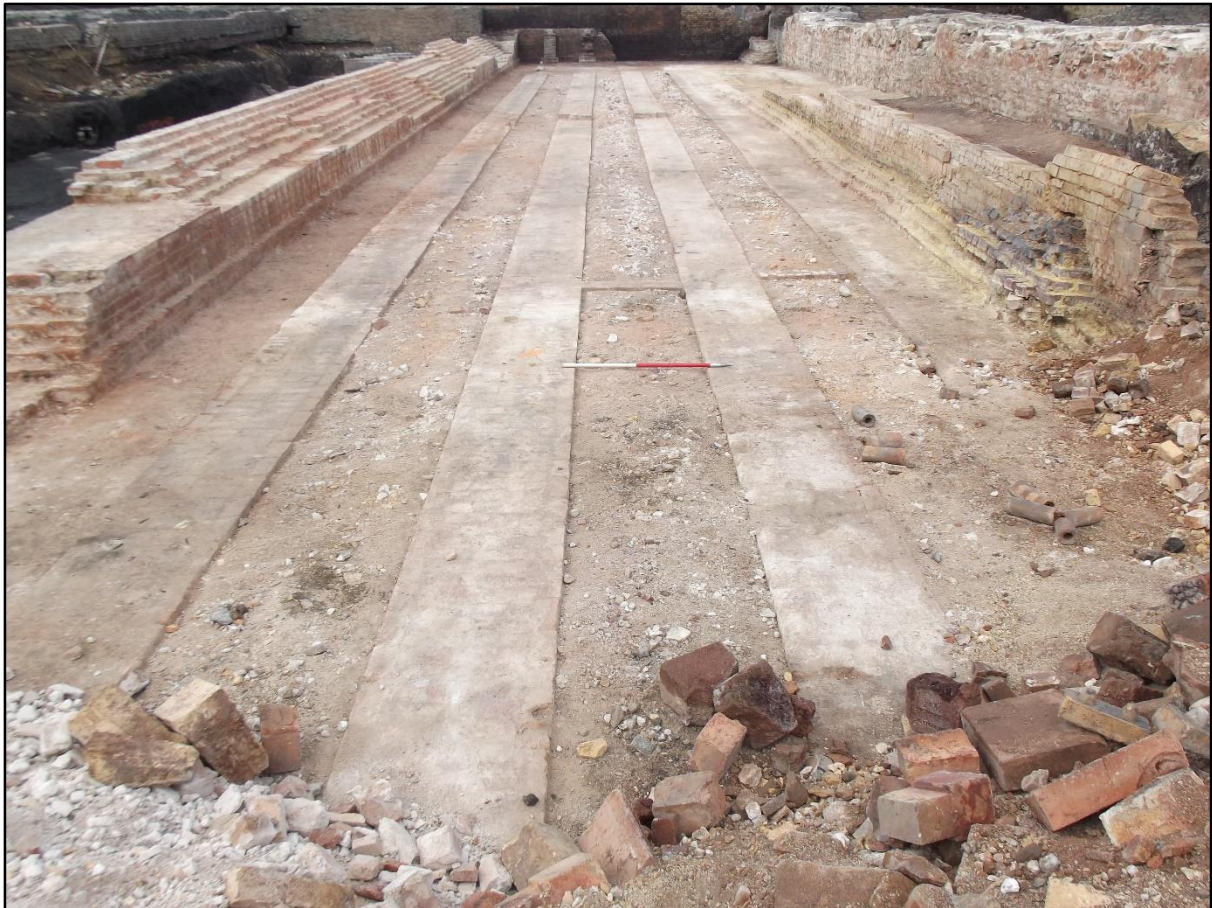
Plate 68. North coke oven battery, strip foundations 2328 (left) to 2331 (right). Retaining wall 2341 is on the far left of the image whilst the remains of the main heat flue are on the far right.

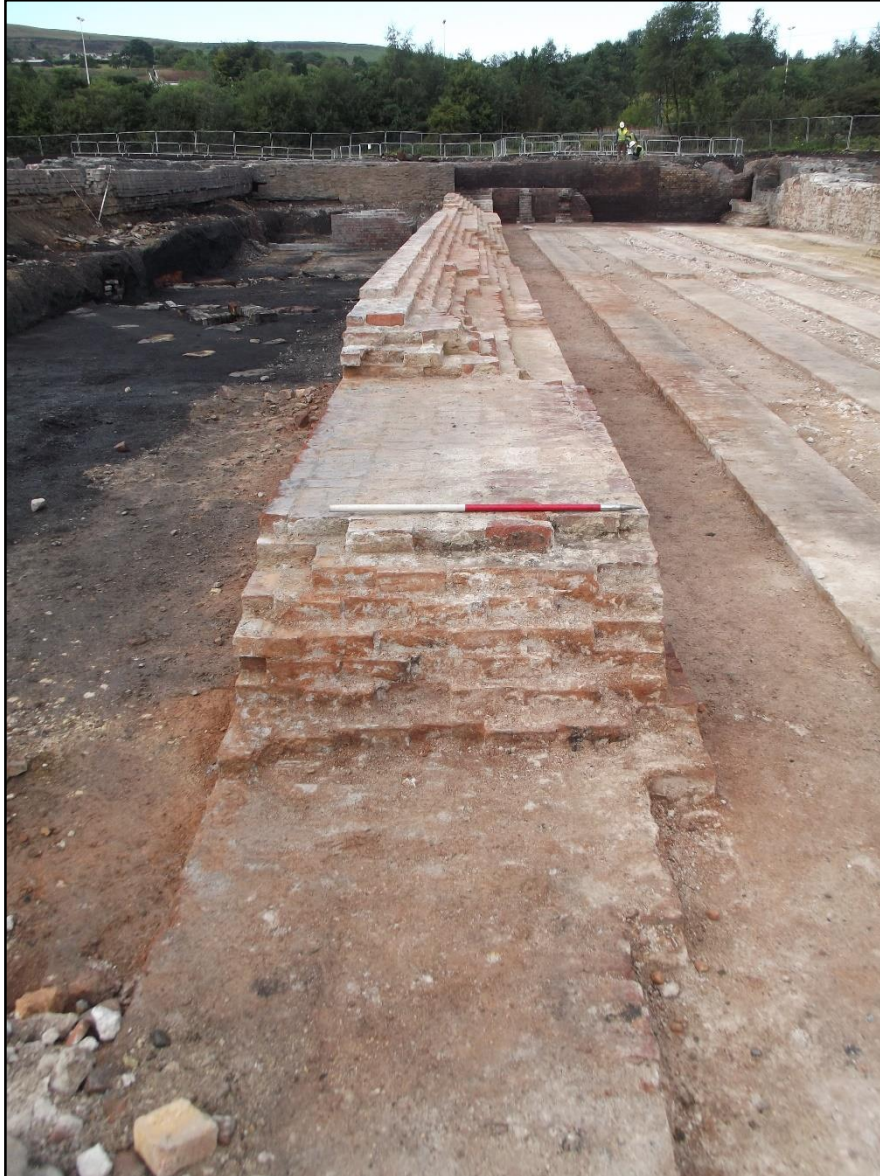
Plate 69. North Coppée coke oven battery, retaining wall 2314 looking along its length. View to west. The vertical left hand face of the wall is likely to mark the location of the front of the Coppée ovens.

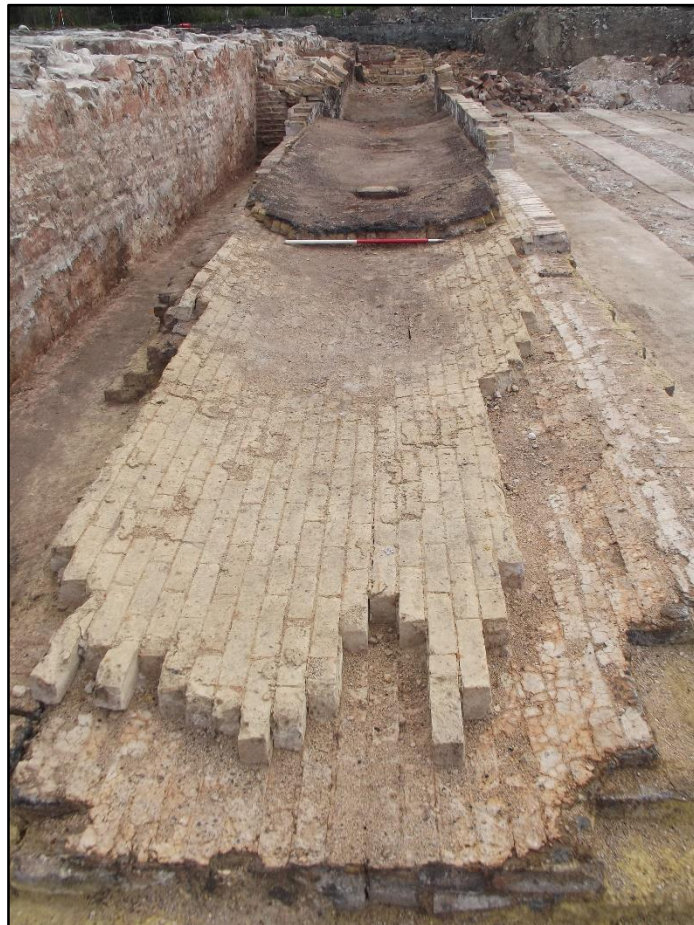
Plate 70. Northern Coppée coke oven battery, surviving floor (2340) of the main gas flue. Note the highly vitrified original floor of the flue just above the ranging rod. View to east.

The base of the main gas flue consisted of a brick surface (2340, Plate 70), 8.64m long and 2.06m wide. The base of the flue had an elevation of 202.44m OD which placed it 1.3m below the level of the northern coke bench trough, which is probably close to the original working surface for the bench. Although circumstantial, in the absence of surviving features, this suggests that the main gas flue for the north oven battery was not buried particularly deeply when it was operational, a fact that may have permitted easier access for the purpose of inspection and repair.

The bricks in floor 2340 had been laid in at least seven courses, each laid in a particular way to create a concave surface which would have formed part of the circular section of the main gas flue. All the bricks in the floor appeared to be of conventional design, bonded with a very

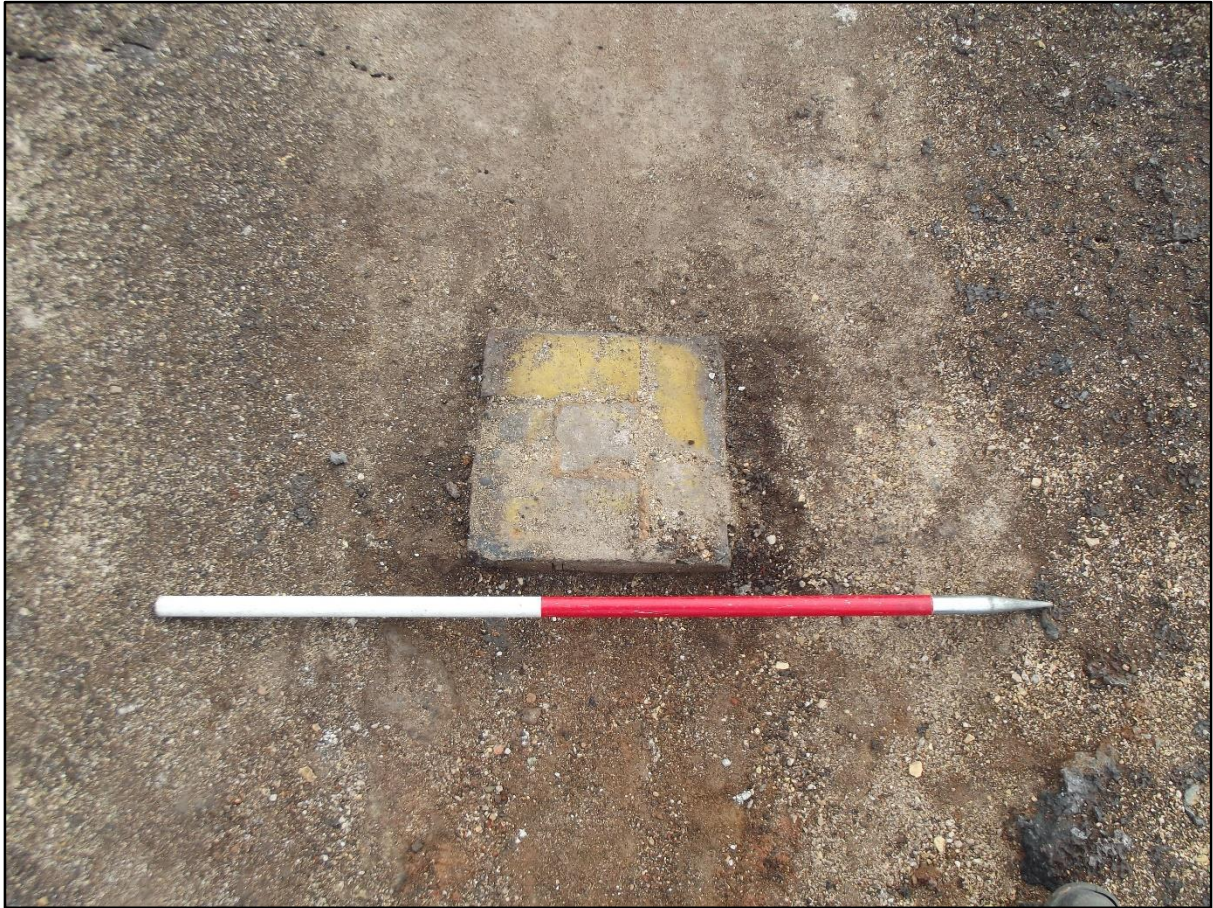
Plate 71. North Coppée coke oven battery, one of the two surviving pillar bases in the vitrified surface of the main gas flue. Scale divisions are 0.5m

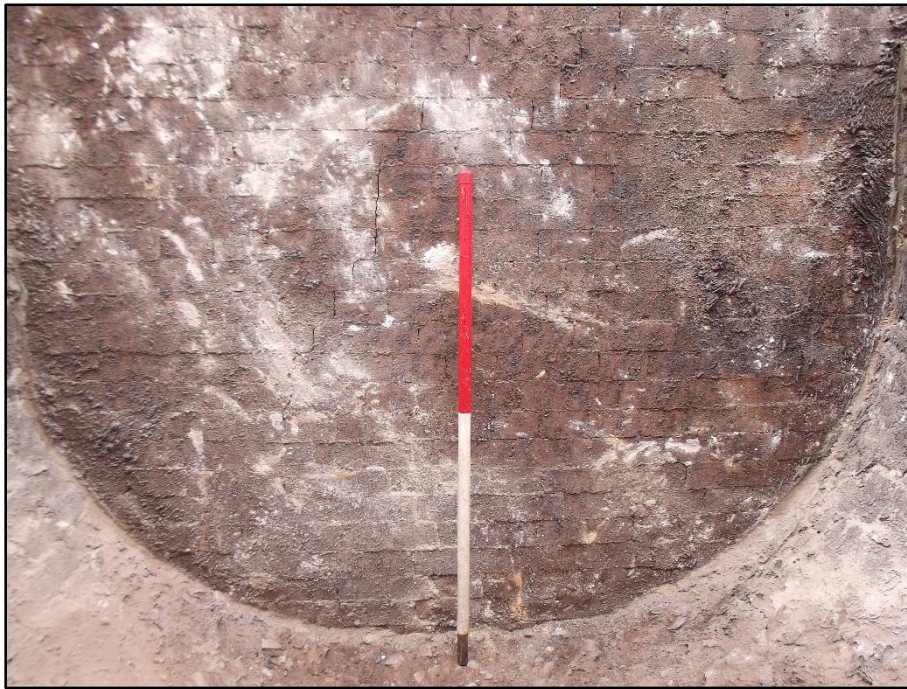
Plate 72. North Coppée oven battery, South wall of secondary gas flue 2338, view to south.

Not only was the floor of chamber 2338 semi-circular, but it also sloped down to the north, towards the mouth of the gas flue. This was a particularly skilled demonstration of bricklaying, with the resulting shape of the chamber being semi conical (Plates 72 and 73). This feature goes some way to justify the statement that Coppée ovens were expensive to build owing to the highly skilled nature of their construction (*Proceedings of the North of England Mining and Mechanical Engineering Institute Vol. 22 1872/3*).

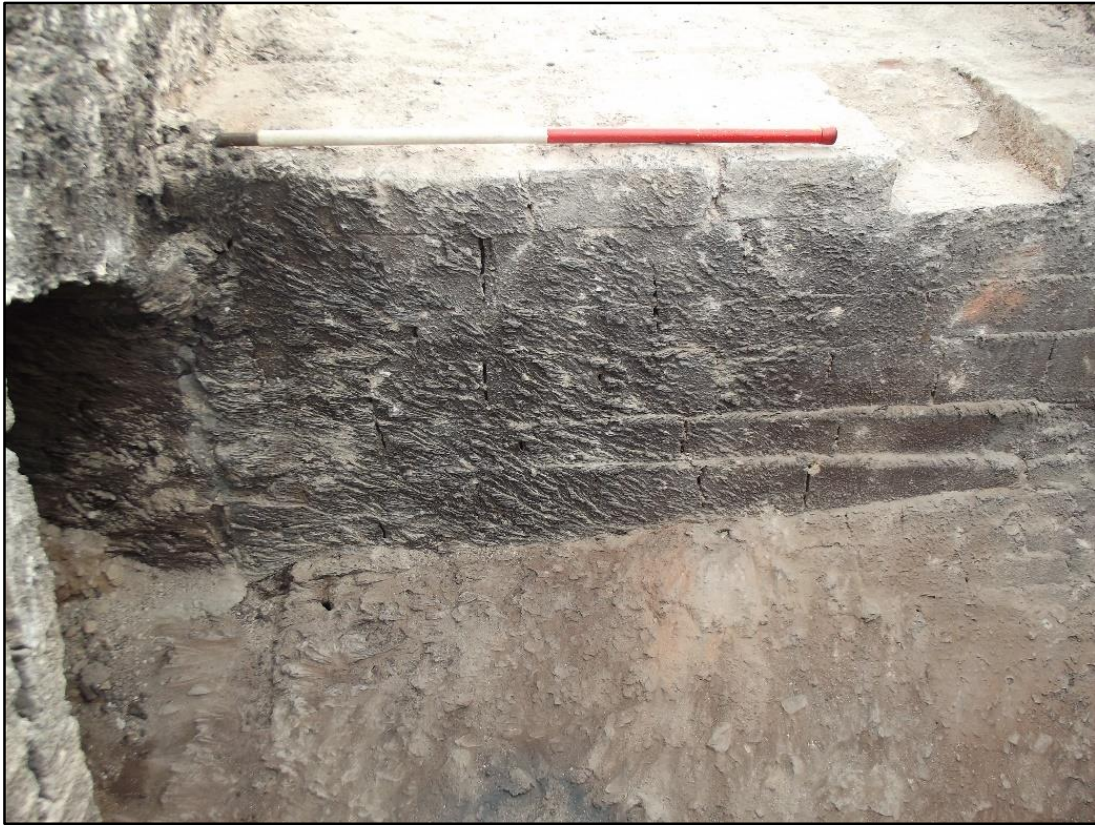
Plate 73. North Coppée oven battery, secondary gas flue chamber 2338. The floor of this chamber sloped in two dimensions, demonstrating the highly skilled nature of the workmanship involved. Note the extensive vitrification. View to east.

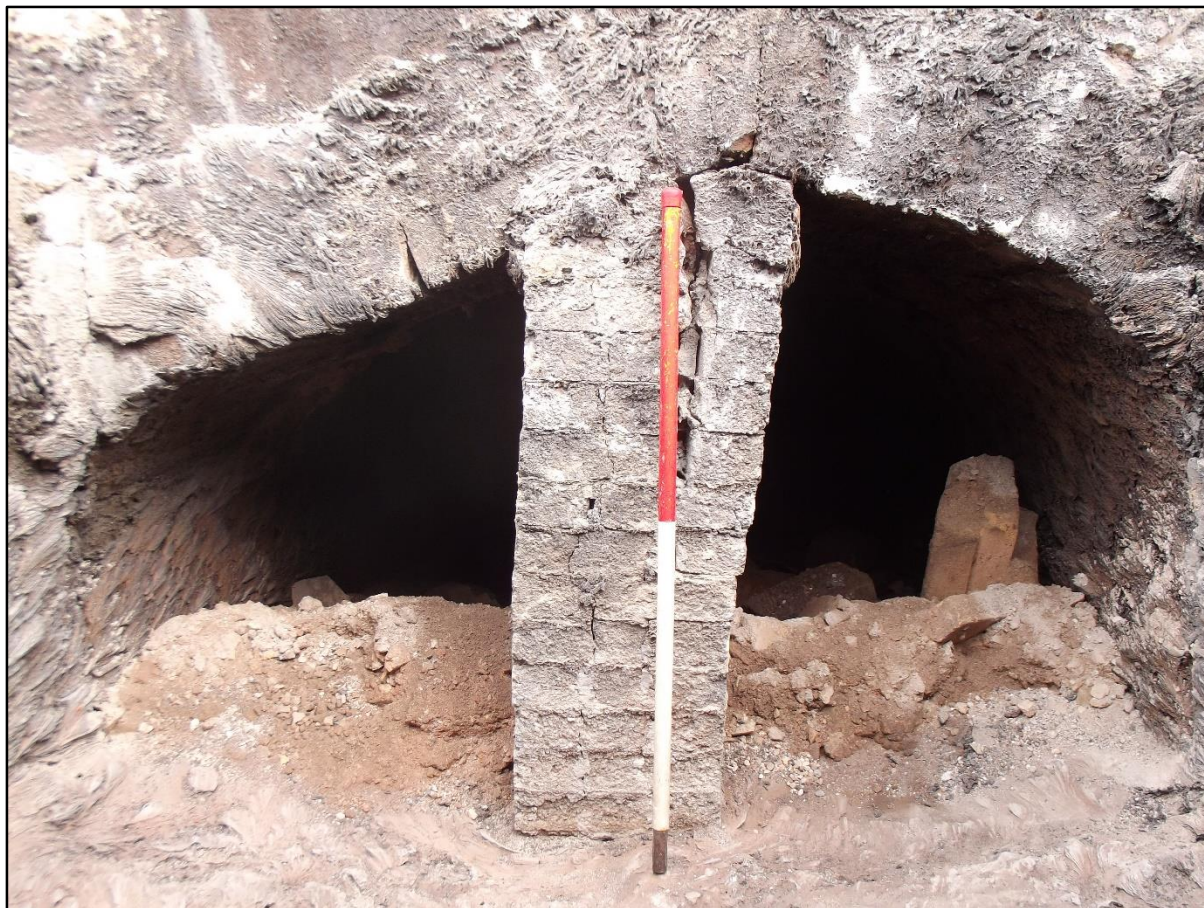
Plate 74. North Coppée oven battery, mouth of the secondary gas flue running from the main gas flue. Note the collapsing arch and the attempt at support being provided by brick pillar 2339. View to north.

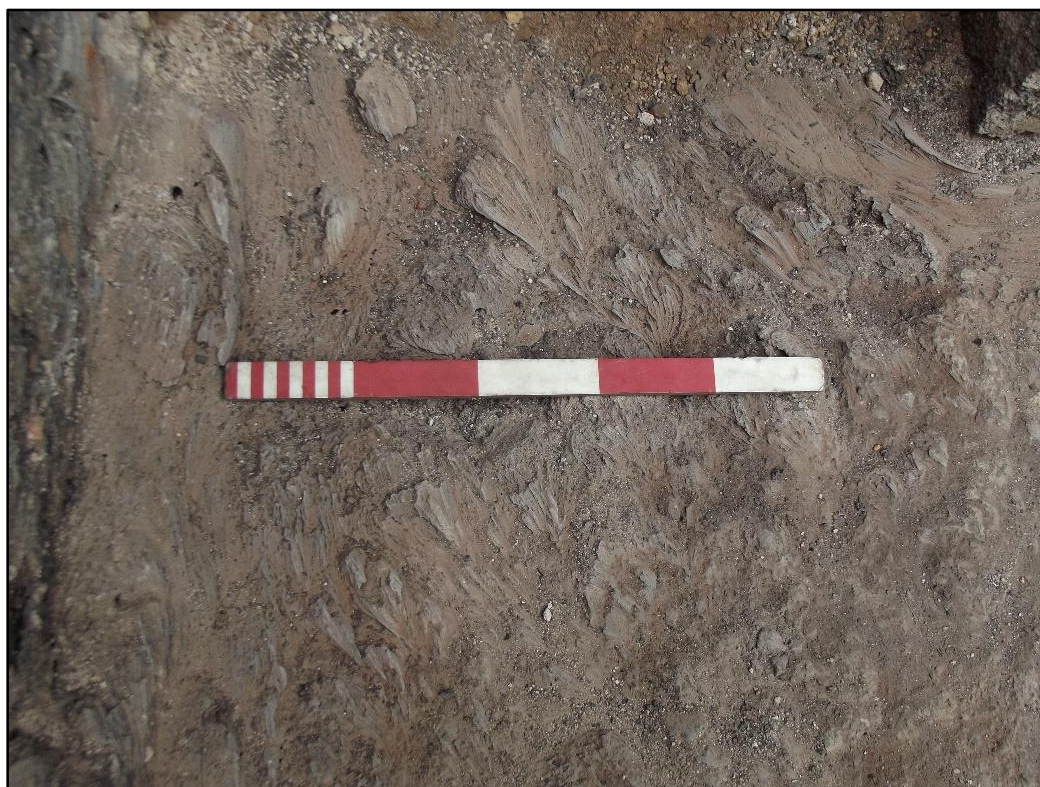
Plate 75. North Coppée oven battery, flow lines in the residue within secondary gas flue 2338. Scale is 0.5m

Of particular note were the patterns of deposition of this residue on the brickwork. These had a distinctive ‘feathery’ appearance and contained thousands of flow lines that suggested the direction in which the gas moved (Plates 75 and 76). These flow lines confirmed that the gasses had travelled from the main flue into the secondary gas flue, although the final destination is unclear as the secondary flue was damaged and open to the air beyond 5m.

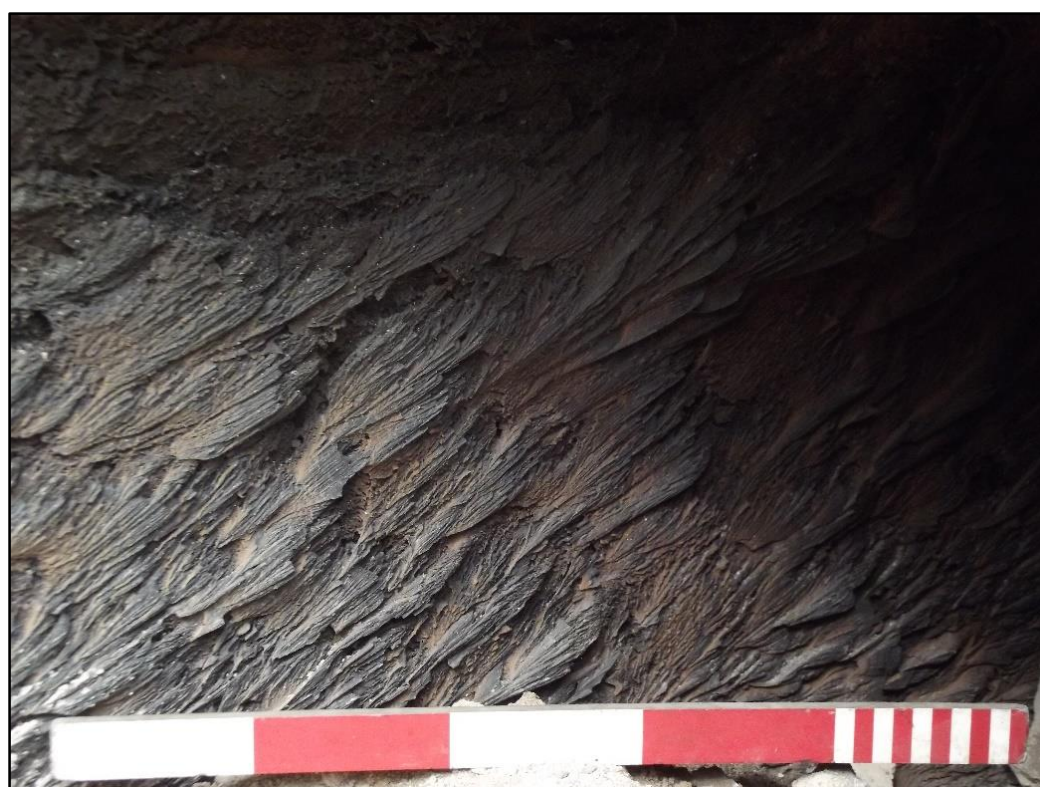
Plate 76. North Coppée coke oven battery, characteristic flow lines in the residue left on the side walls of the secondary gas flue. Scale is 0.5m.

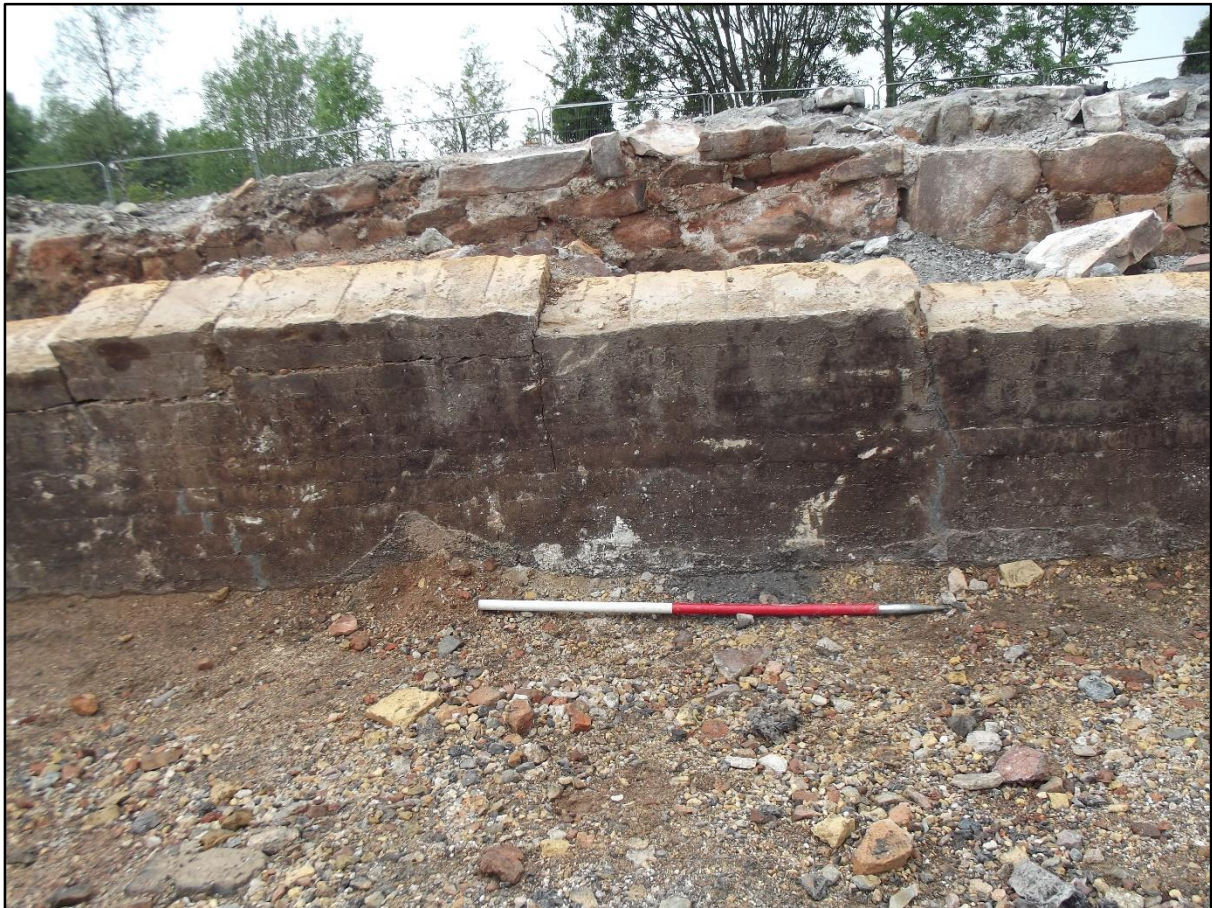
Plate 77. North Coppée coke oven battery, the north wall of the main gas flue (wall 2435). View to north with masonry wall 2437 to the rear.

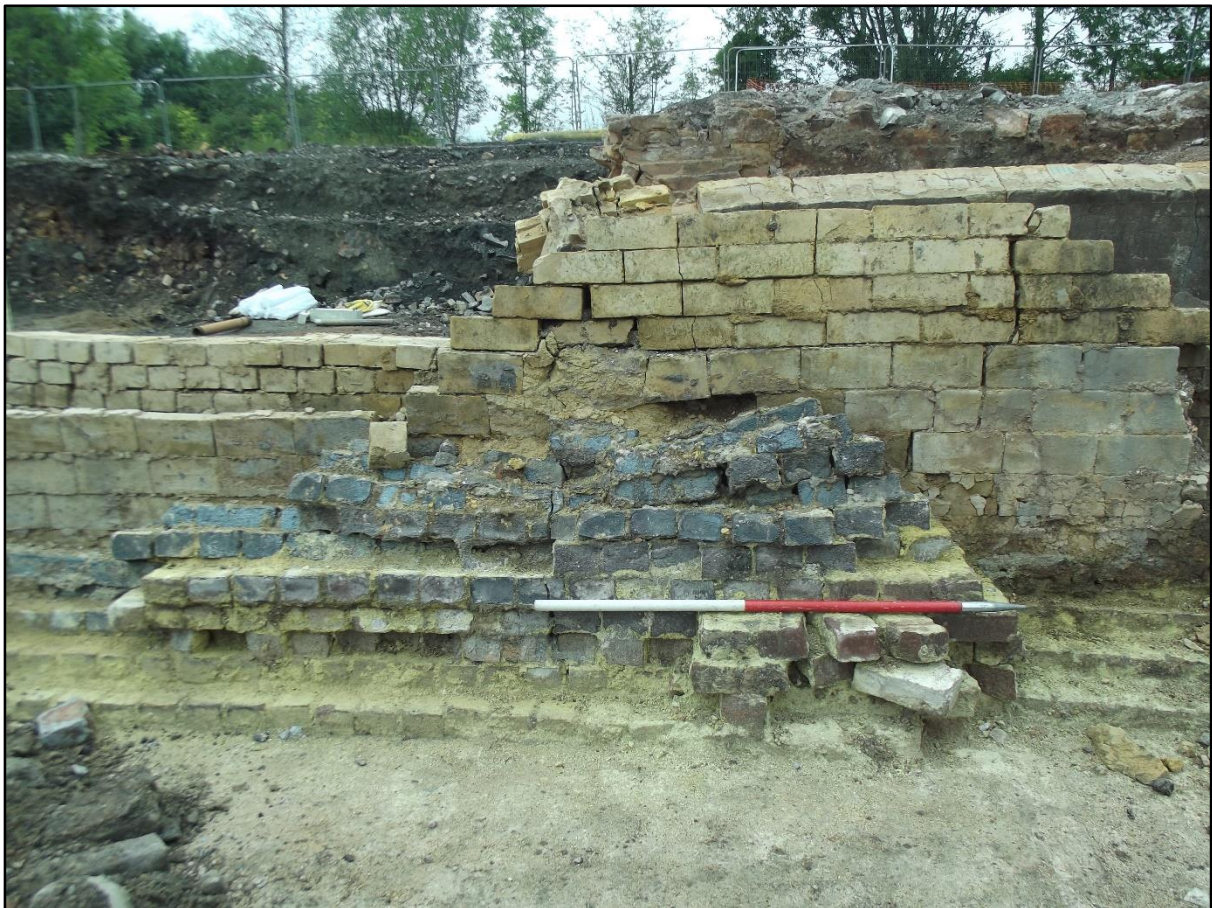
Plate 78. North Coppée coke oven battery, the south wall of the main gas flue (wall 2436) to the rear, and feature 2508, with a ranging rod resting on it. feature 2508 may, in fact have been the only surviving portion of the walls of the transverse flues for the ovens. View to north.

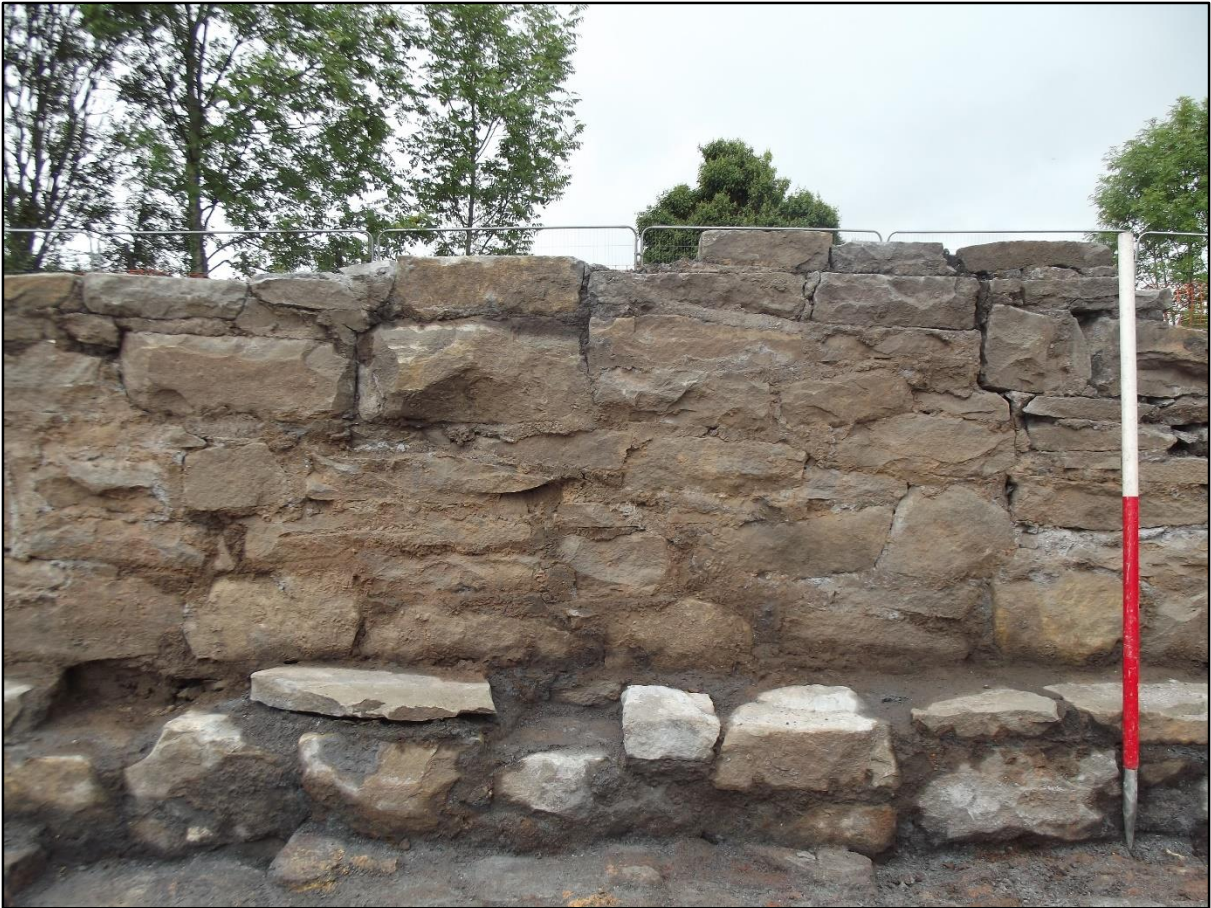
Plate 79. North Coppée coke oven flue complex, south elevation of wall 2442 showing stepped foundation. View to north.

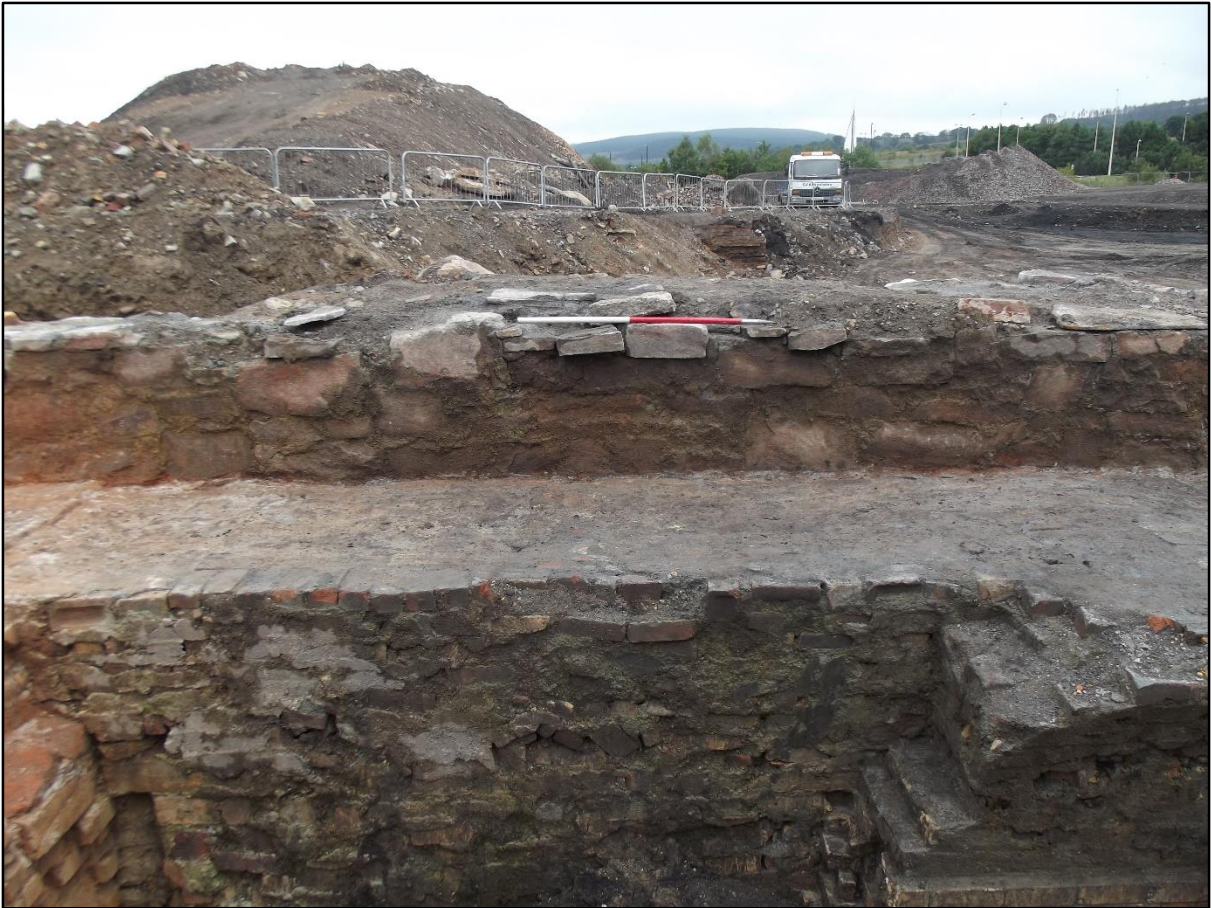
Plate 80. North Coppée oven flue complex, north elevation of wall 2437. Note the absence of a stepped foundation. Brick floor 2481 is visible, as is part of a chamber forming part of chimney 2464. View to south.

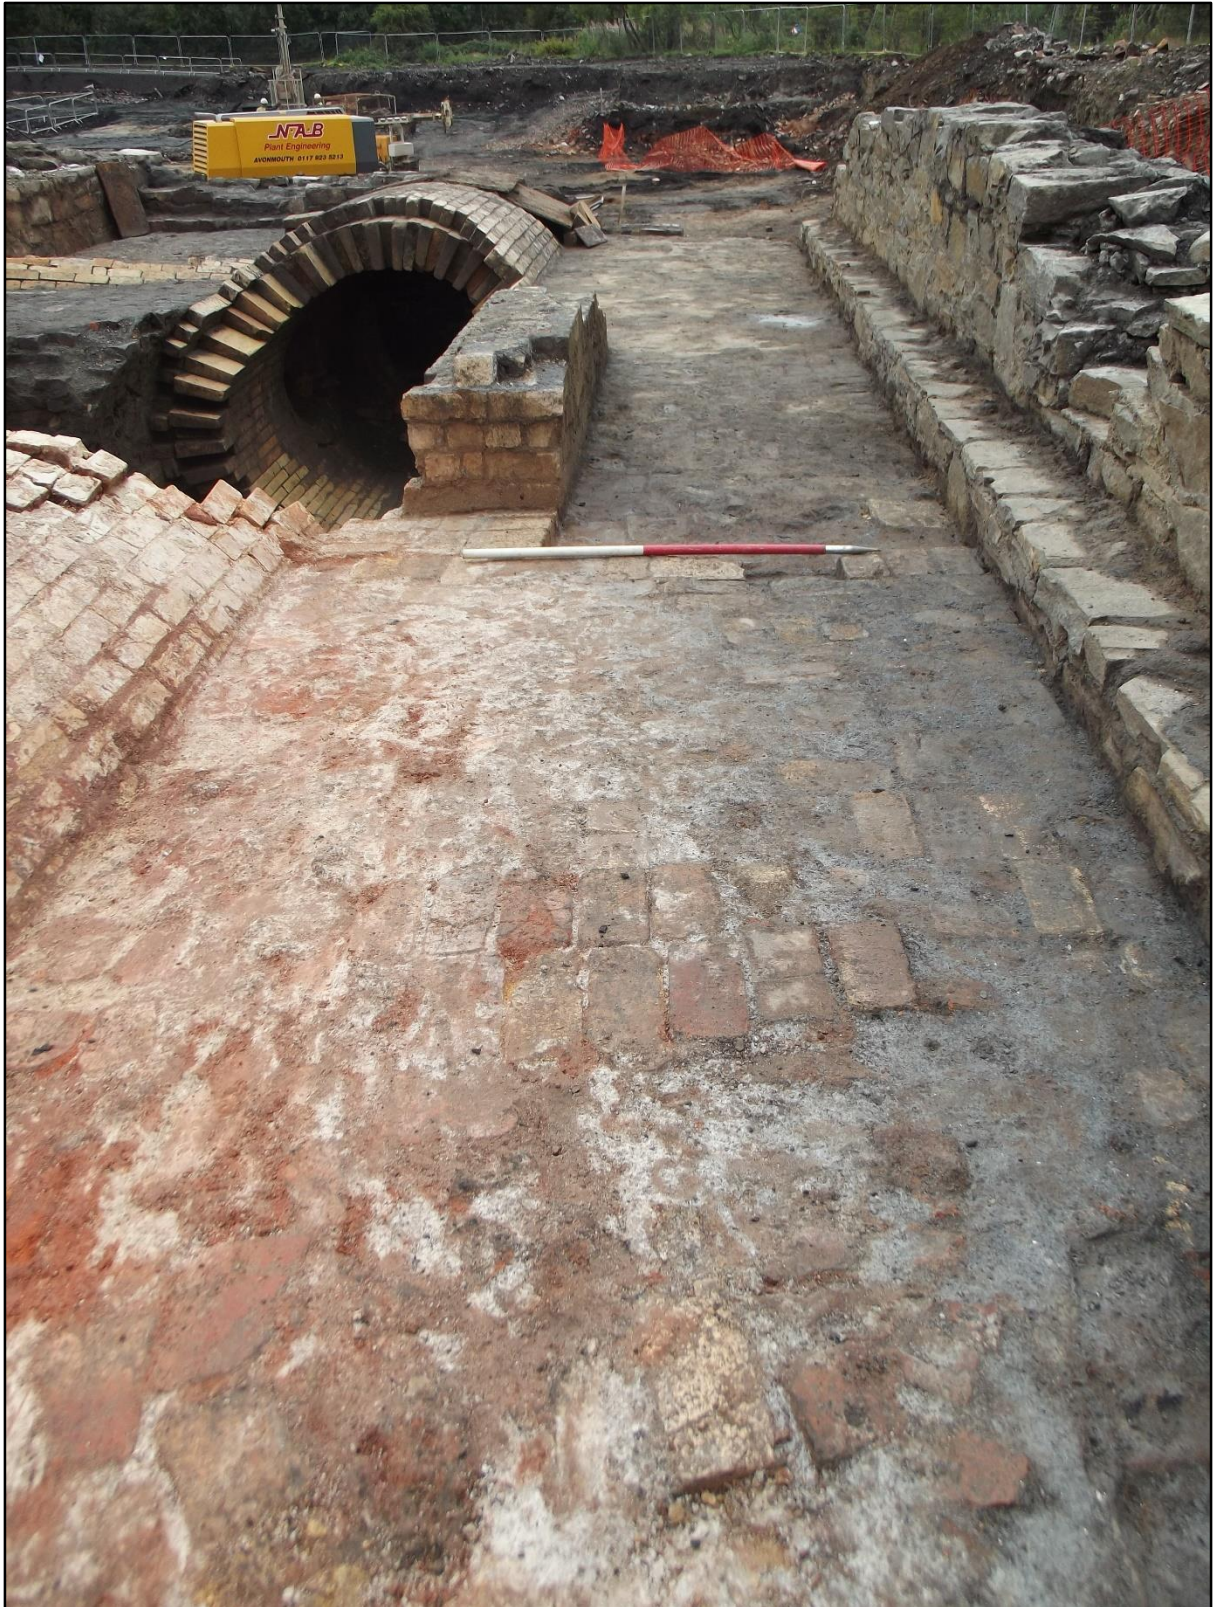
Plate 81. North Coppée coke oven flue complex, view of floor surface 2446 that formed the north side of the channel for the main gas flue in this area. Note the gas flue to the left and wall 2443 to the right. View to west.

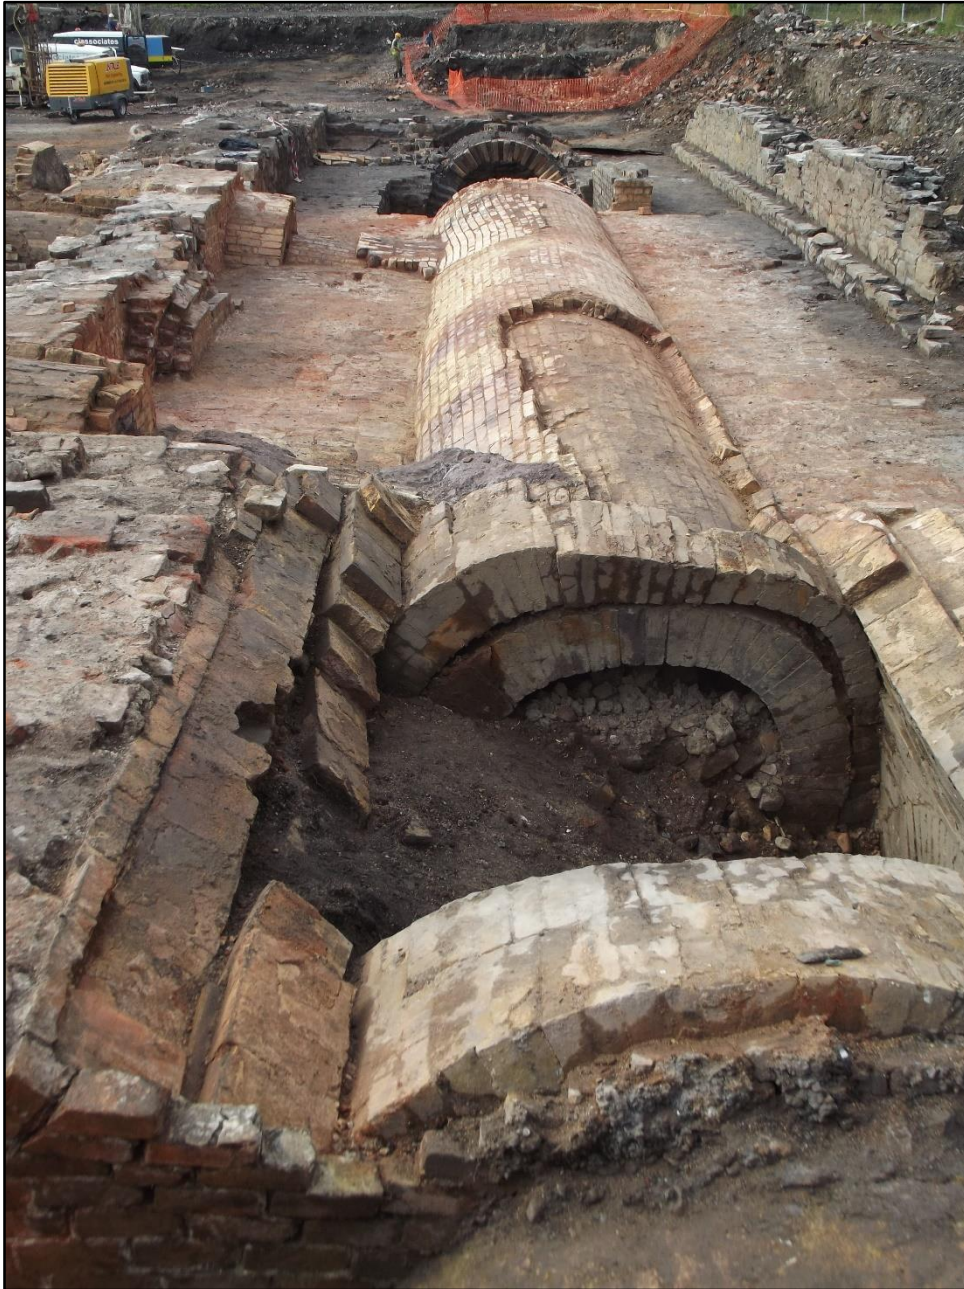
Plate 82. North Coppée coke oven flue complex, showing the arrangement of walls and floors to create a substantial 'cradle' in which to construct main gas flue 2448. Junction base 2464 is closest to the camera. View to west.
