Cyfarthfa Coke Works (The Old Thorn Lighting Works) Merthyr Tydfil

Excavation report and analysis

October 2017

GGAT report no. 2017/051
Project no. P1844
National Grid Reference:
SO 03708 06785

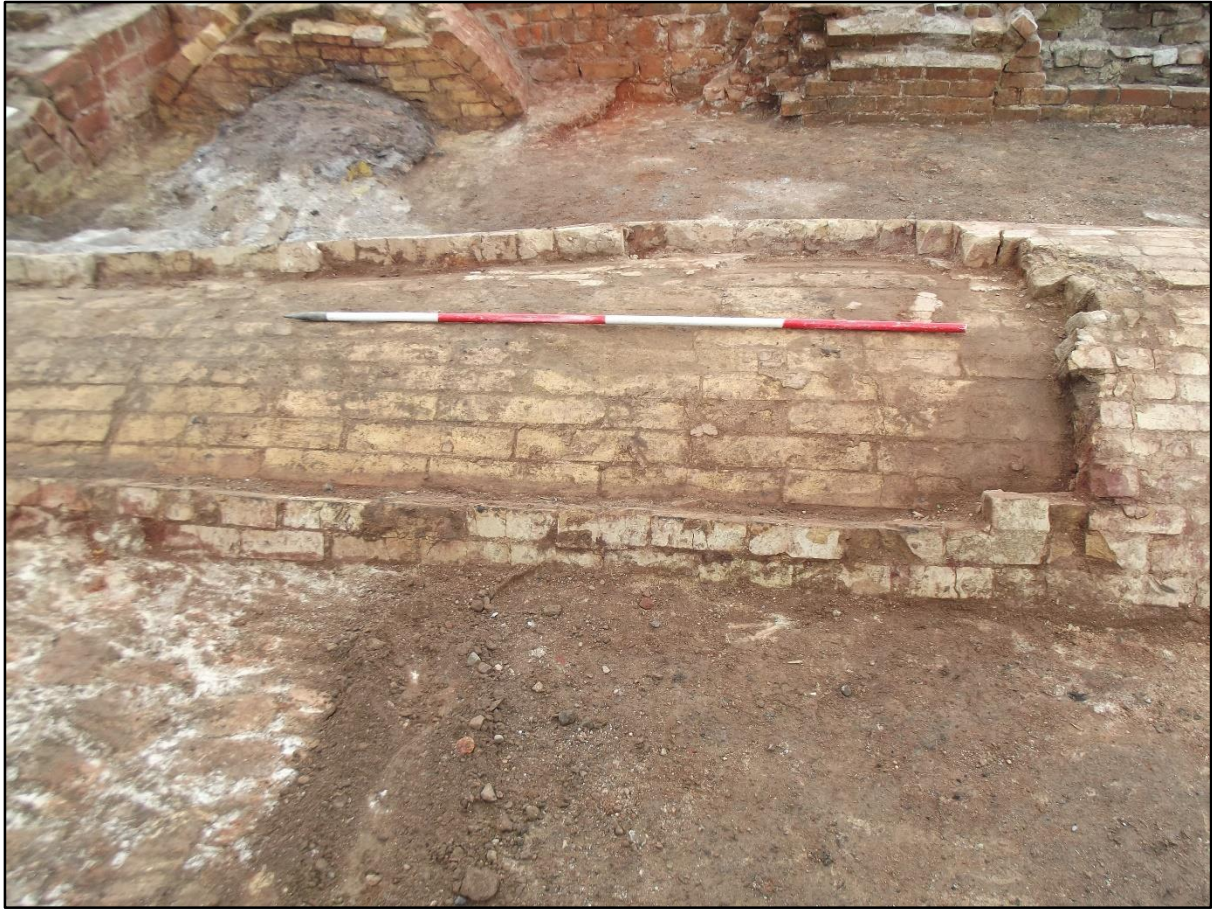
Plate 83. North Coppée oven gas flues, roof of the main gas flue 2448 showing the outer skin of standard refractory brick and the outer surface of the specialist wedge shaped brick that formed the flue itself. Scale is 2m. View to south.

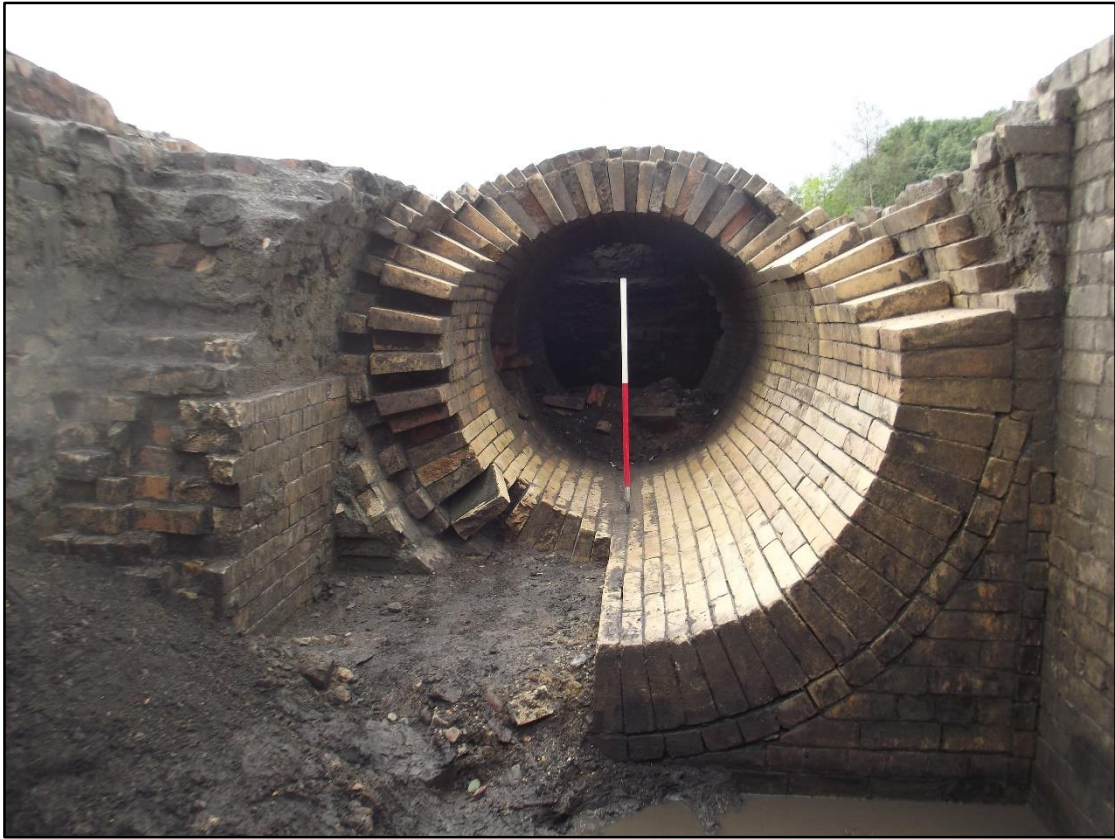
Plate 84. North Coppée Coke oven flue complex, oblique sectional view through damaged main gas flue 2441. Note the method of construction using high quality specialist bricks. Scale is 1m, View to west.

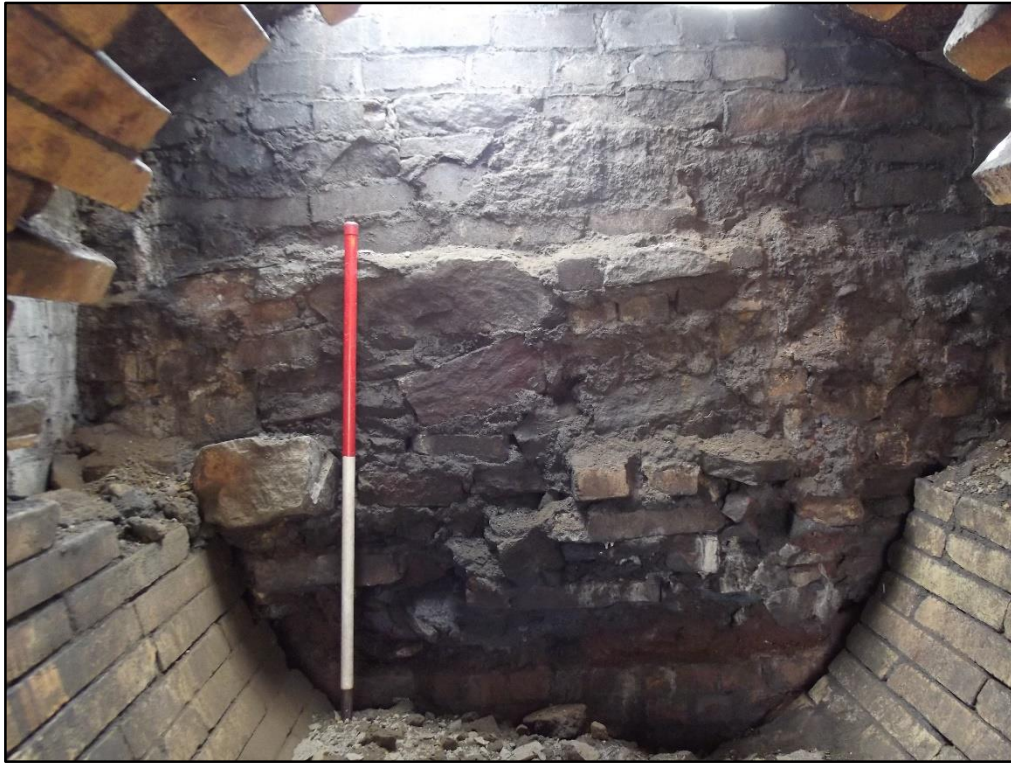
Plate 85. North Coppée coke oven flue complex, view of the interior of the western end of main gas flue 2448 showing the lower half of the flue abutting wall 2433. View to west.

The western end of the flue abutted a masonry wall (walls 2433 and 2471) which formed the eastern section of the main Coppée oven down-take channel (Plates 85 and 86). Whilst the lower half of the flue abutted the wall, the roof had never been completed, instead being capped by four rectangular iron plates (plates 2444), one of which had broken into two pieces. These were *in situ* at the time of the excavation and appeared to serve as a removable inspection cover that provided access to the main gas flue. Each of the 5mm thick sheets measured 1.21m by 1.61m and were aligned with the long edges running parallel to the direction of the flue (Plates 87 and 88). Several spare specialist refractory bricks had been used to prop the plates up so they did not move but otherwise the arrangement was unremarkable. The discovery of the plates does however suggest that a minimal amount of heat was encountered in this section of the flue, a fact supported by the fact that the interior of the flue displayed no evidence of vitrification or discolouration caused by heat.

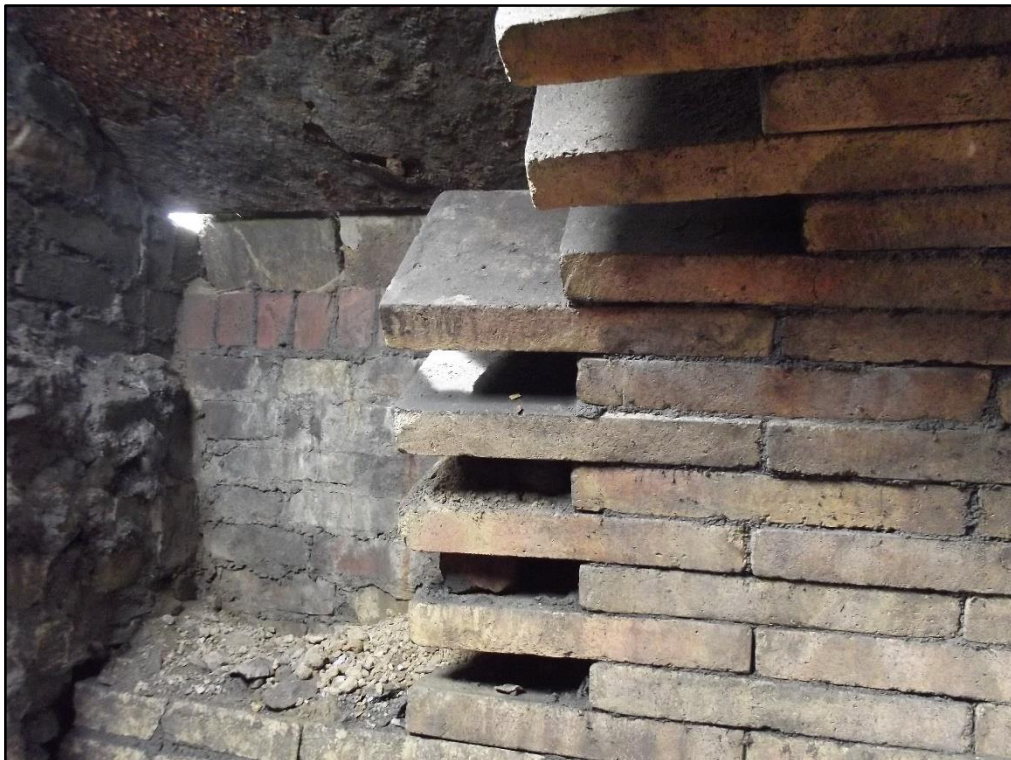
Plate 86. North Coppée coke oven gas flue complex, view of the unfinished western terminal of flue 2448. View to north west.

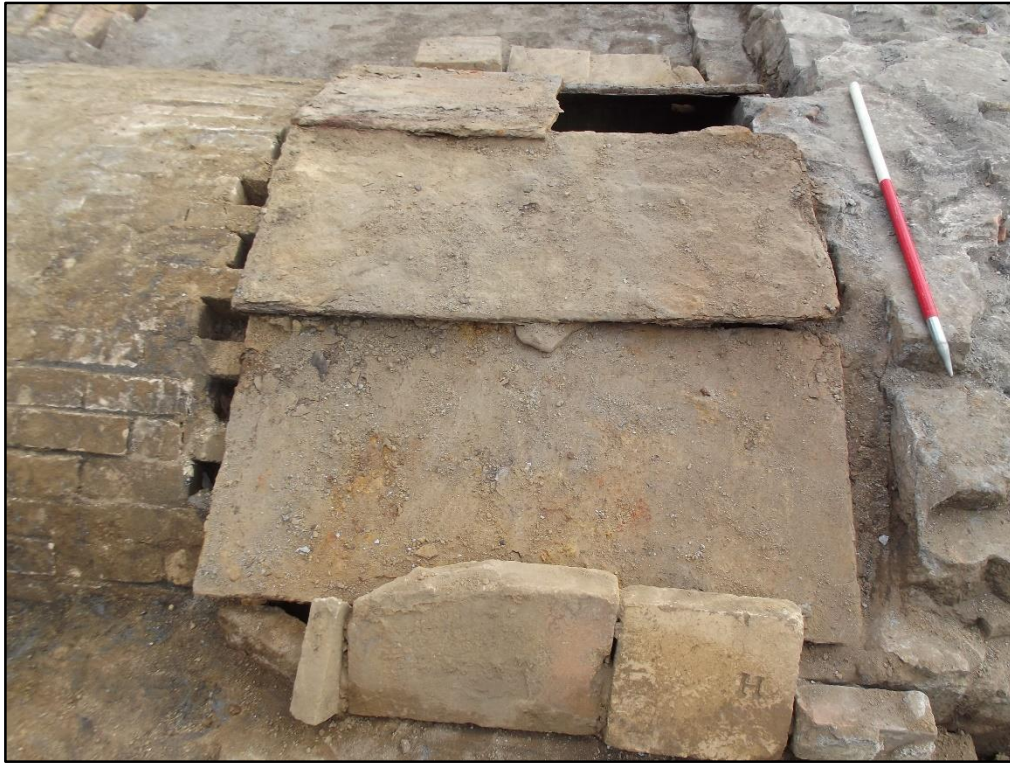
Plate 87. North Coppée coke oven flue complex, iron plates 2444 placed over the uncompleted western terminal of main gas flue 2448 as a removable inspection cover. Note the specialist bricks propping the sheets in place, which were found in their original positions. View to south.

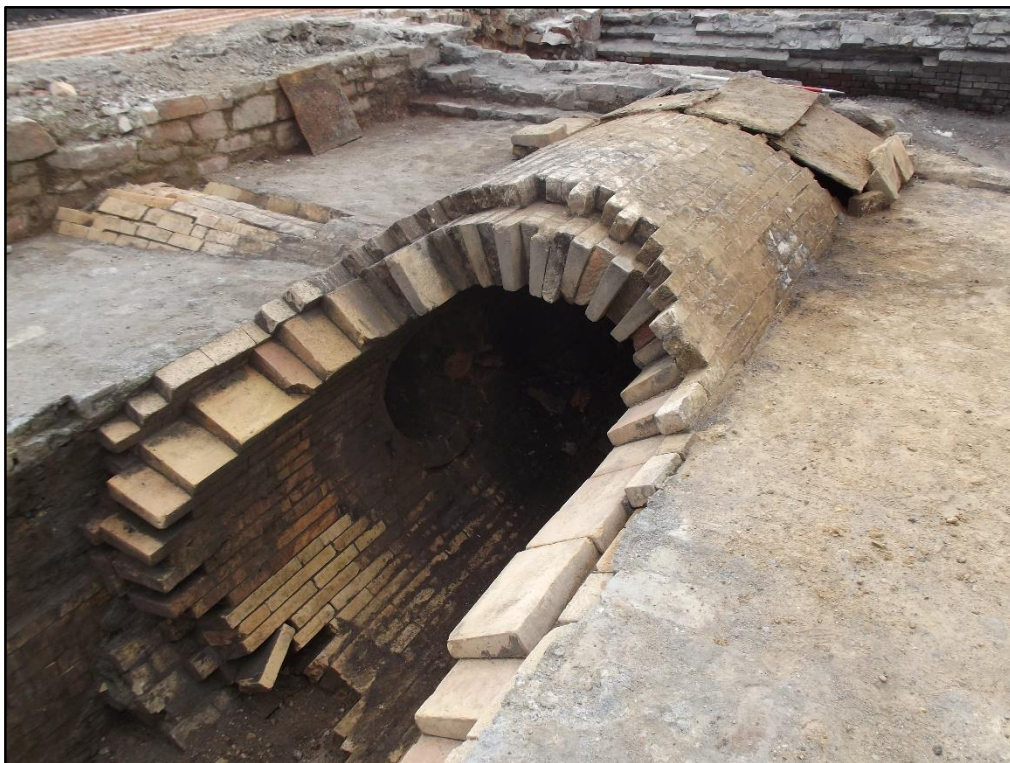
Plate 88. North Coppée coke oven flue complex, oblique view of the western terminal of main gas flue 2448. Several interesting features are visible including the mouth of secondary flue 2442 inside the main flue, and iron plates 2444. View to south west.

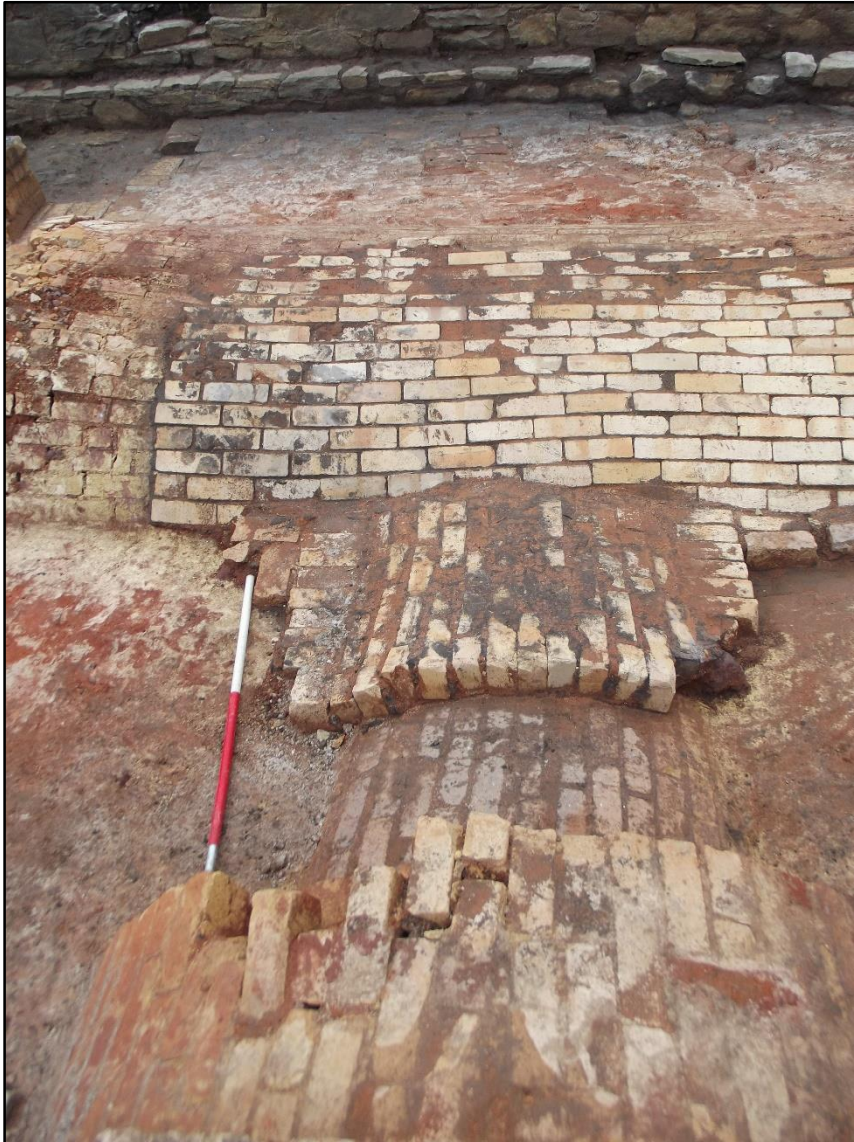
Plate 89. North Coppée coke oven flue complex, repair or insert to the roof of the main gas flue 2448. The repair may have been intended to remedy a collapse of secondary flue 2447, which is visible at the bottom of the image. View to north.

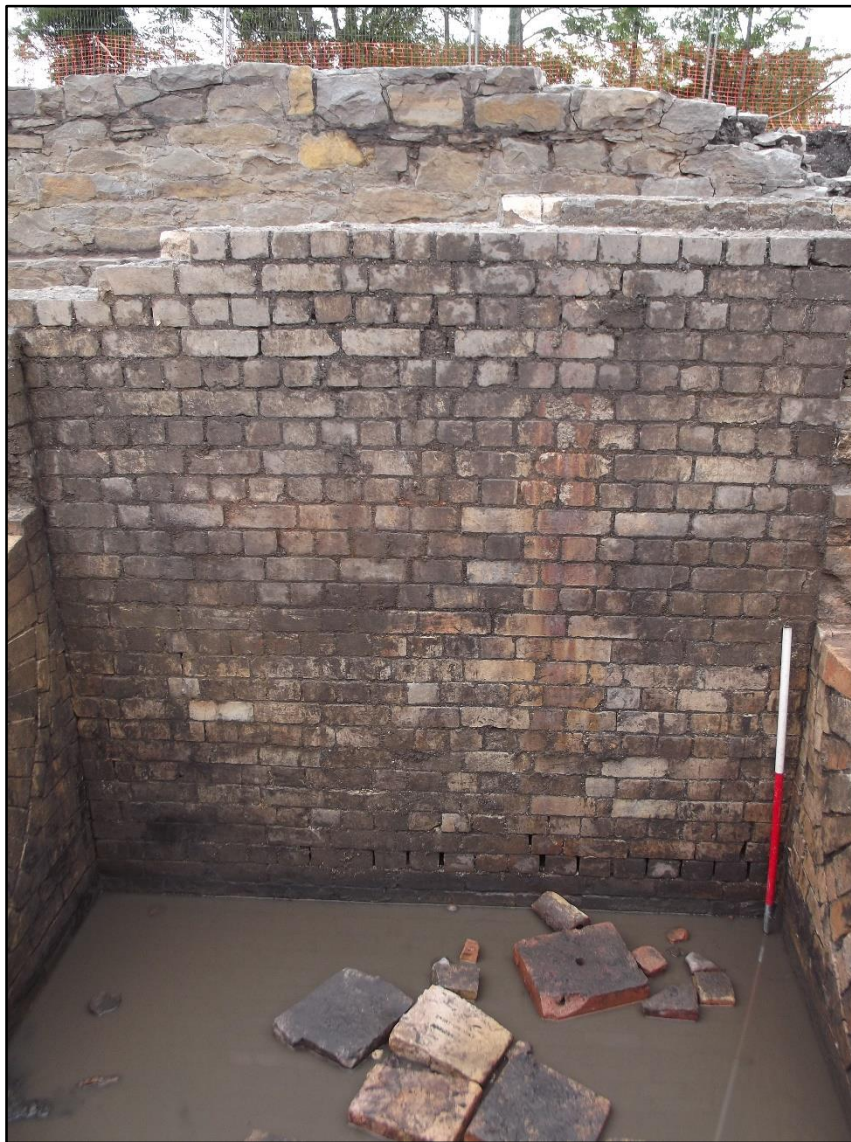
Plate 90. North Coppée coke oven complex, north wall of chimney base 2132. The structures just visible to left and right are the mouths of main gas flue 2448. View to north.

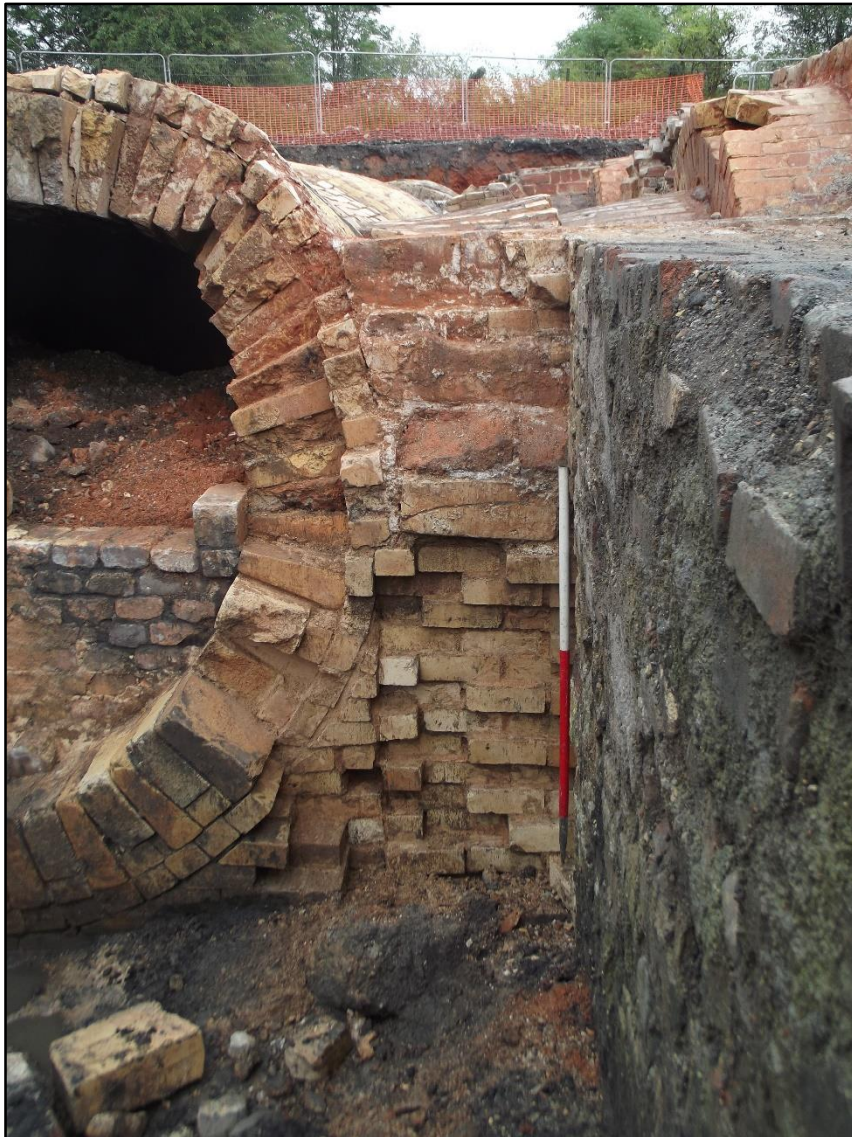
Plate 91. North Coppée coke oven flue complex, mouth of main gas flue 2448 at its junction with chimney base 2132. Floor surface 2439 also served as the south wall of the chamber. View to east.

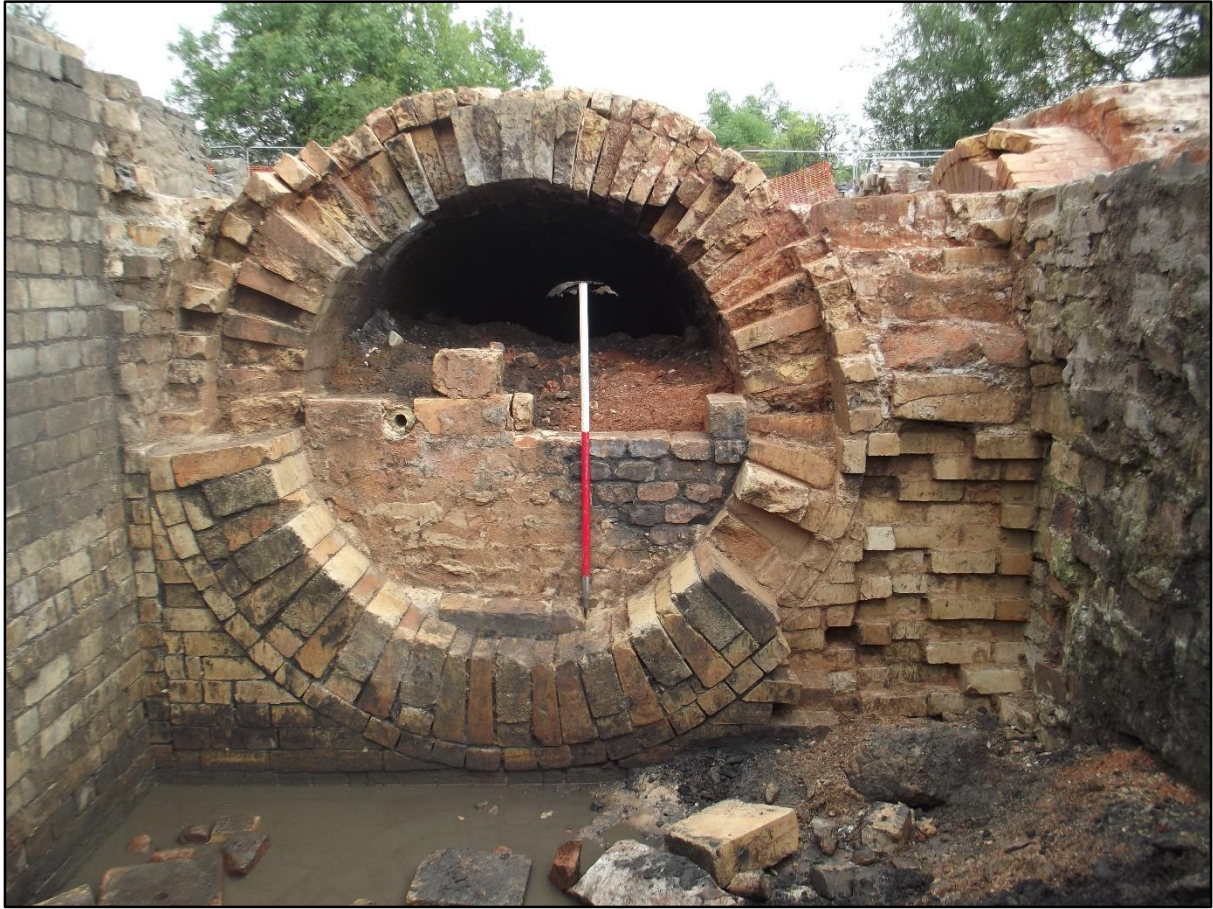
Plate 92. North Coppée coke oven flue complex, partially blocked mouth of the main gas flue within chimney base 2132. This feature was possibly a baffle to reduce the ingress of residue into the chamber base. Note the distortion of the roof, probably caused by heat. View to east.

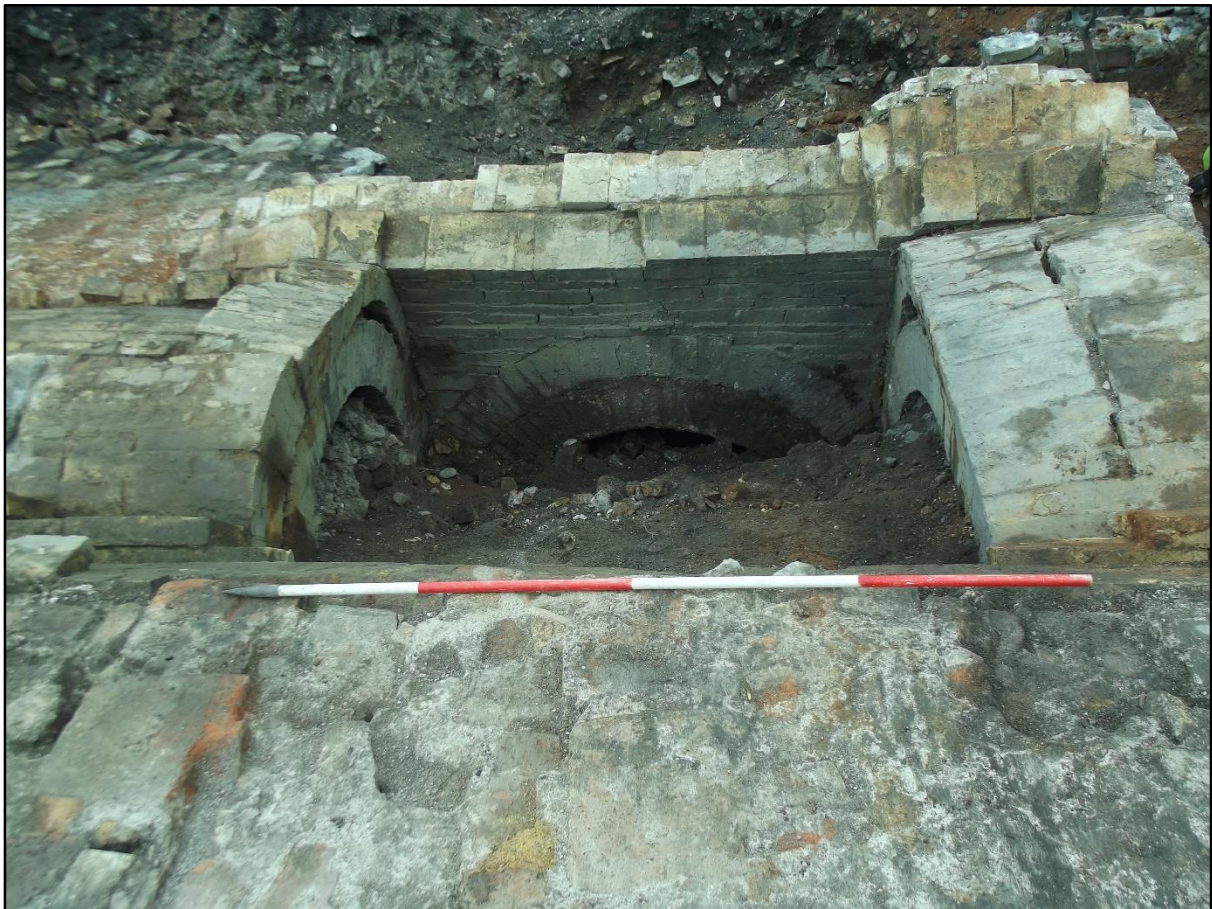
Plate 93. North Coppée coke oven flue complex, brick chamber 2464, which was the junction of flues 2456, 2448 and 2459. Scale is 2m, View to north.

The eastern chamber (2464) consisted of a rectangular box measuring 2.45m by 2.57m constructed largely of yellow refractory brick. This base served as the junction of three large flues (flues 2456, 2448 and 2459) and was quite unlike chimney base 2132, which was located 13.2m to the west. The base was also dissimilar in that the upper levels incorporated the spring points of multiple arched roofs, leading to the conclusion that base 2464 was simply a heavily reinforced junction point, and not a chimney. The bricks used to construct the feature were of a specialist refractory type, some of which were stamped 'J.B. Fisher and Company' (see brick report). The mouths of each of the flues that opened into the chamber had been provided with brick reinforcing collars (Plate 93).

One other factor militating against chamber 2464 being a chimney base was the fact that the upper elements of the north and south walls of the chamber were furnished with obvious spring points for the continuation of arches, which would not be the case were the chamber to be a chimney base.

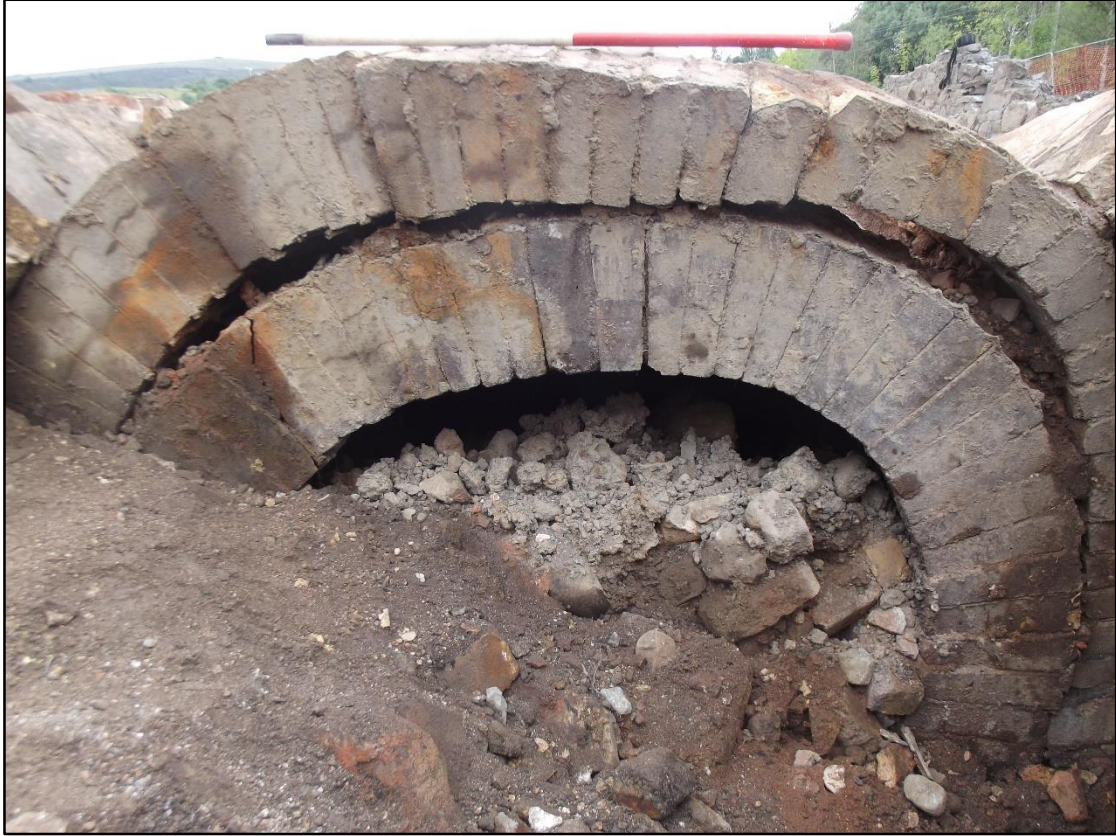
Plate 94. North Coppée coke oven flue complex, mouth of the western flue (flue 2458) opening into flue junction 2464. View to west.

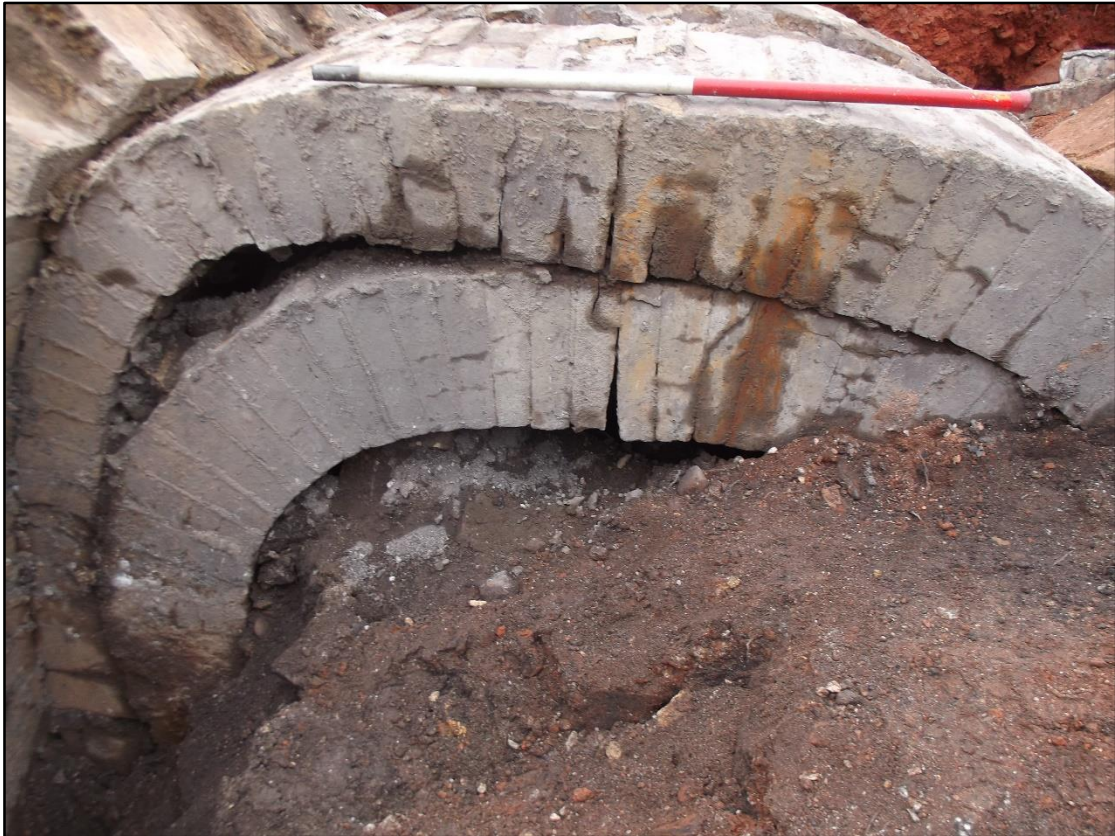
**Plate 95. North Coppée coke oven flue complex, eastern flued mouth 2456 opening into flue junction 2464.
View to east.**

The western flue mouth and collar had an exposed width of 2.05m and height of 1.26m, the structure had been constructed from a double skin of specialist brick (Plate 94). The eastern flue mouth (flue 2456) was of identical construction, having an exposed height of 1.3m and a width of 1.06m. The flue was described as elliptical in shape but a large crack was visible in the brickwork and the flue had consequently distorted into an ellipse (Plate 95).

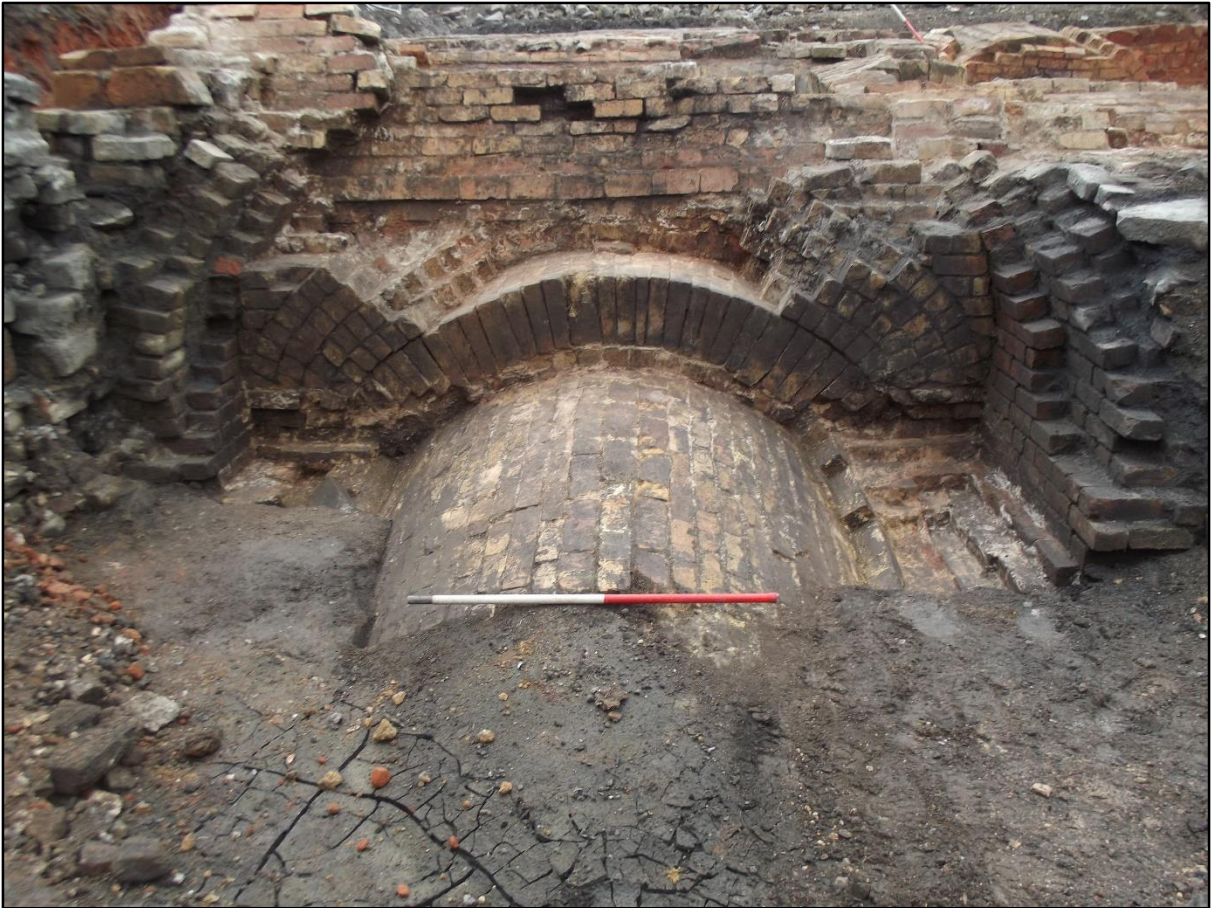
Plate 96. North Coppée coke oven flue complex, rear view of flue 2459 showing the reinforced collar of the flue and elements of the relieving arch on either side. View to south.

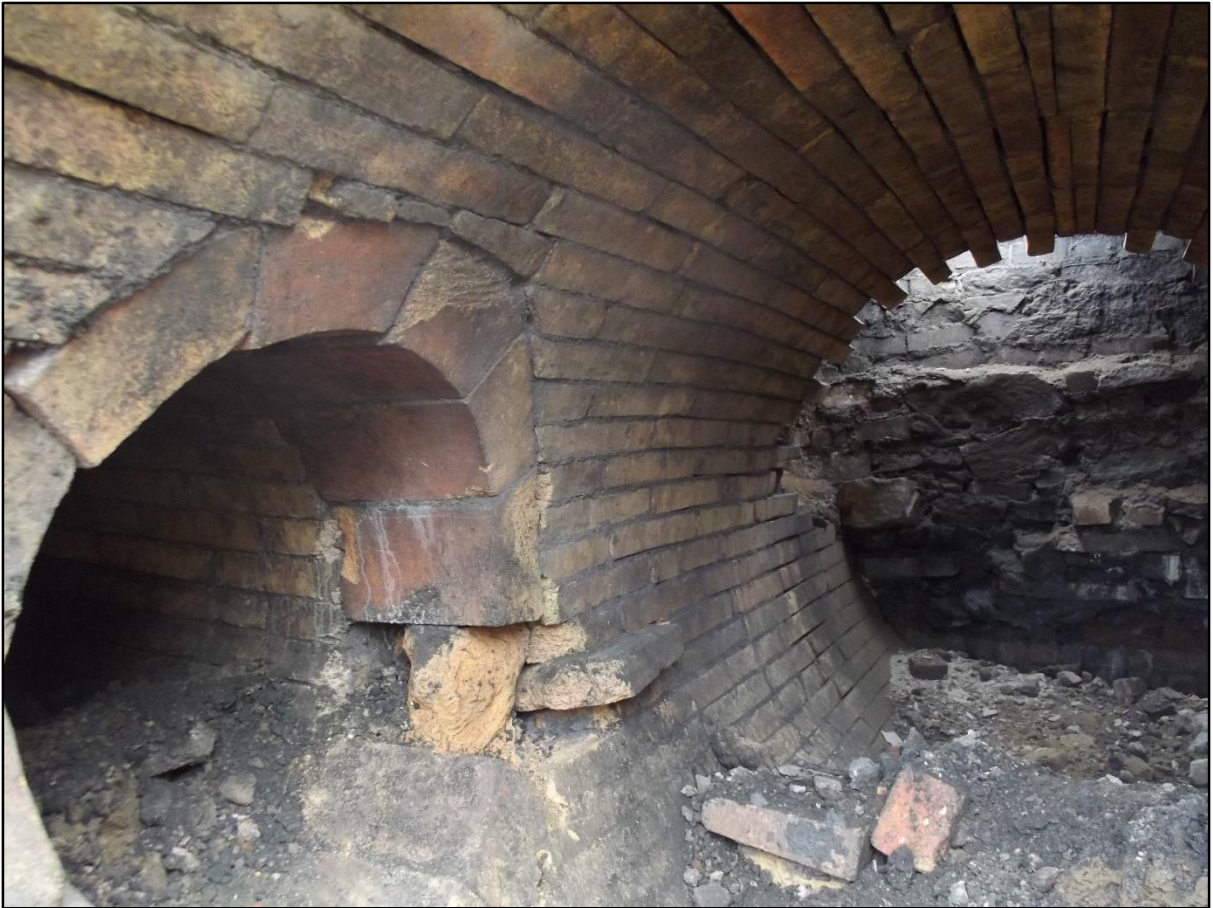
Plate 97. North Coppée coke oven flue complex, mouth of flue 2442 entering main gas flue 2441. View to south west.

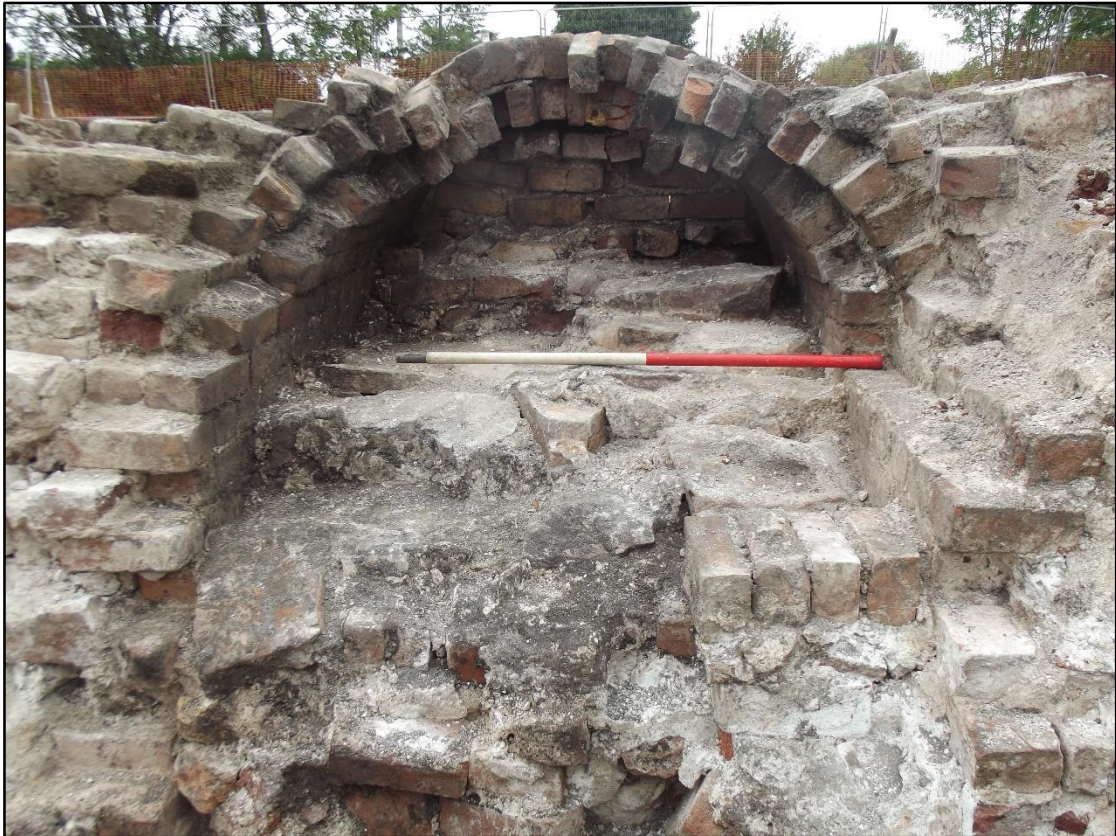
Plate 98. North Coppée coke oven flue complex, rear of blocked archway 2449. This may be a vestigial flue that once connected the main gas flue with brick base group 2468. View to north.

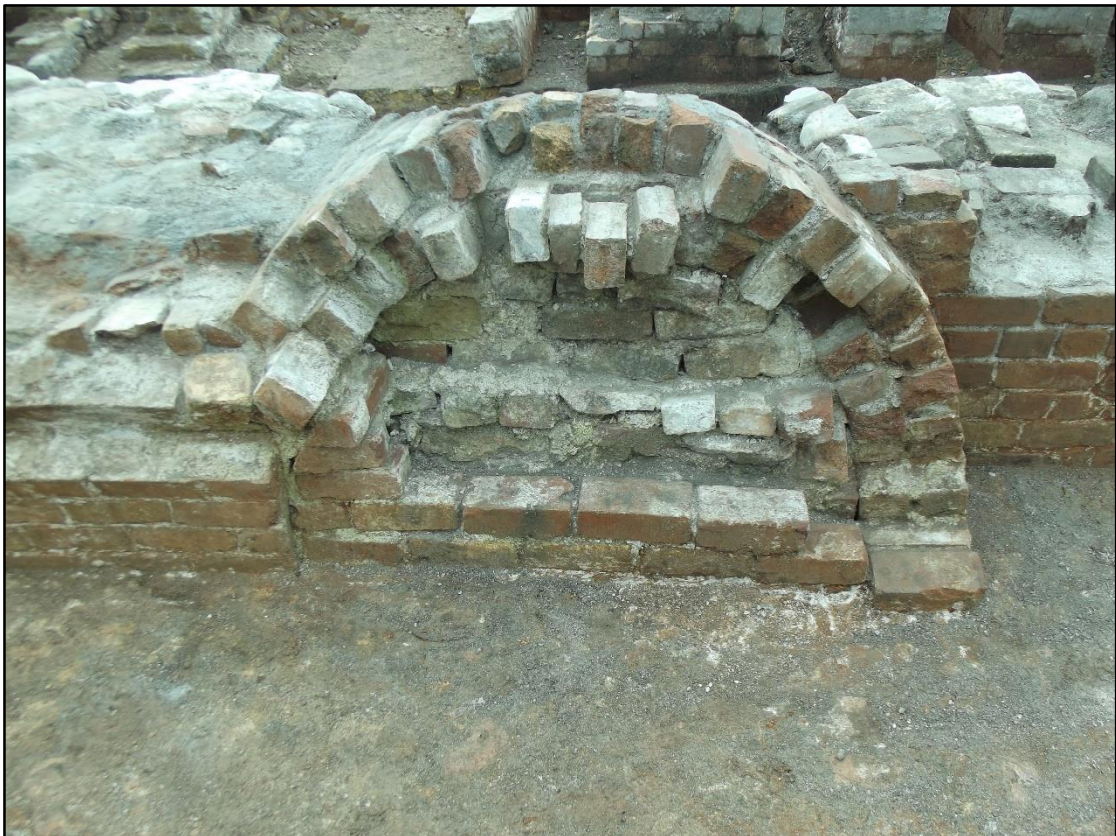
Plate 99. North Coppée coke oven flue complex, Blocked archway 2449. Note brick base group 2468 to the rear of the arch. View to south.

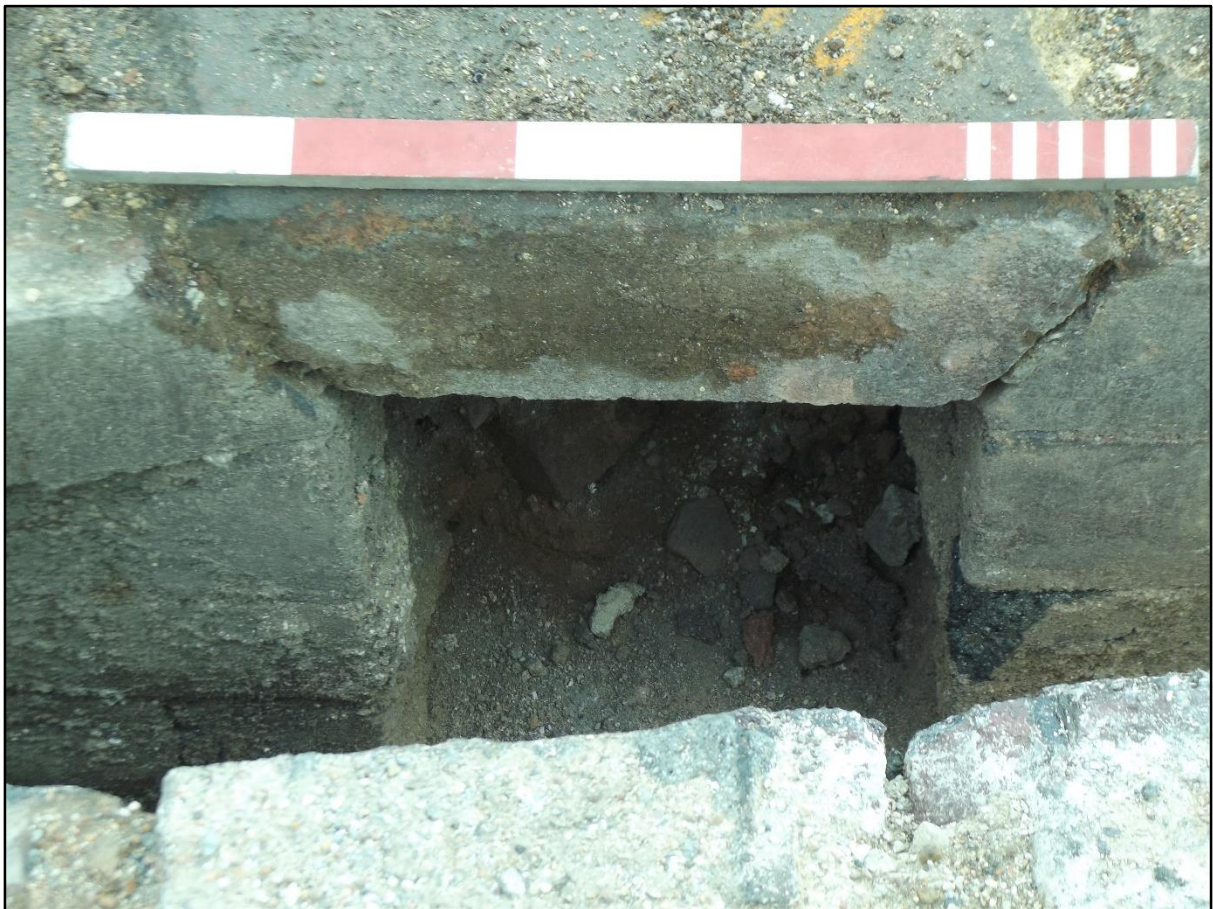
Plate 100. North Coppée oven battery, a capping brick in place over one of the brick bays forming part of group 2468. Note the chamfered nature of the brick to ensure a good seal. Scale is 0.5m

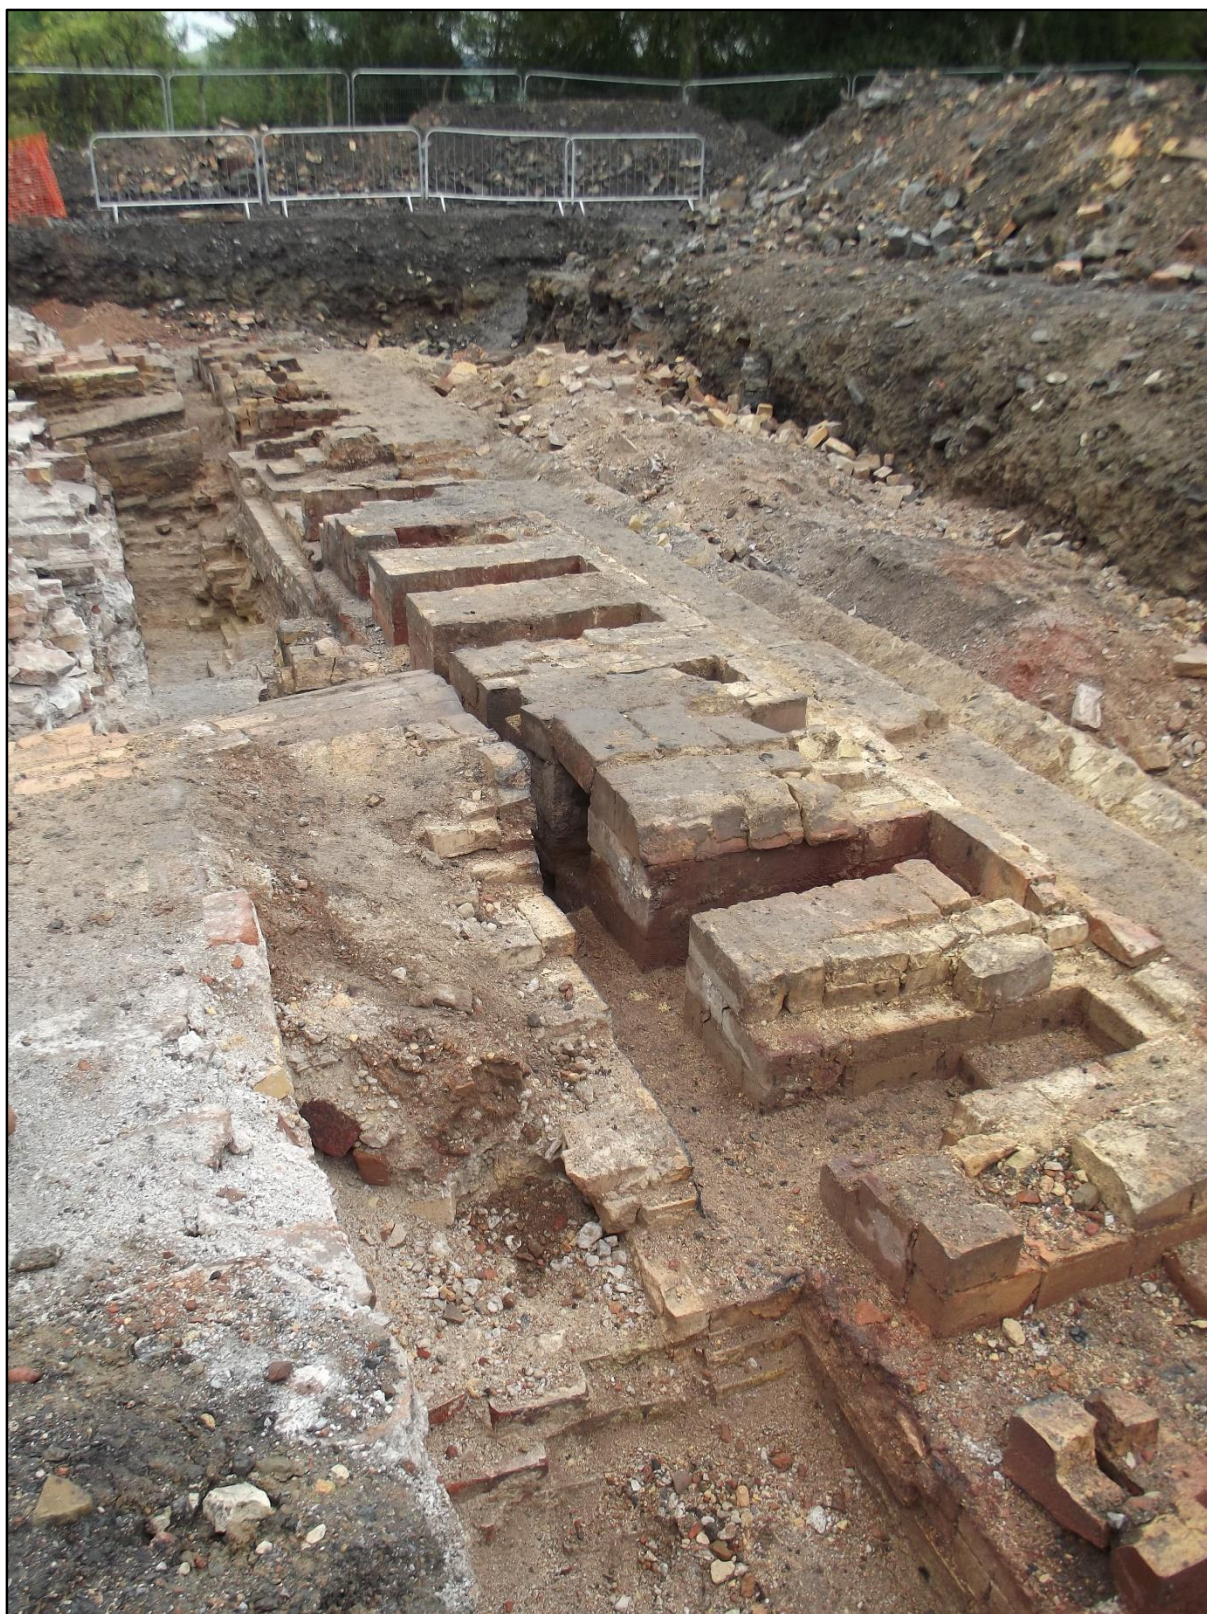
Plate 101. North Coppée coke oven battery, brick built bays group 2468 looking south east

The main gas flue for the north coke oven battery terminated at the east end in a vertical wall, which isolated it from a grouping of rectangular brick built bays (Group 2468). This group was a 15.1m long and 1.78m wide area of multiple (at least 16) brick built bays (Figure 17, Plates 101 to 104). The group was almost certainly longer originally but the eastern end remained buried as it ran outside the development area. The whole structure was made mostly of standard sized, yellow refractory brick bonded with brown/yellow mortar, although a number of specialist bricks were present in the bays. Specifically, these examples were related to capping of the only fully intact bay in the group, with the uppermost bricks of the dividing walls being chamfered to accept capping bricks (Plate 100).
