Cyfarthfa Coke Works (The Old Thorn Lighting Works) Merthyr Tydfil

Excavation report and analysis

October 2017

GGAT report no. 2017/051
Project no. P1844
National Grid Reference:
SO 03708 06785

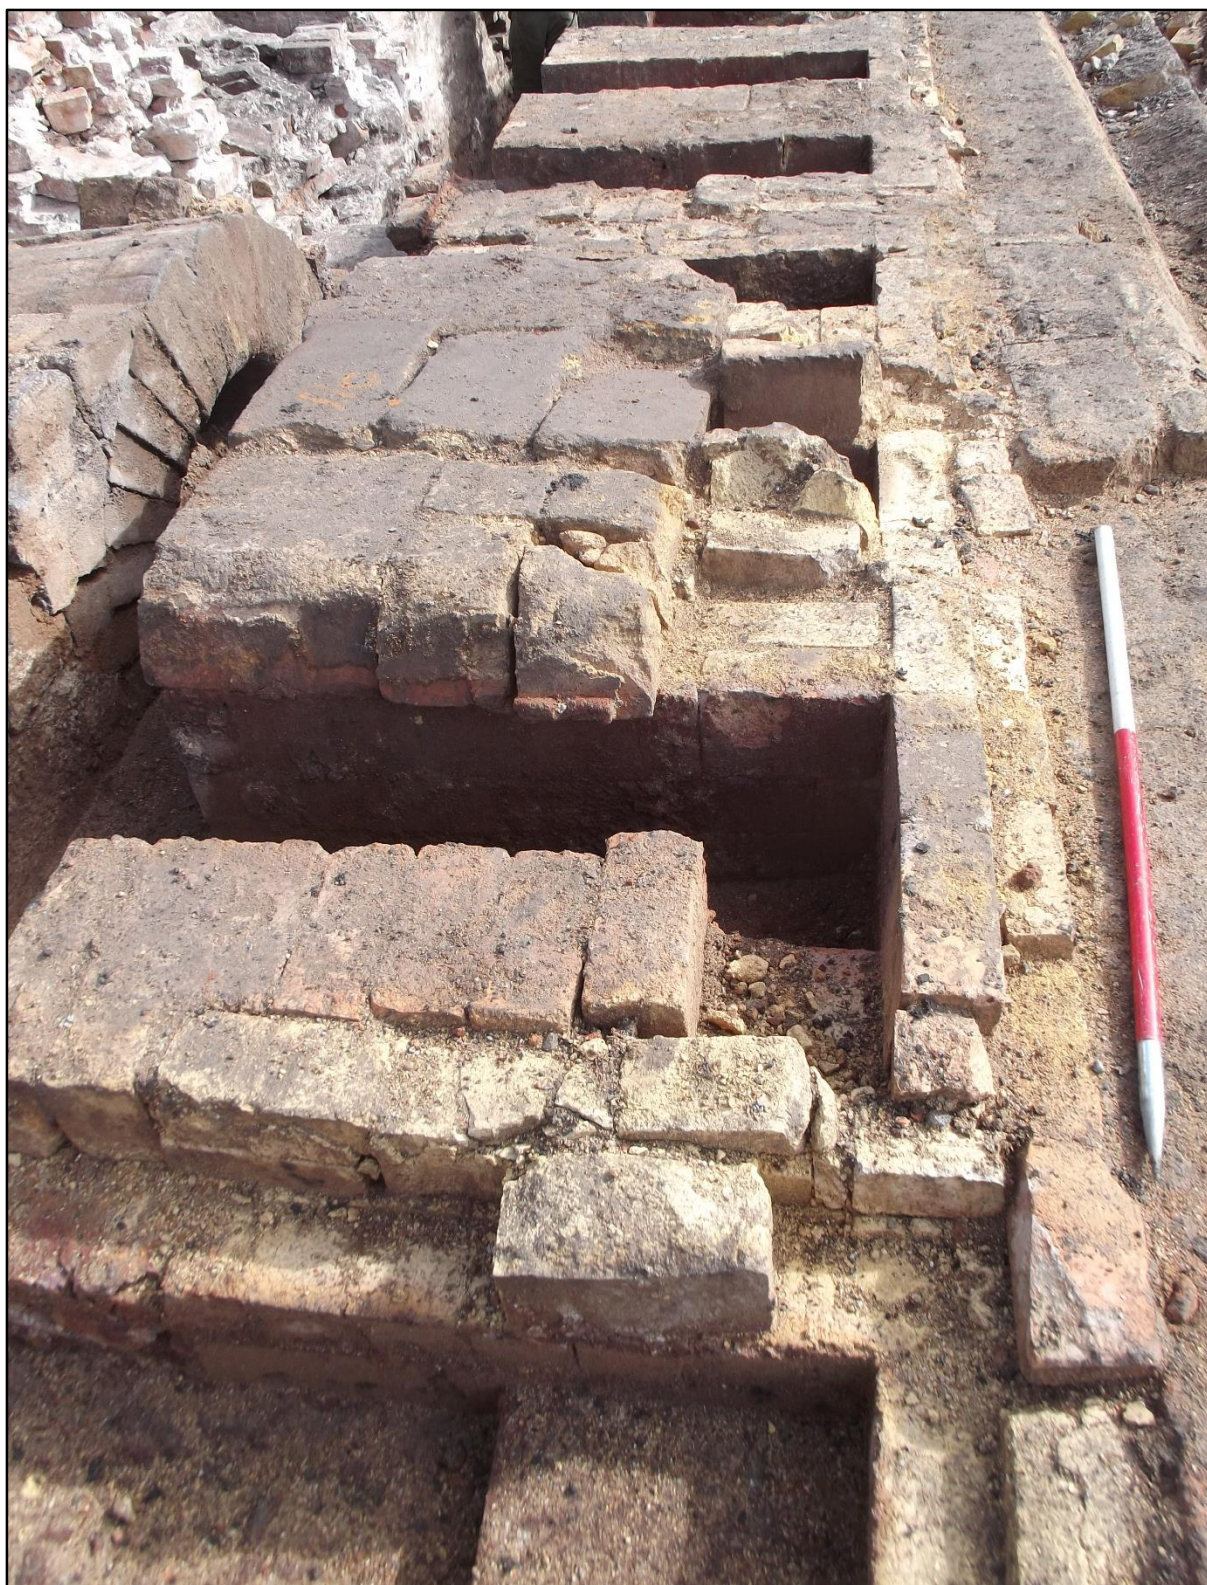
Plate 102. North Coppée coke oven battery, brick bay group 2468, view to east

The main gas flue for the north coke oven battery terminated at the east end in a vertical wall, which isolated it from a grouping of rectangular brick built bays (Group 2468). This group was a 15.1m long and 1.78m wide area of multiple (at least 16) brick built bays (Figure 17, Plates 101 to 104). The group was almost certainly longer originally but the eastern end remained buried as it ran outside the development area. The whole structure was made mostly of standard sized, yellow refractory brick bonded with brown/yellow mortar, although a number of specialist bricks were present in the bays. Specifically, these examples were related to capping of the only fully intact bay in the group, with the uppermost bricks of the dividing walls being chamfered to accept capping bricks (Plate 100).

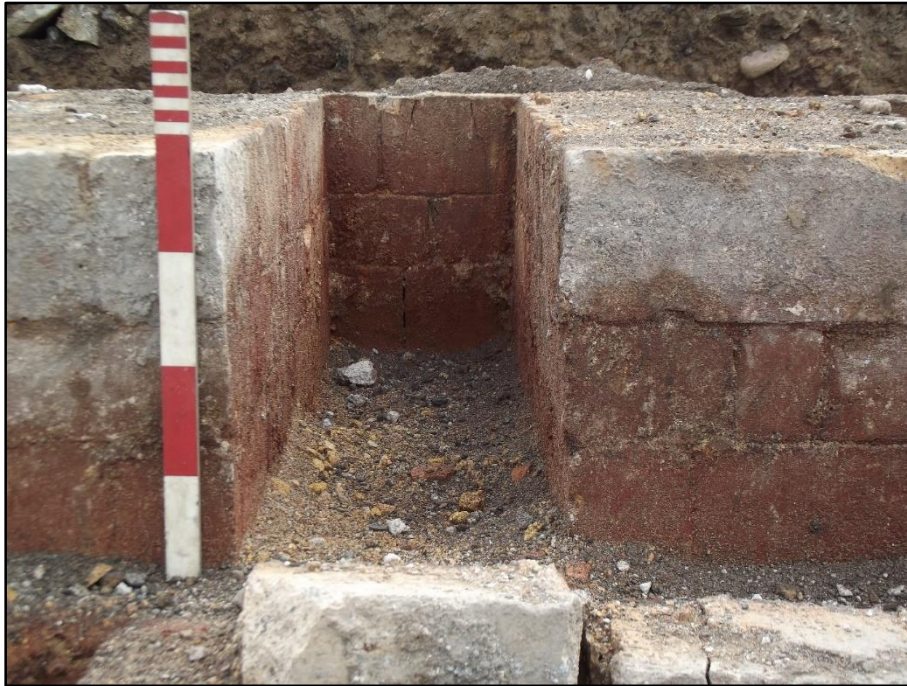
Plate 103. Close up view of the construction of one of the bays forming part of group 2468, part of the north coke oven battery. Note the reddened appearance caused by intense heat.

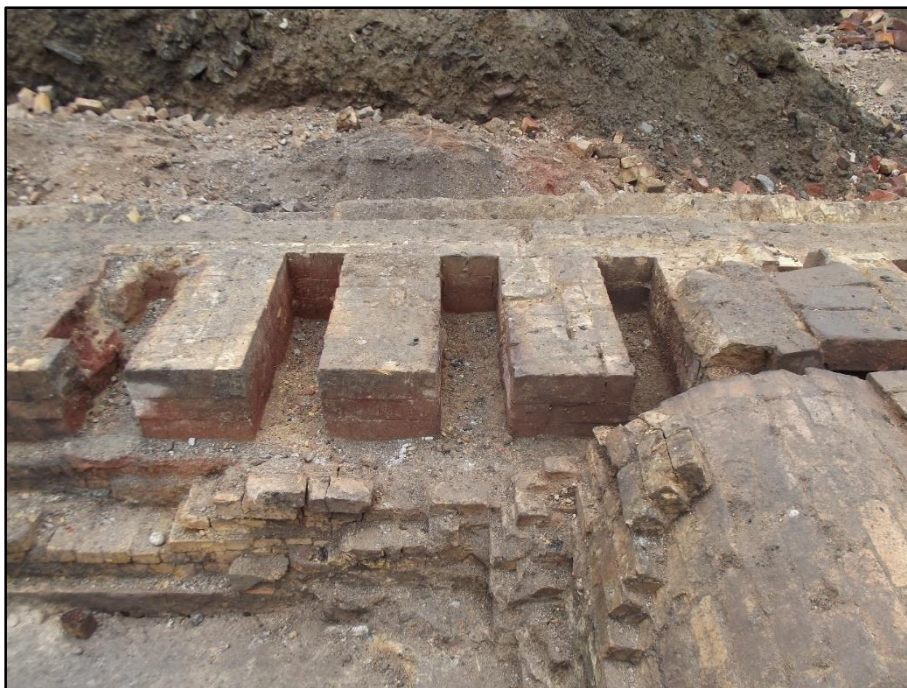
Plate 104. North Coppée oven battery, wider view of brick channel group 2468, with the mouth of flue 2447 visible at the bottom right of the photograph. View to south.

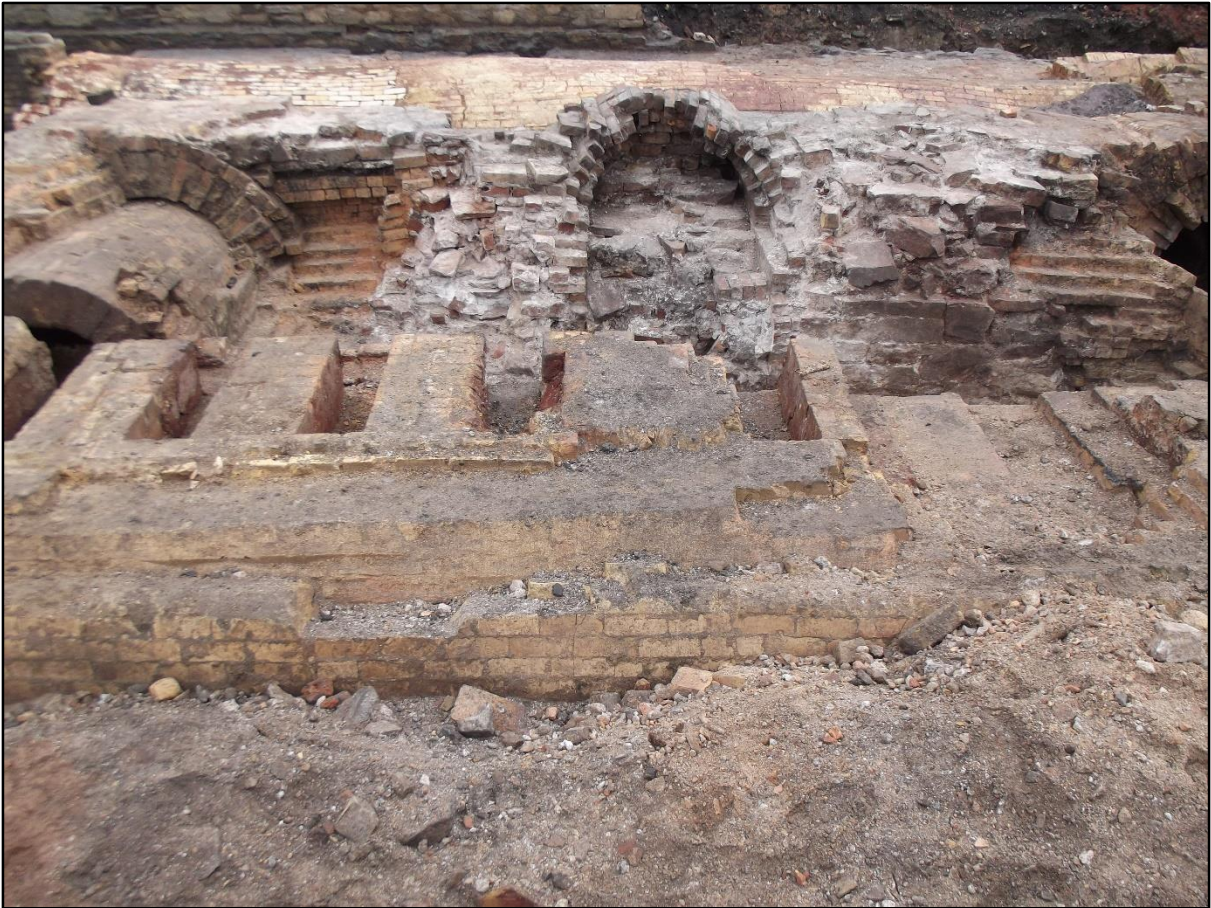
Plate 105. North Coppée oven battery, the mouths of three secondary flues which were open to channel 2480. Note the centre flue (flue 2449) had been blocked during its lifetime. Flue 2448 is on the left and flue 2453 is on the right. View to north.

The brick channel into which the bays opened had originally provided access to the mouths of three separate circular flues in the north side of the structure. One of these had been blocked during its lifetime although the remaining two were open at the time of the demolition of the works (Plate 105). These flues, and the system of which they were a part, are discussed below.

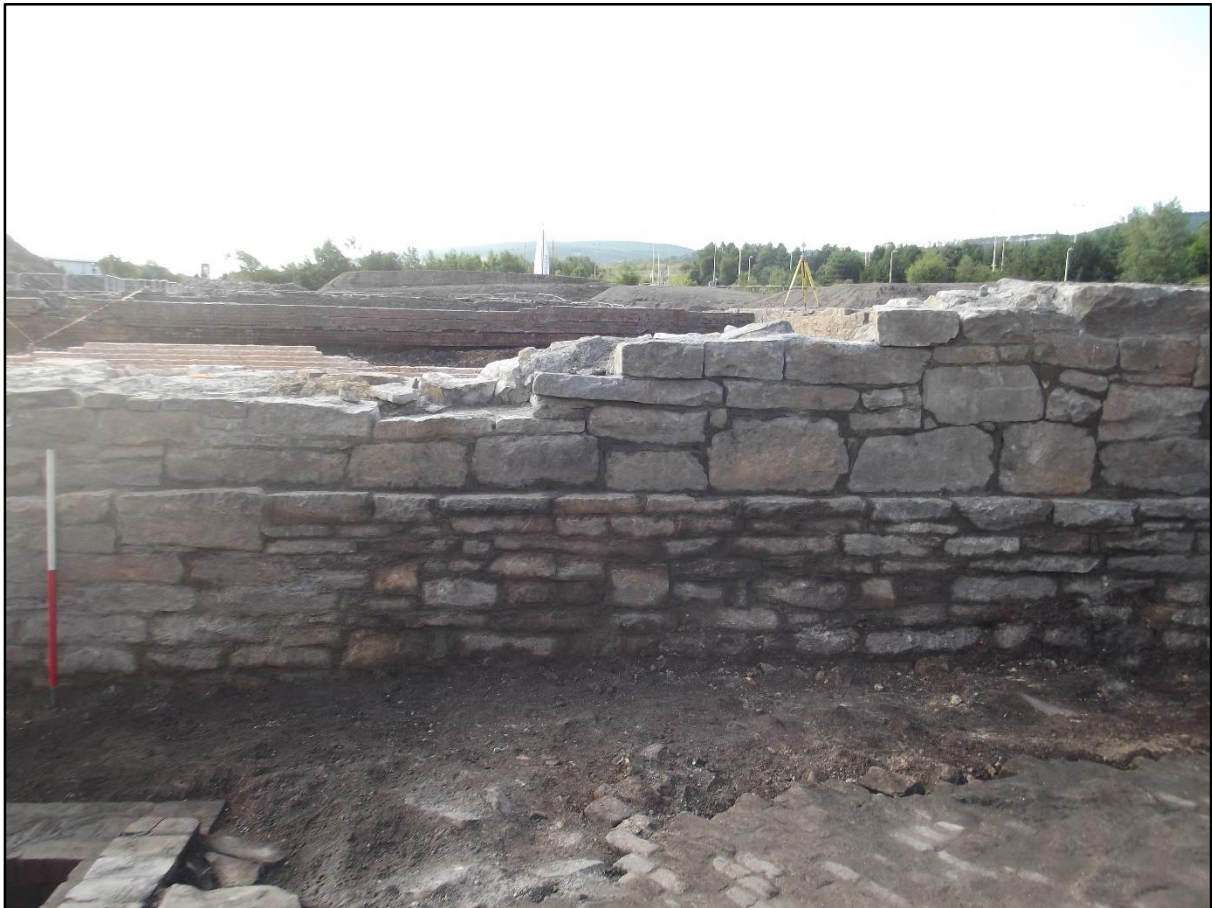
Plate 106. North Coppée coke oven rammer wall, north elevation of wall 2324 showing constructional differences. View to south.

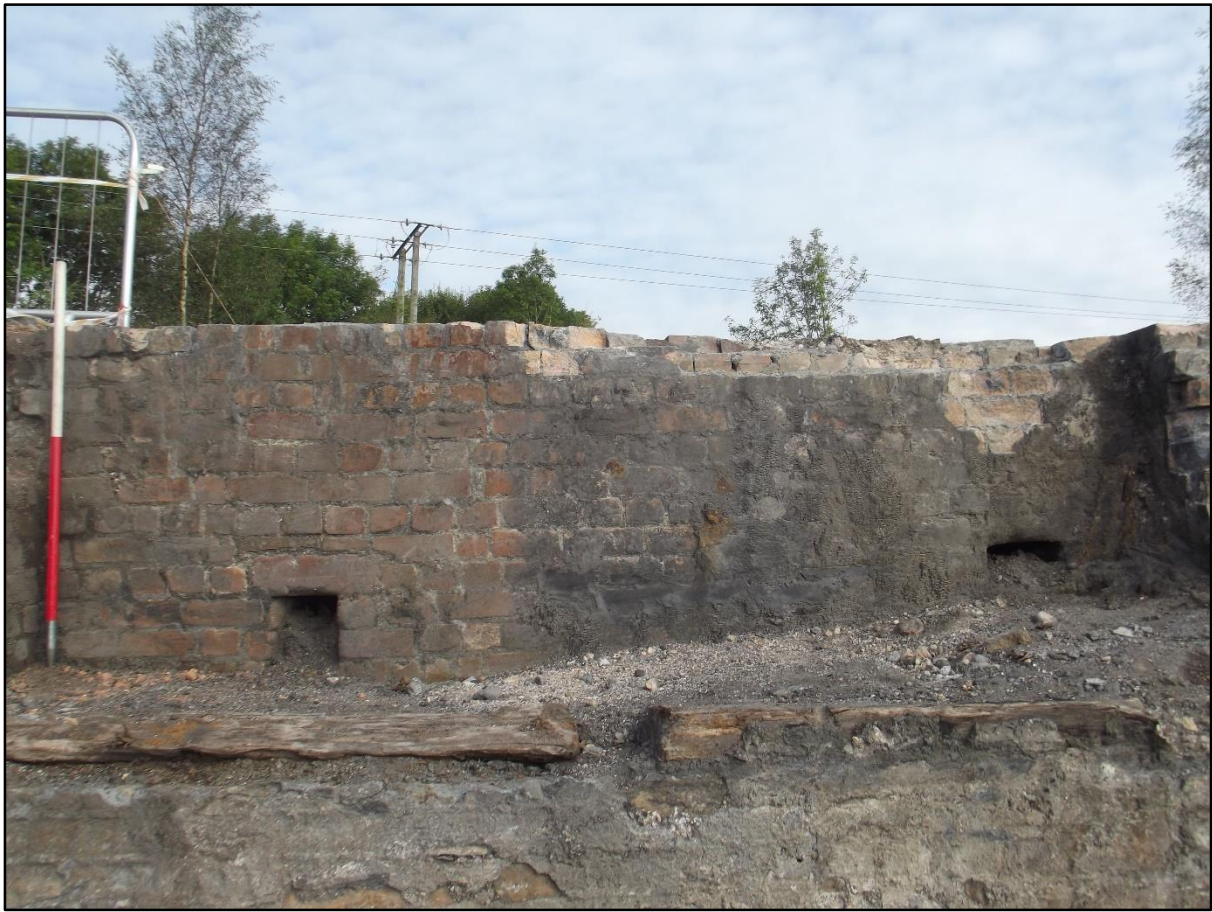
Plate 107. North Coppée coke rammer wall, alcove 2321 showing the remains of timber planking and two recesses in the south elevation of wall 2324. View to north.

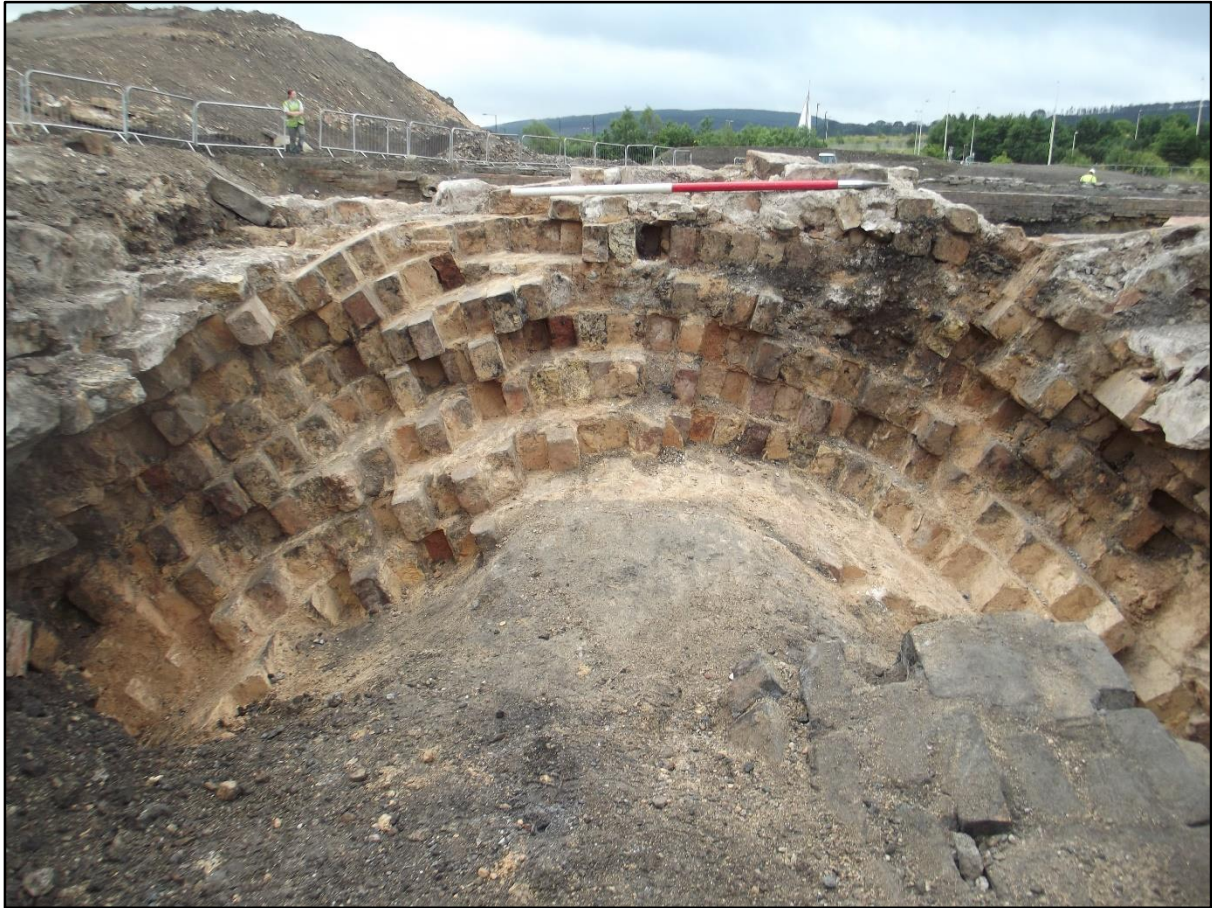
Plate 108. North Coppée oven gas flue system, brick reinforcing collar above the mouth of flue 2338/2432. The grey brickwork in the foreground is part of collapsed relieving arch 2391. View to south.

acted both as a cooling measure and to carry the weight of any overlaying structure away from the flue; this archway had collapsed onto the underlying flue prior to excavation. Both the surviving elements measured 9m in length, and occupied a space 4m in width. The secondary gas flue had been massively reinforced above its mouth by the construction of a collar of brickwork, at least eight courses thick and bonded with yellow/white lime mortar (Plate 108).

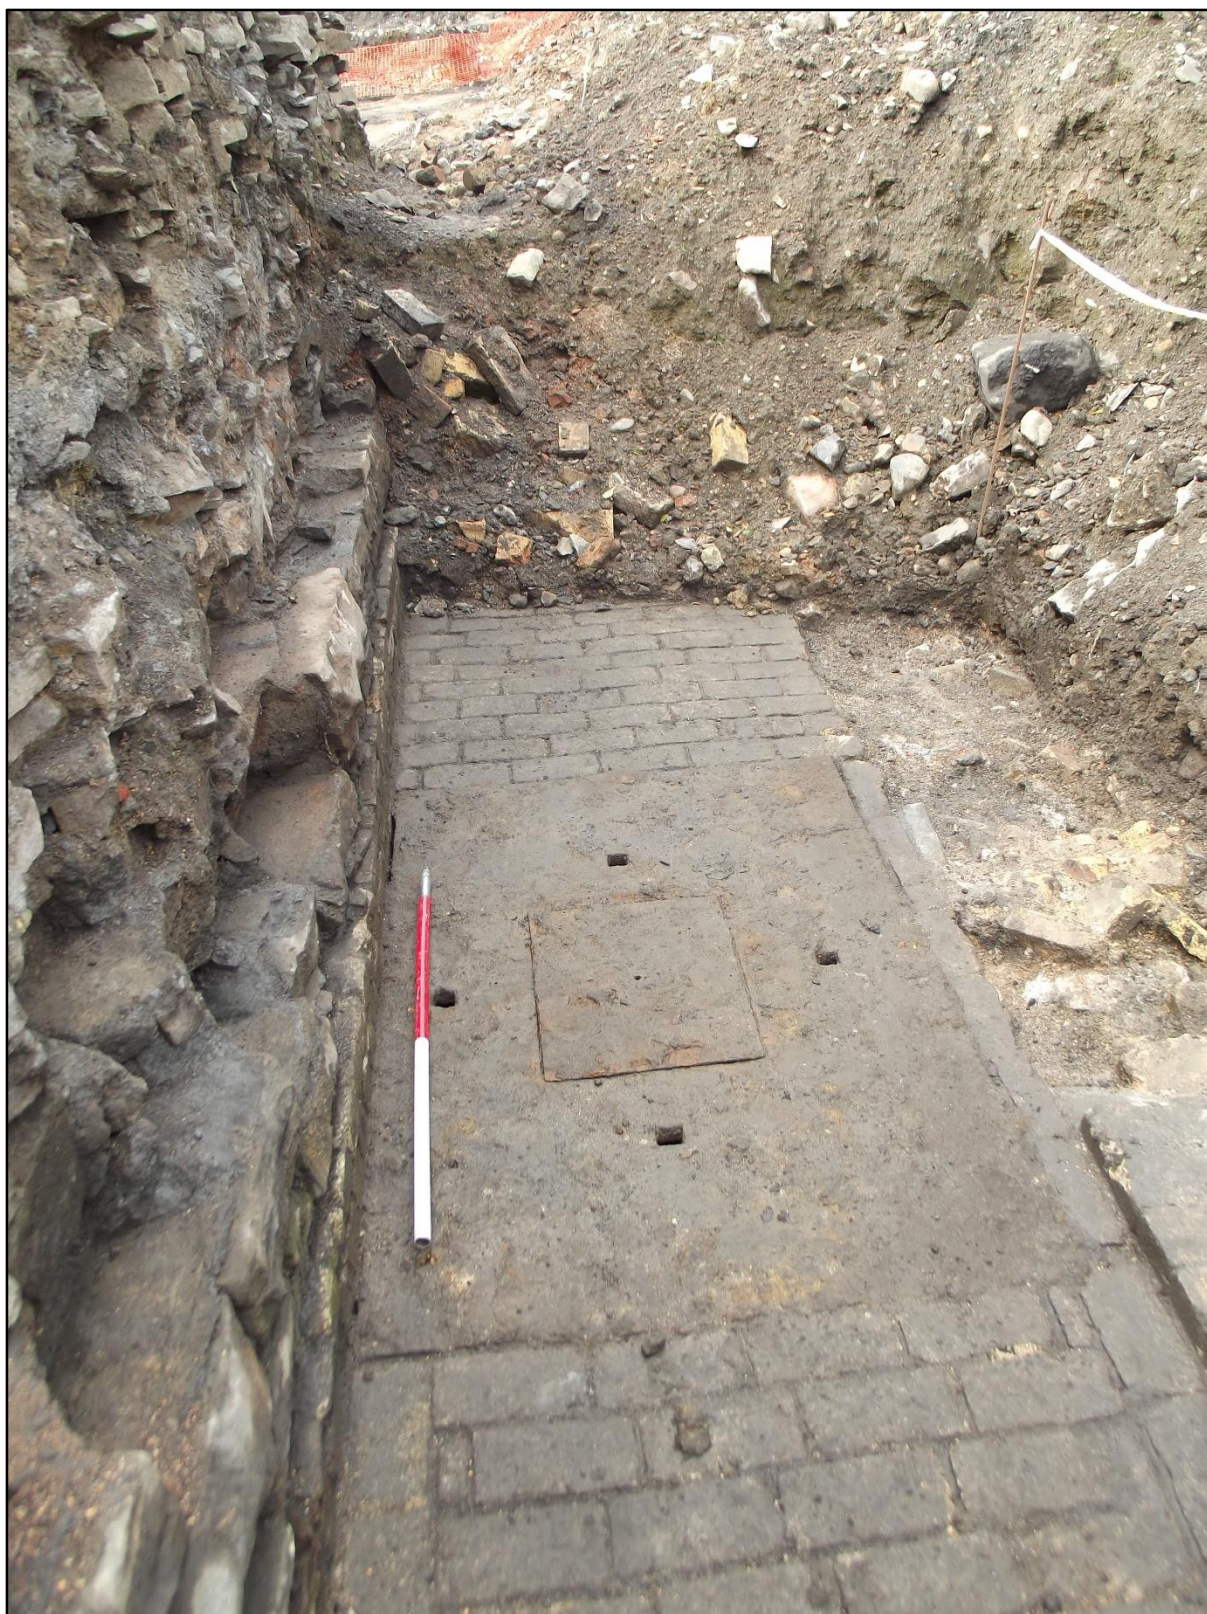
Plate 109. North Coppée coke oven rammer wall, brick surface 2029 and iron access plate 2469. View to west.

The only features north of the north rammer wall to be revealed by excavation consisted of a well-made brick floor surface (brick floor 2029) into which an iron plate had been set (Plate 109). Floor 2027 consisted of a rectangular (as exposed) area of yellow firebrick measuring 2.7m by 1.2m. The surface extended to both the north and east but was not fully explored due to the discovery of asbestos in the area. The iron plate (plate 2469) measured 1.64m by 1.16m and was 25mm thick. The plate had been fitted with a separate rectangular plate, serving as an access hatch to chamber 2485 and flue 2486. The refractory brick built chamber beneath (2485) measured 1.54m by 1.06m and had a depth of 1.41m. It provided access to a blocked flue (2486) which was located in the north wall of the chamber (Plate 110). Access to this chamber and the flue was not possible for health and safety reasons.

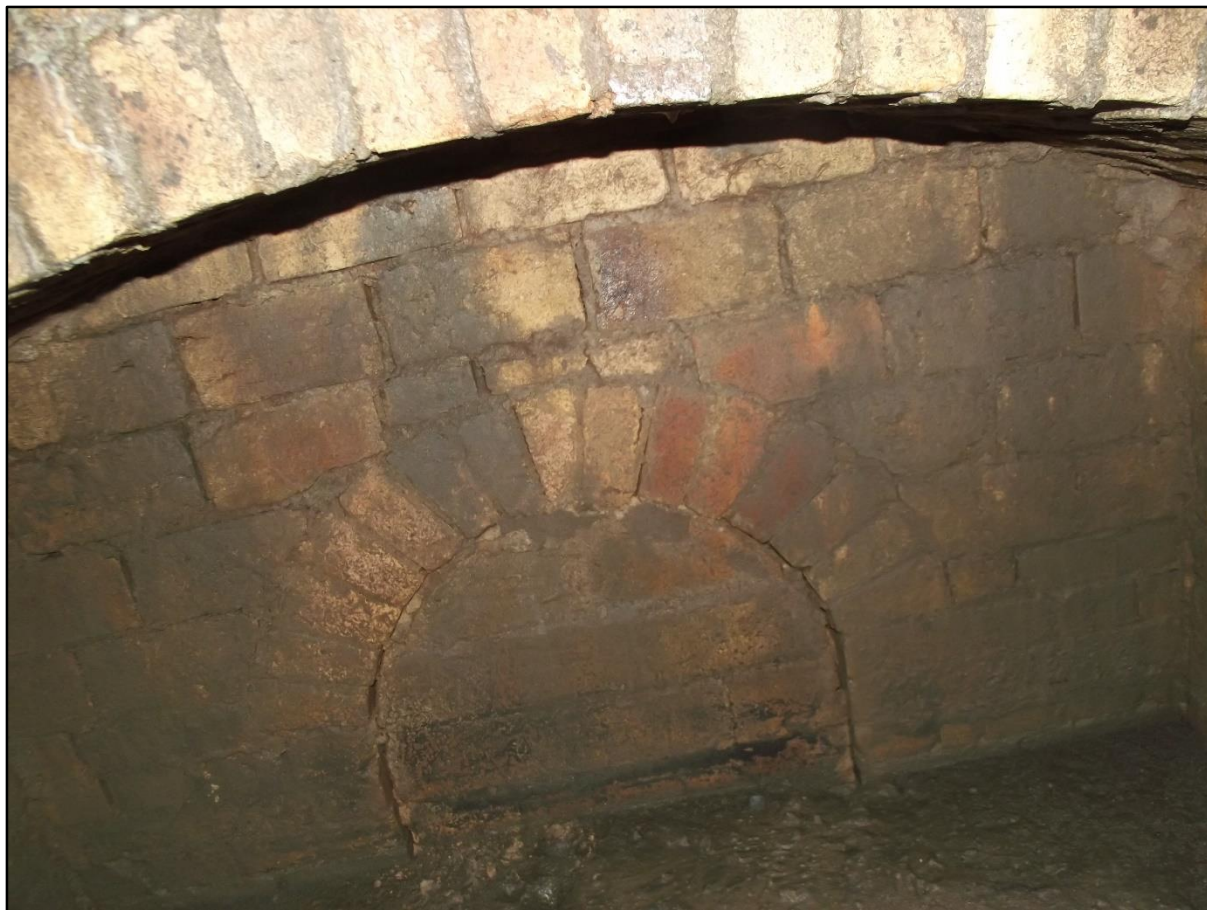
Plate 110. North Coppée coke oven rammer wall, poor photograph of chamber 2485 and blocked flue 2486. Full access to the chamber was not possible for health and safety reasons. View to north.

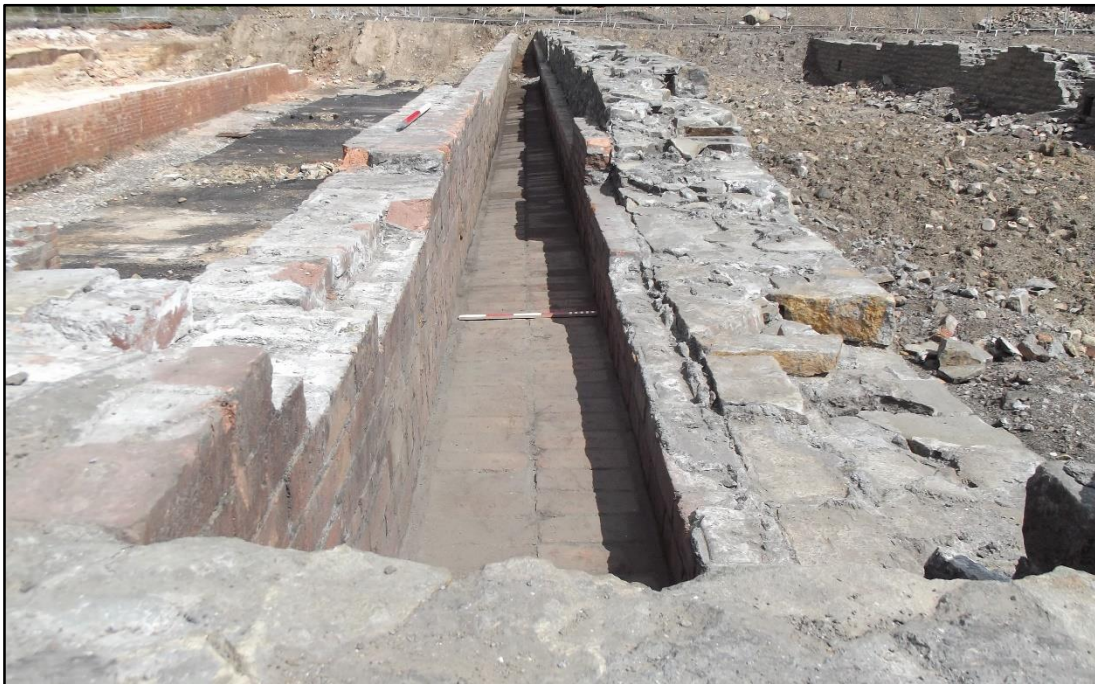
Plate 111. Brick built trough 2202 that once housed the high pressure water system for the north coke bench. View to north east. Masonry wall 2199, which formed the north part of the coke storage bunker is visible to the right of the trough.

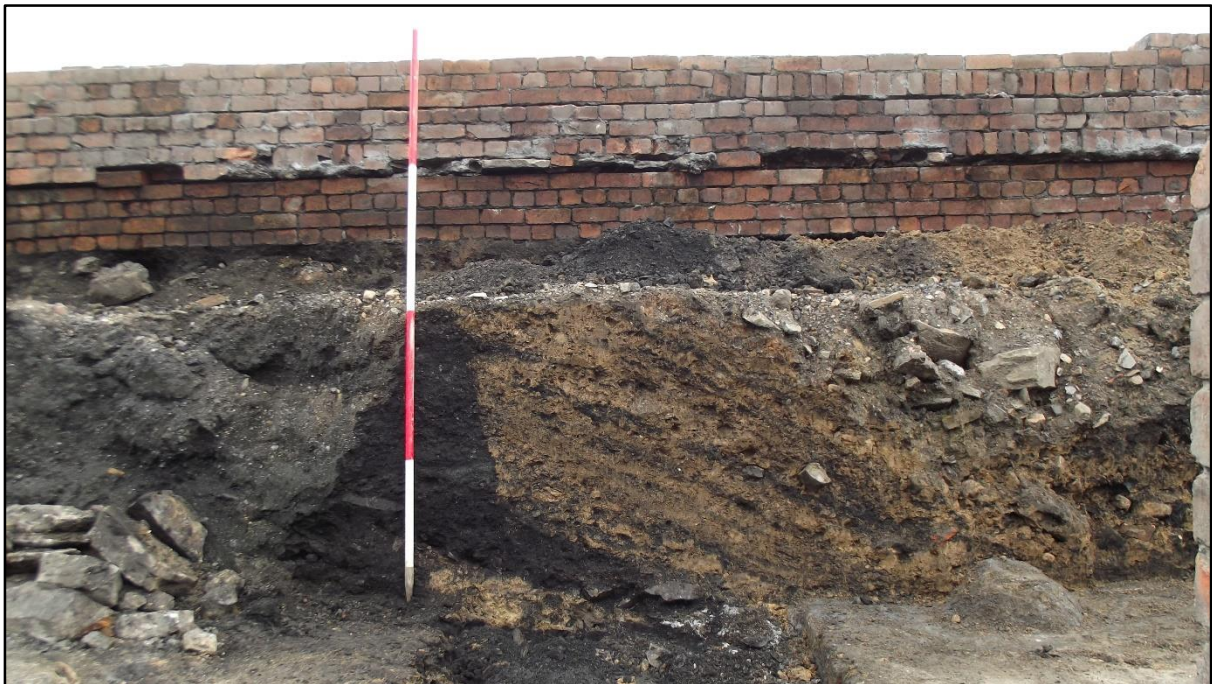
Plate 112. View of the north wall of trough feature 2201. This photograph also shows the insubstantial nature of the material that likely formed the fill for the coking benches, and may explain why both the troughs had subsided.

The exterior, north elevation of the trough survived to a height of up to 1.35m, and was very roughly finished, supporting the contention that this elevation was originally buried (Plate 112). The floor of the trough had tilted towards the north, resulting in a canted appearance (Plate 113). This subsidence is probably explained by the nature of the fill that appears to have made up the bulk of material beneath the floor of the coking benches; where it was noted, this appeared to consist primarily of coal dust and clay loam and would have been somewhat unstable over time. That this subsidence occurred during the lifetime of the coke ovens is confirmed by the presence of a deposit of hard, rust coloured silt along part of the north side of the trough channel, which is likely to have been deposited when the water system was in use (see Plate 113). The subsidence evident in the north trough does not appear to have been as acute as that for the southern coke bench (2201), which showed evidence of remedial repairs during its operational life (see below).

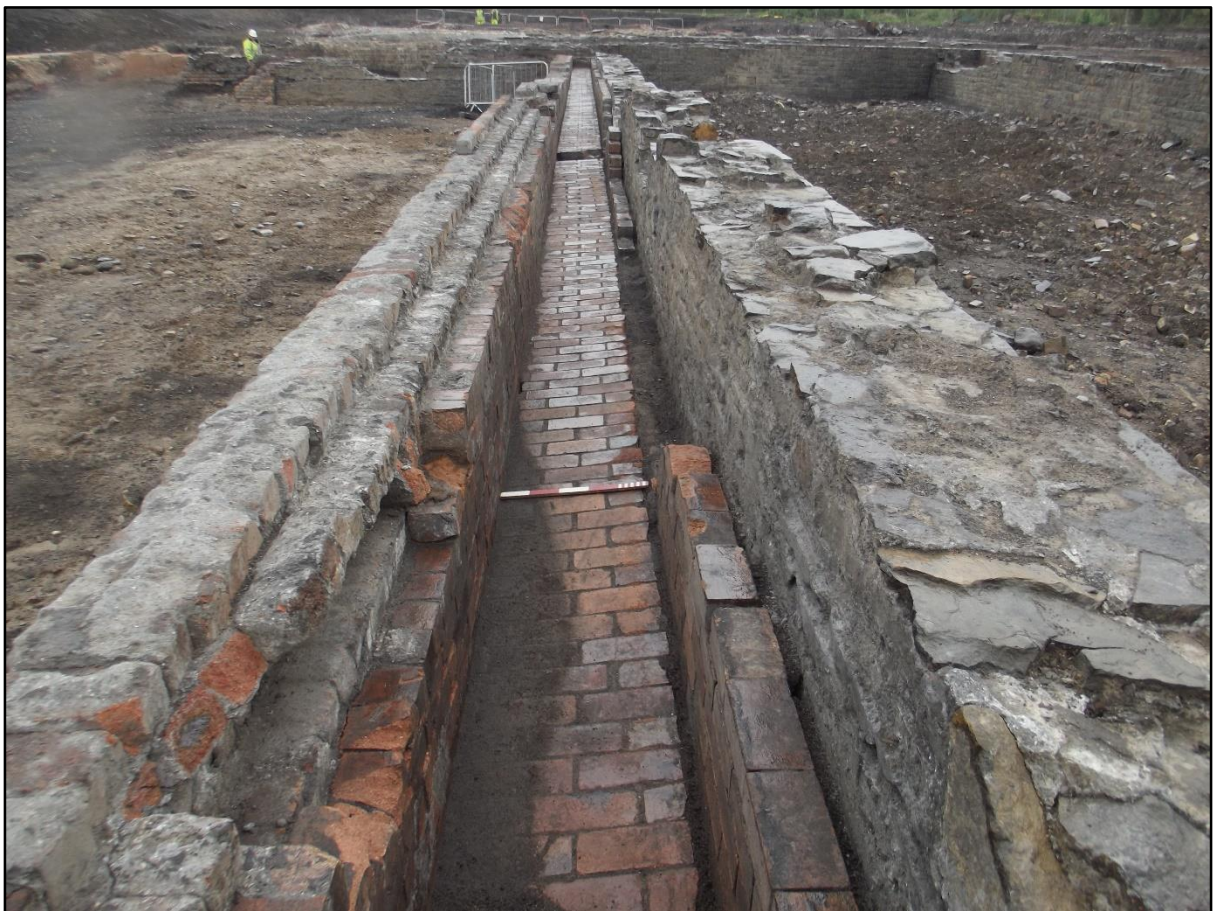
Plate 114. South Coppée coke battery coke bench, trough 2201 looking west. Note that the gap that opened between the trough and wall had been partially filled with brickwork, suggesting that subsidence had been an issue during the operational lifetime of the coke bench.

The remains of the south coke battery coke bench were very similar to those of the north in that they consisted of a brick built trough (2201) backing onto the south wall of the coke bin (2199) (Plates 114 and 115). The base of the trough had slumped away from the adjoining masonry wall during the lifetime of the project, necessitating a filling of the resulting cavity with a line of bricks. The channel had originally measured 0.5m across, backing onto the southern wall of the central coke storage bin (wall 2198). The trough is believed to have held the hose equipment

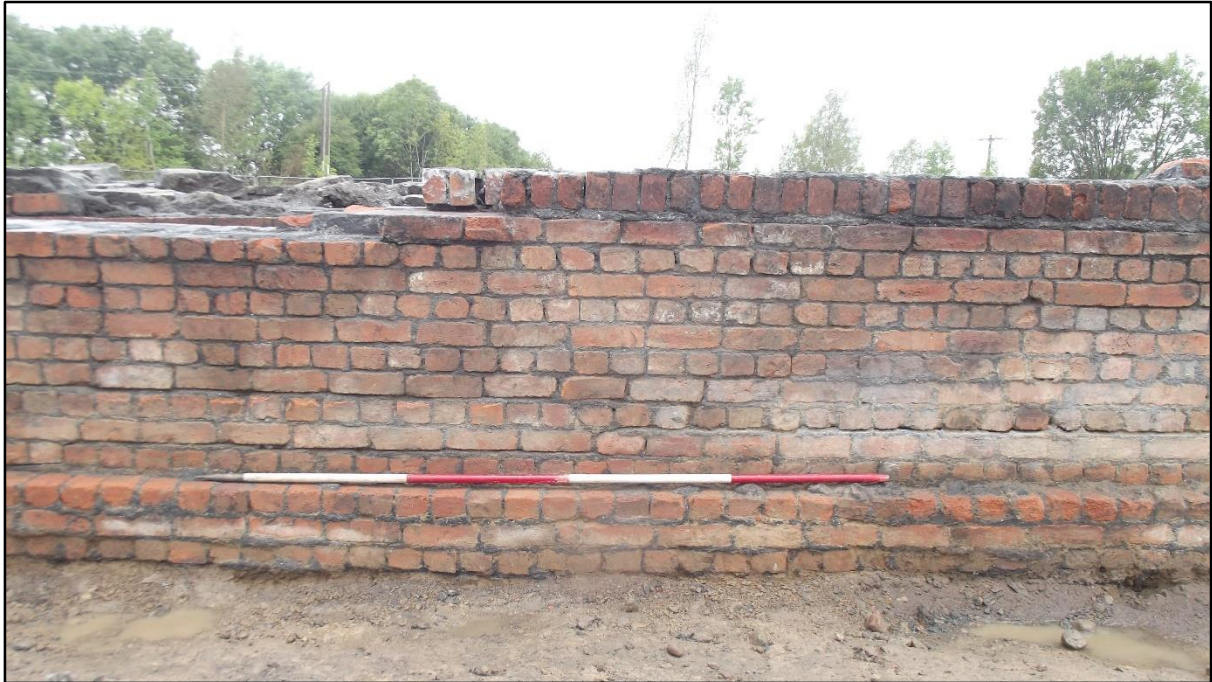
Plate 115. South Coppée coke oven coke bench, view of the south wall of trough 2201. View to north.

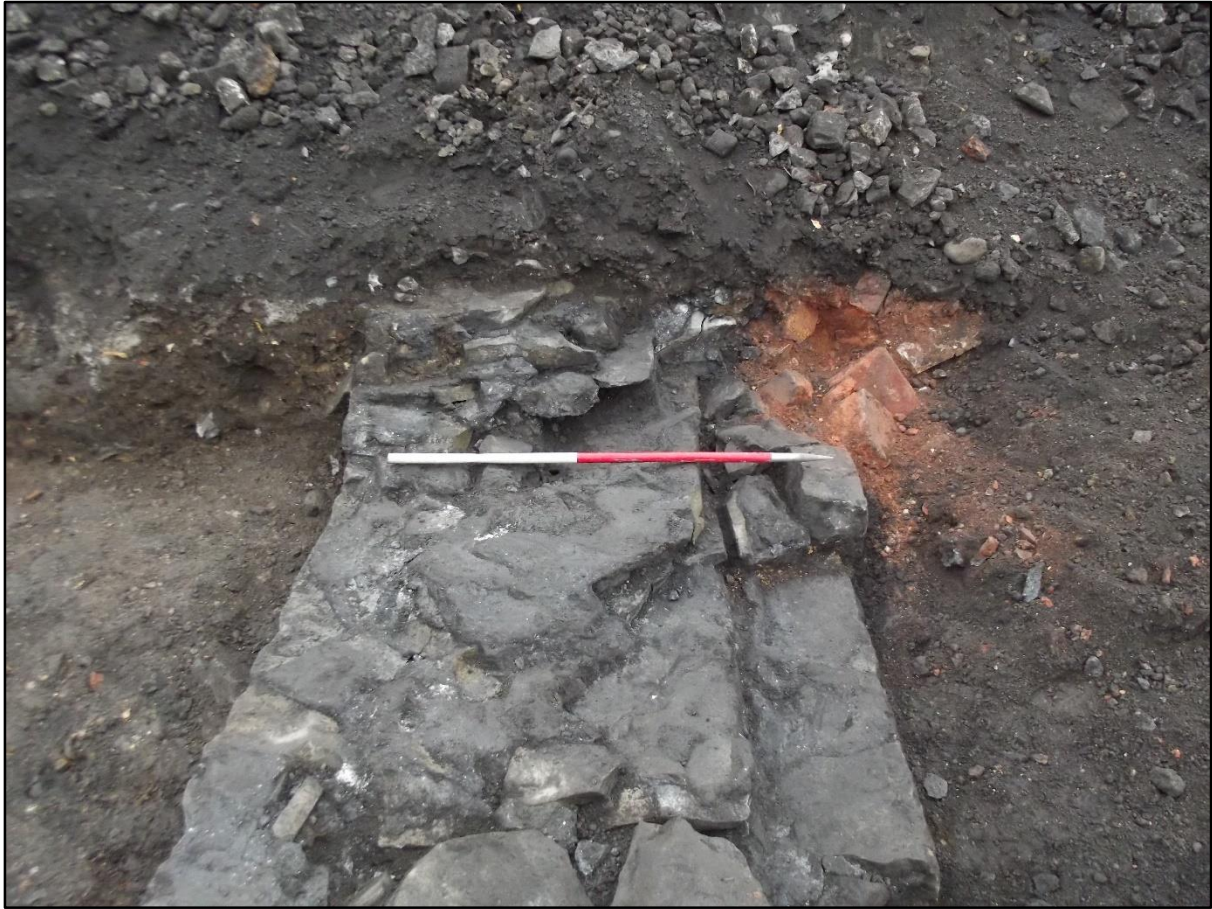
Plate 116. South Coppée coke oven, south elevation of the southern coke rammer wall (wall 2133)). View to east

Comparatively little of the southern coke ramming engine wall (wall 2510) had survived. The remaining element consisted of a 16m long section of pennant sandstone built masonry wall, aligned east/west, with a width of 1.4m and a maximum excavated height of 0.5m; the stones had been bonded with hard grey mortar containing coal flecks. The stones comprising the south elevation were neatly dressed, unlike those of the north, suggesting that the south elevation was

intended to be seen. The masonry had been laid in uneven courses but was not random (Plate 116).

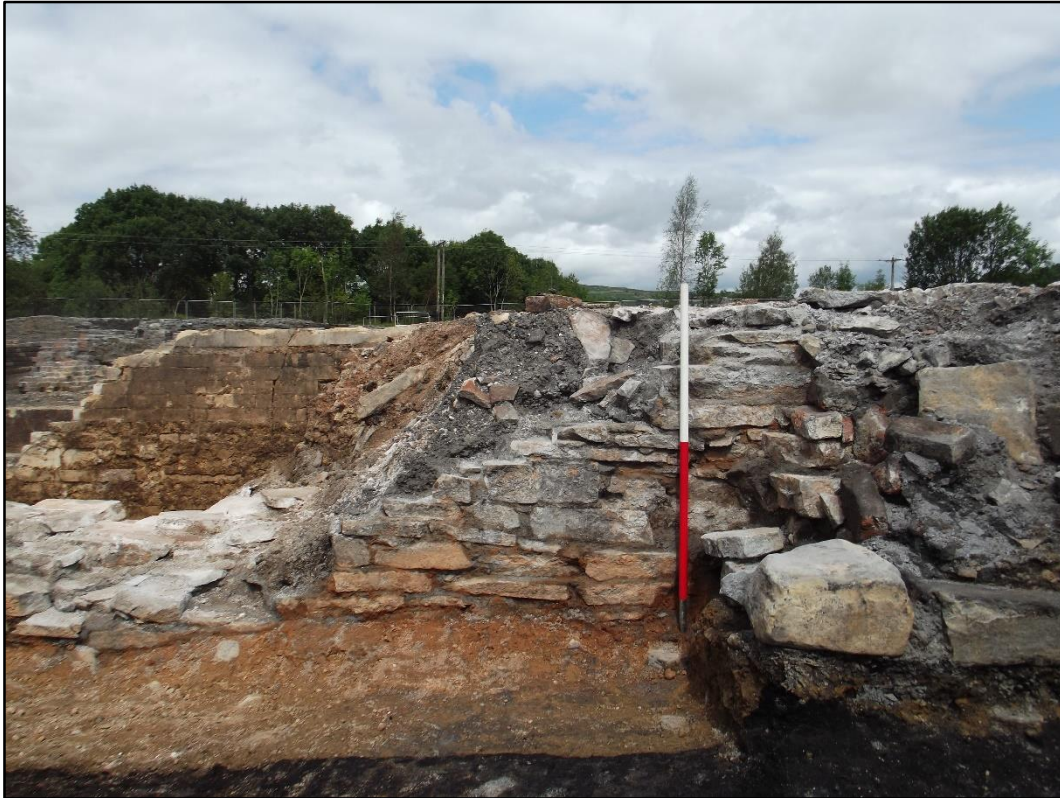
Plate 117. South Coppée coke oven battery, useful photograph showing the south elevation of the south main gas flue (flue 2012 at the rear left, and coke rammer masonry walls 2009 (centre) and 2133 (right). The very straight construction cut for the wall (cut 2135) is clearly visible at the bottom of the photograph. View to north.

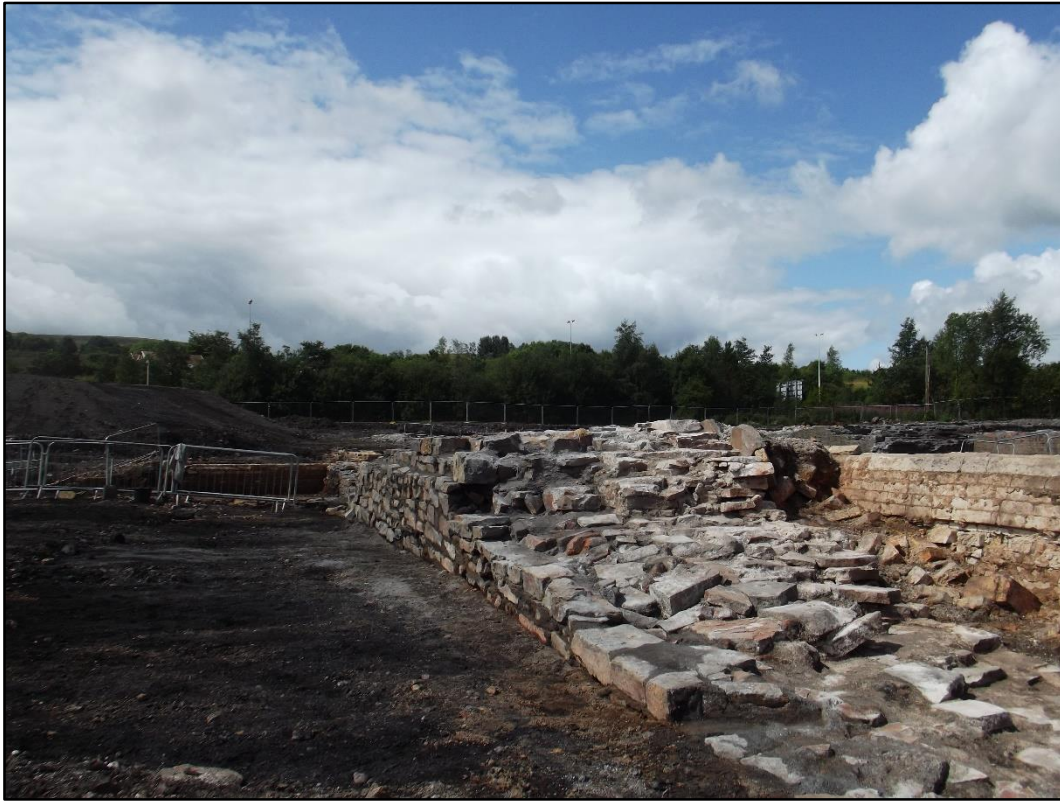
Plate 118. South Coppée coke oven coke rammer walls, oblique view of the rammer walls and the main gas flue to the rear. This image provides an indicator of the combined width of the wall in this location, which was in excess of 2m. View to north west.

The northern coke rammer wall consisted of two phases of east/west aligned pennant sandstone masonry walling, (wall 2009 and wall 2133, Plate 118). Wall 2009 measured 23m long by 1.05m in width and survived to a maximum height of 1.1m. The masonry blocks of 2009 were roughly coursed, appearing to be little more than rubble bonded with a friable white/grey mortar. The southern elevation of the wall, where visible, had a neatly dressed face and it is possible that this was the original rammer wall. The north elevation abutted onto a void filled with sandy grit and rubble which appeared to be a spacing layer between the rammer wall and the main coke oven gas flue (flue 2012).

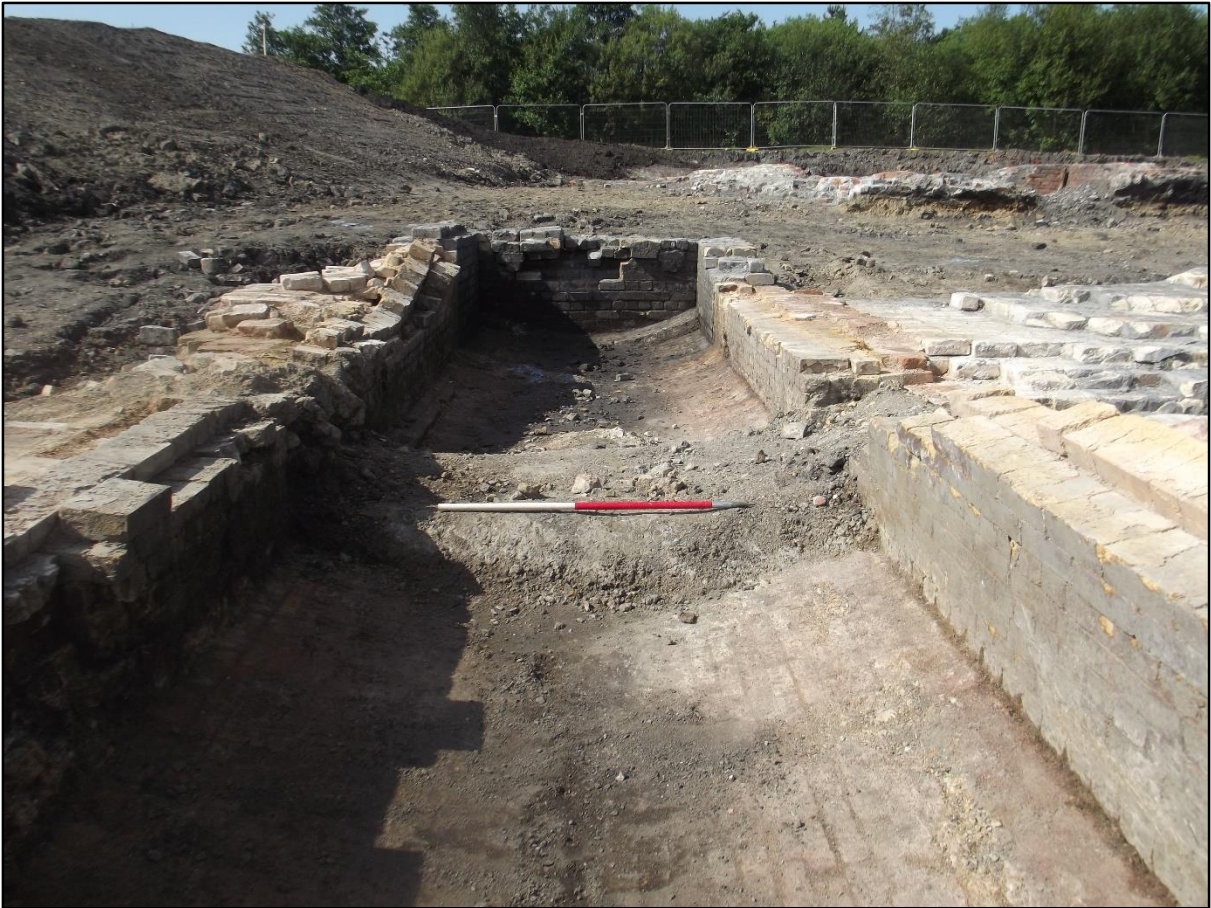
Plate 119. South Coppée Coke oven battery, western terminal end of the main gas flue (flue 2012). The scale is resting on the course of a more modern Phase 4 pipe trench, view to west

The east/west oriented southern main gas flue (Flue 2012) was exposed intermittently for a length of approximately 80m. The feature was similar to that for the northern main gas flue in that it consisted of an ovoid sectioned brick built flue with an arched brick roof (which was absent except at the far eastern end) supported by at least twelve brick pillars down its length. The base of the channel was 2m wide, narrowing to 1.86m close to the spring-point of the arch (Plate 119). A spur to the flue was located 15m from its western terminal, running south at 90 degrees from the main channel. This spur originally had a roof supported by two brick partitions (wall 2281 and 2180) in the centre of the channel and is a further example of a discrepancy between the cartographic sources and the actual structures as excavated. Further exploration of these discrepancies is contained in the discussion.

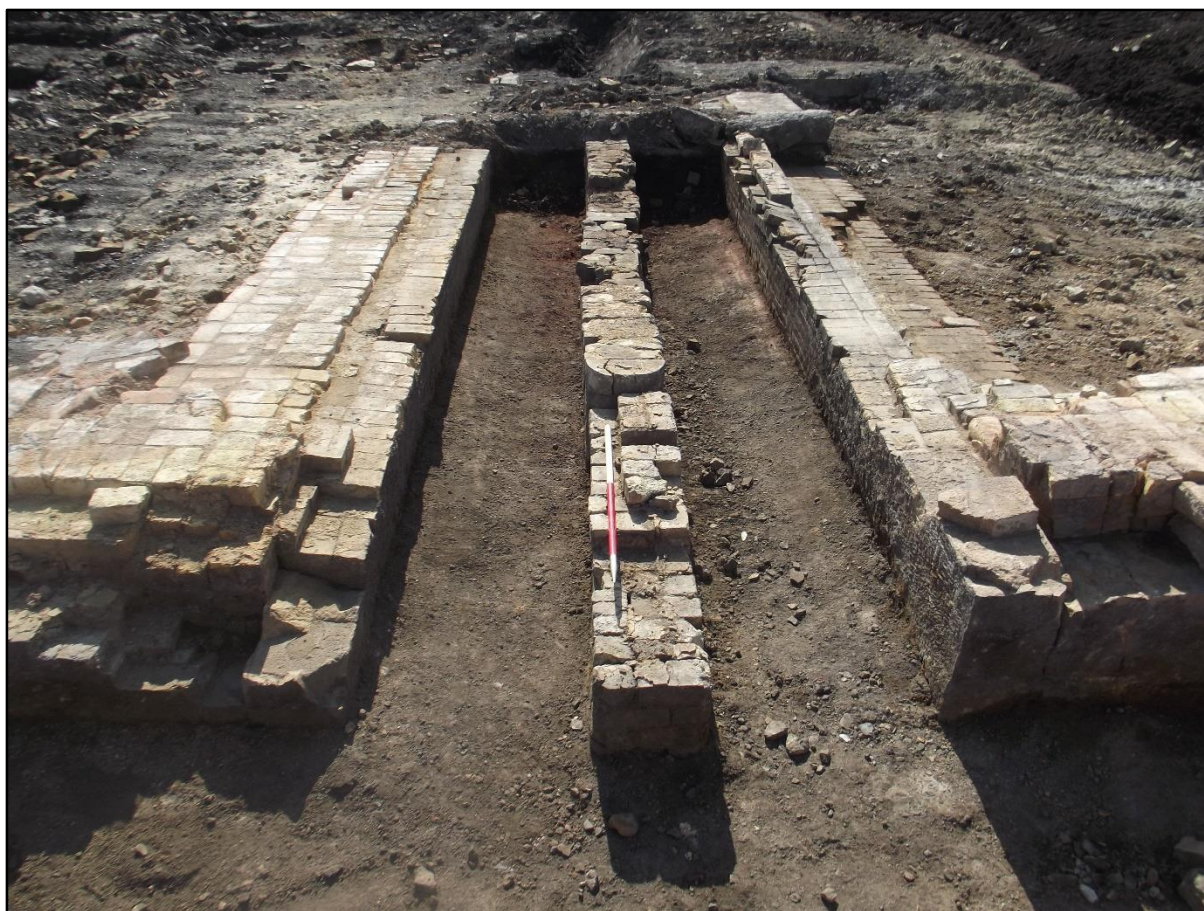
Plate 120. South Coppée coke oven main gas flue, spur to flue 2012 showing the supporting partition walls 2280 (nearest camera) and 2281. View to south.

The partition walls showed two phases, with 2281 being the earliest. Both walls had a width of 0.38m and had been constructed of refractory brick bonded with sandy lime mortar. Wall 2281 had an exposed length of 4.98m with a rounded north terminal end, possibly to reduce friction from air flow. The line of this wall had been extended to the north by the construction of wall 2280, which abutted the rounded end of 2281. No similar attempts to introduce aerodynamics had been made, and wall 2280 was a simple, rectangular structure, 1.72m long (Plate 120).
