Cyfarthfa Coke Works (The Old Thorn Lighting Works) Merthyr Tydfil

Excavation report and analysis

October 2017

GGAT report no. 2017/051
Project no. P1844
National Grid Reference:
SO 03708 06785

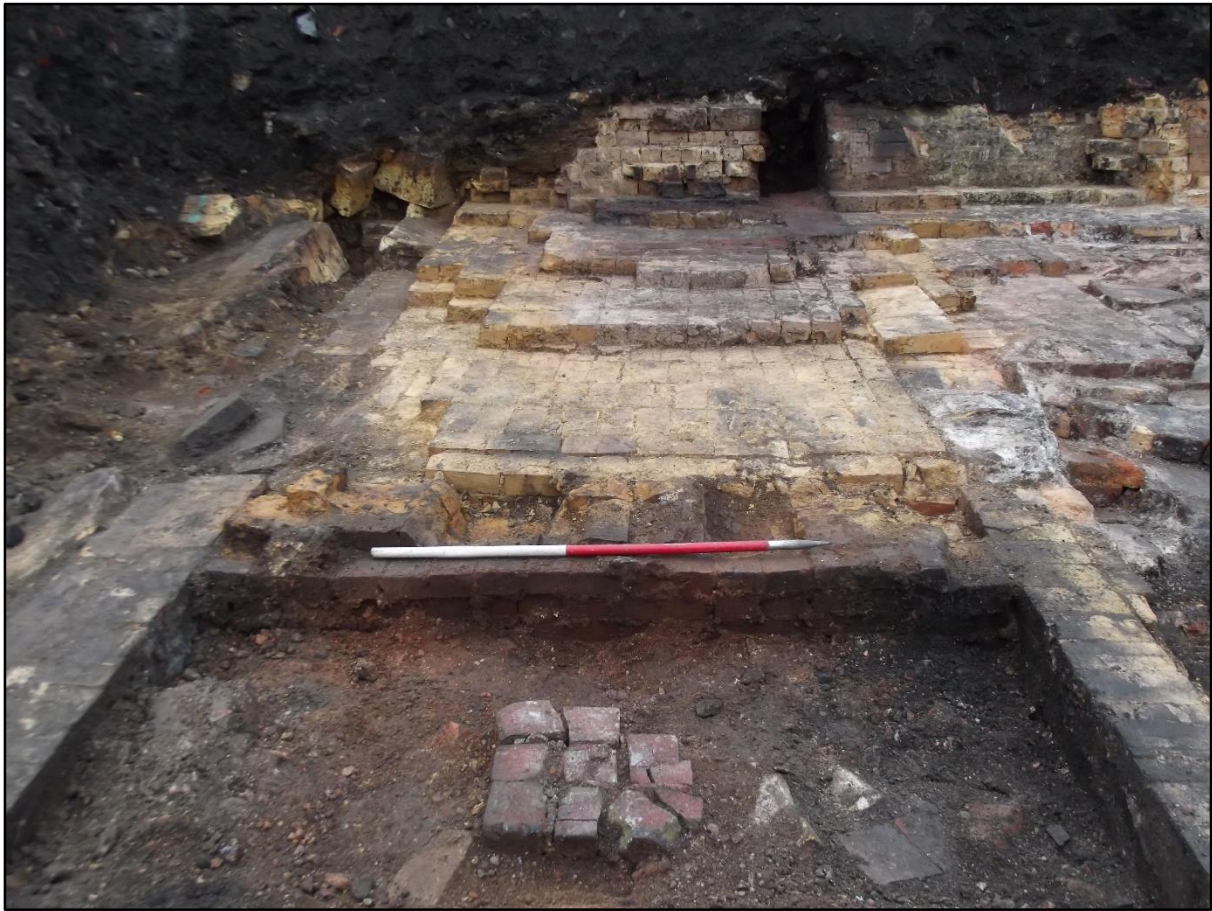
Plate 121. South coke oven flue complex, eastern terminal end of main gas flue 2012 showing one of the square pillar bases that supported the roof and the brick bay grouping beyond. The level of vitrification was greater here than for the northern flue. View to east.

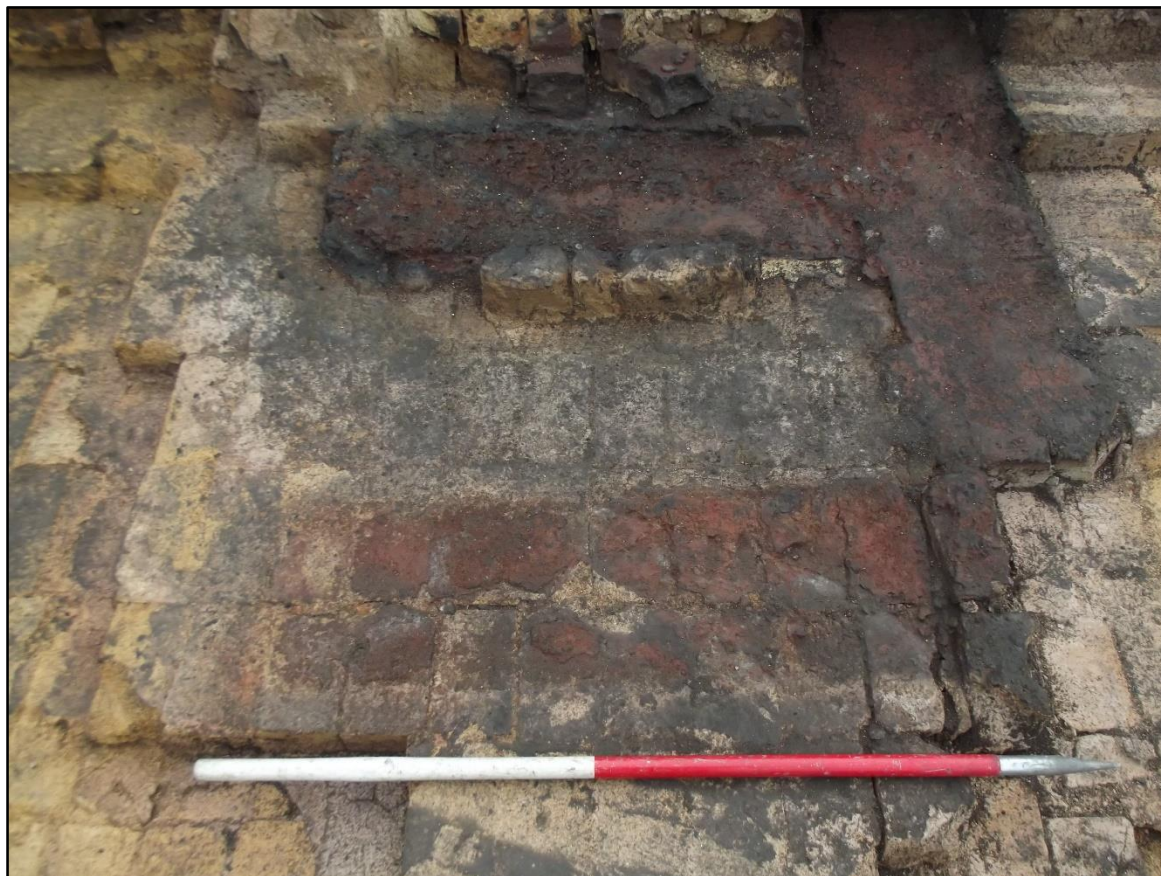
Plate 122. Southern Coppée coke oven flue complex, remains of recesses 2560 (closest) and 2559 visible as heavily vitrified areas of brick. View to east.

The grouping of brick bays revealed dimensions comparable with those from the northern grouping, with the recesses measuring 0.27m in width by 1.02m in length. The brickwork which had originally formed the sides of the recesses was absent but the original positions were easily seen due to the pattern of vitrification, which was far more extensive than for the northern group (Plate 122). The central channel (flue 2557) that linked the individual bays also compared favourably, being 0.31m wide. Similarly, the southern flue complex was equipped with at least one smaller north/south oriented flue which connected the brick bays to what appeared to be a secondary gas flue connected to a chimney (flue 2526 and chimney 2509). The mouth of the smaller flue was visible at its junction with the secondary gas flue, revealing the highly specialised nature of the brick used in its construction. One of these was stamped 'Timmis 18 Stourbridge' and more information is available at the brick report below. This junction had been crudely blocked by the positioning of a series of un-bonded bricks at the mouth (blocking 2556, see plate 123) which may be contemporary with the alterations visible within the chimney base chamber (see below).

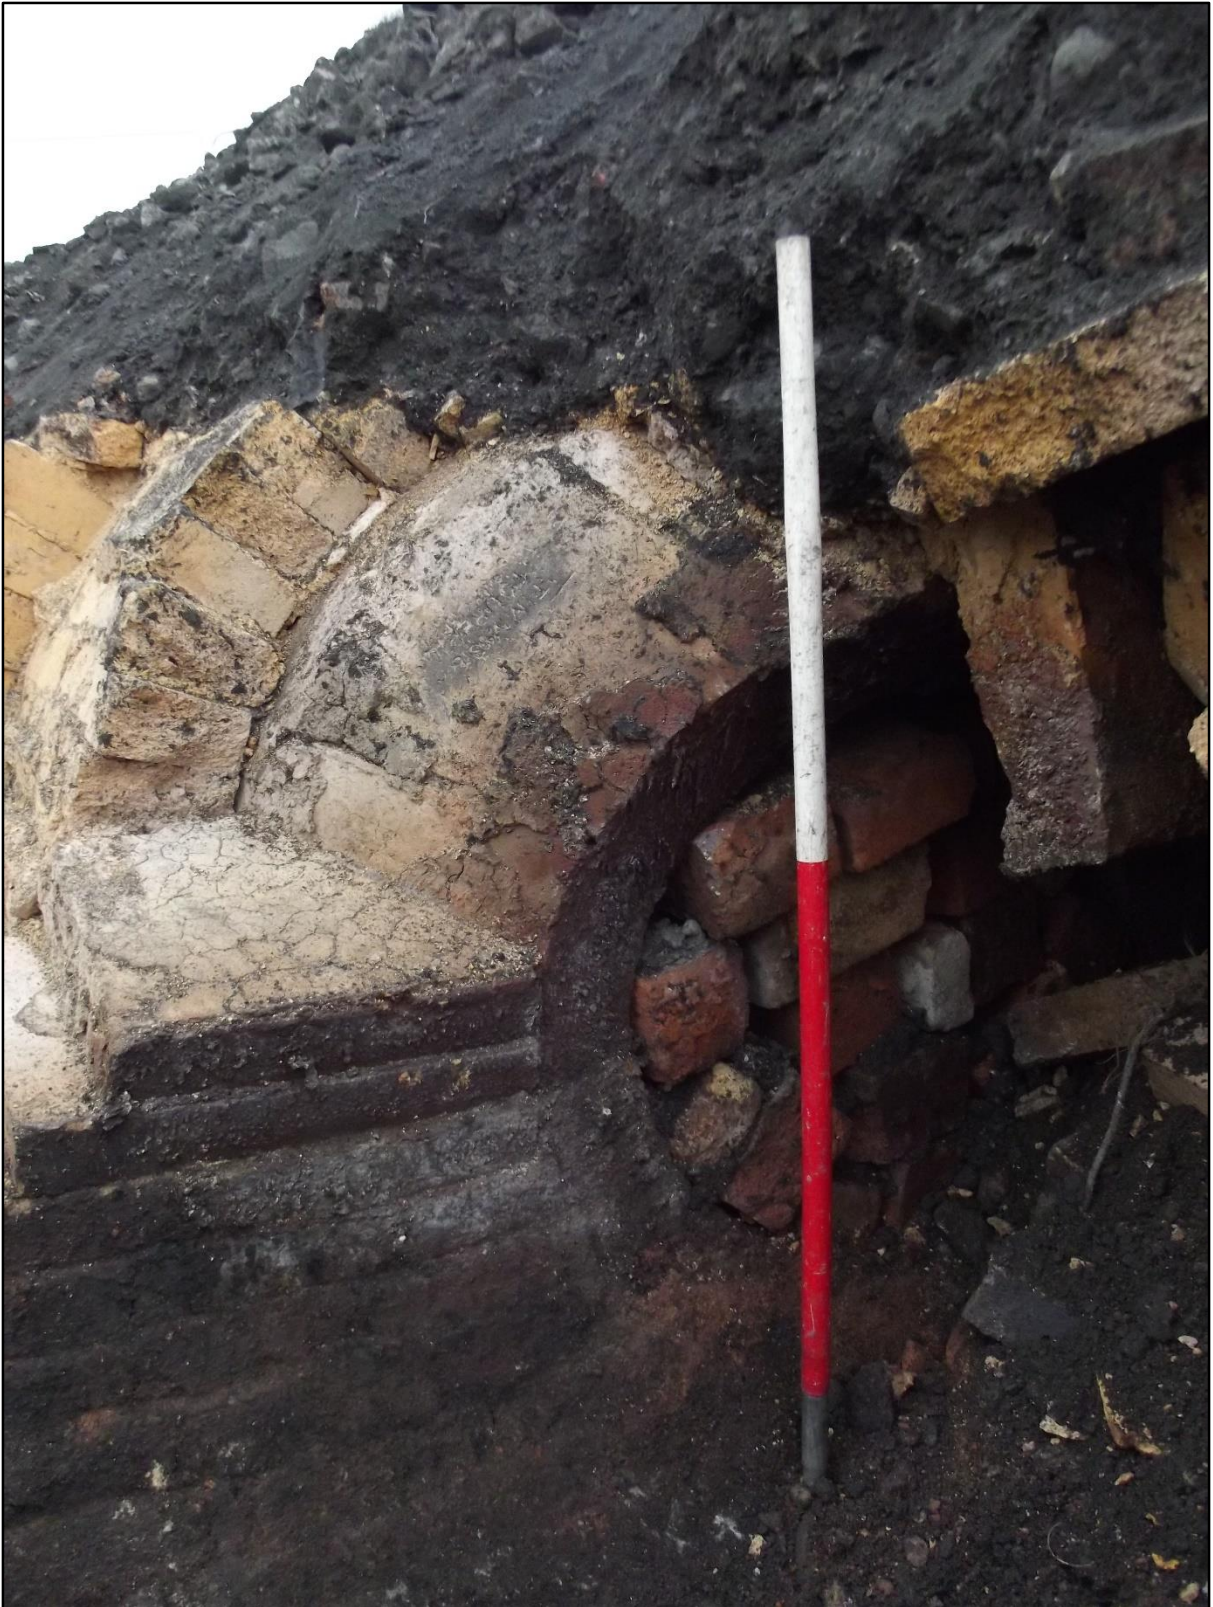
Plate 123. South Coppée coke oven flue complex, crude blocking visible at the junction of flues 2555 and 2526. This blocking may be contemporary with the modifications evident in the chimney base chamber (see below). View to north east.

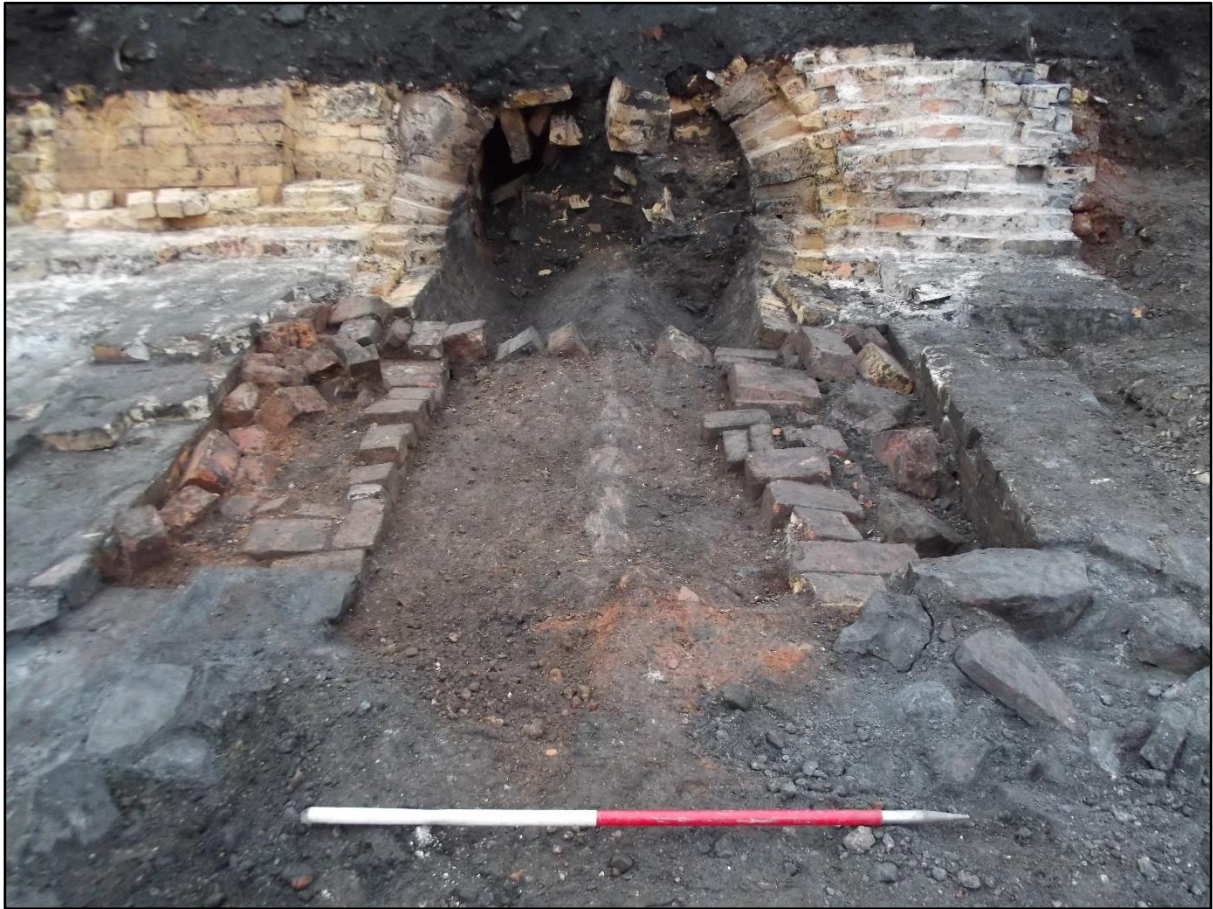
Plate 124. South Coppée coke oven flue complex, view of secondary gas flue 2526 and chimney base 2509. Note the ridge of accreted material in the centre of the channel and the deliberate attempt to narrow the chimney base chamber. View to east.

The secondary gas flue (flue 2526) ran parallel to the main gas flue and was located 4m south of it, being separated by the brick bays and attendant smaller flues. 2526 was circular in section, having an internal diameter of 1.51m, and had been constructed from specialist, wedge shaped

refractory brick. The flue was exposed for a length of 5m but the majority remained buried in the unexcavated area to the east (Plate 124).

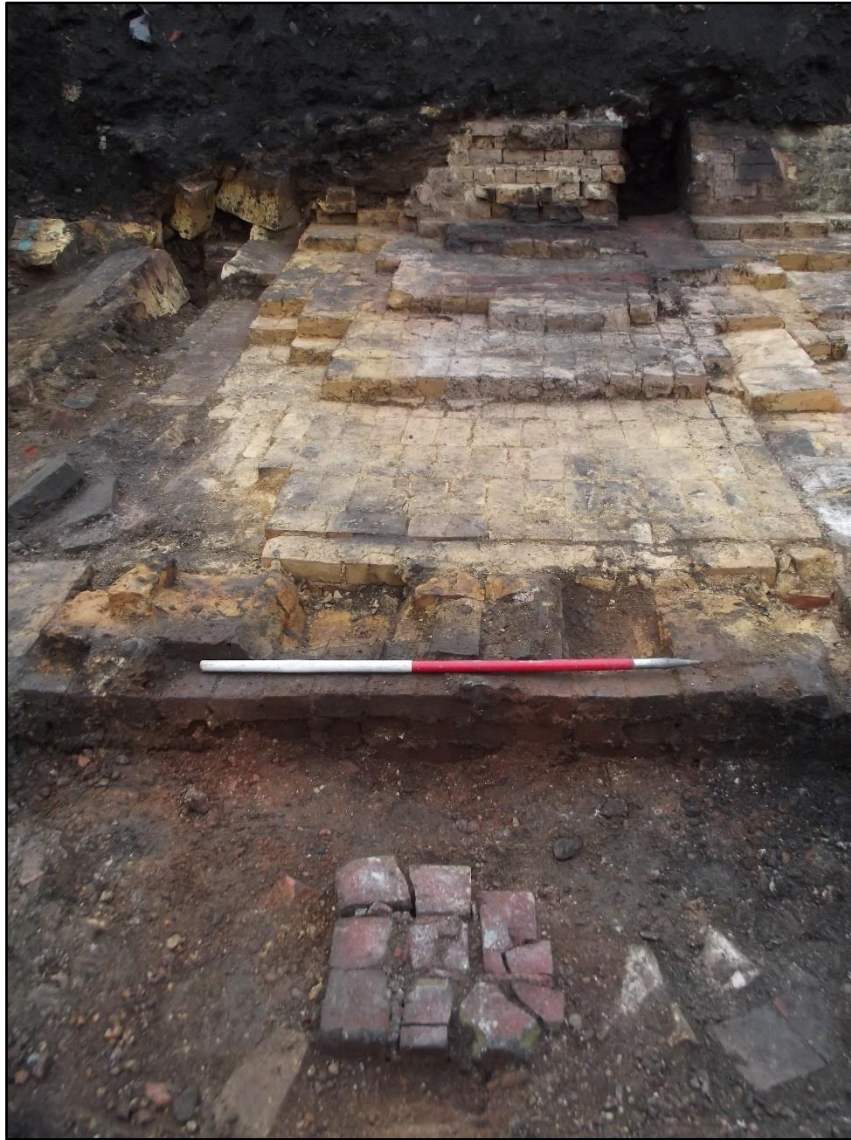
Plate 125. South Coppée coke oven flue complex, another view of the eastern terminus of main gas flue 2012 showing the possible mounting for a grille or similar. View to east.

shorter. Two square recesses (feature 2563) close to the terminus are suggestive of a mounting and it is possible that a grille or similar opening had originally been present (Plate 125).

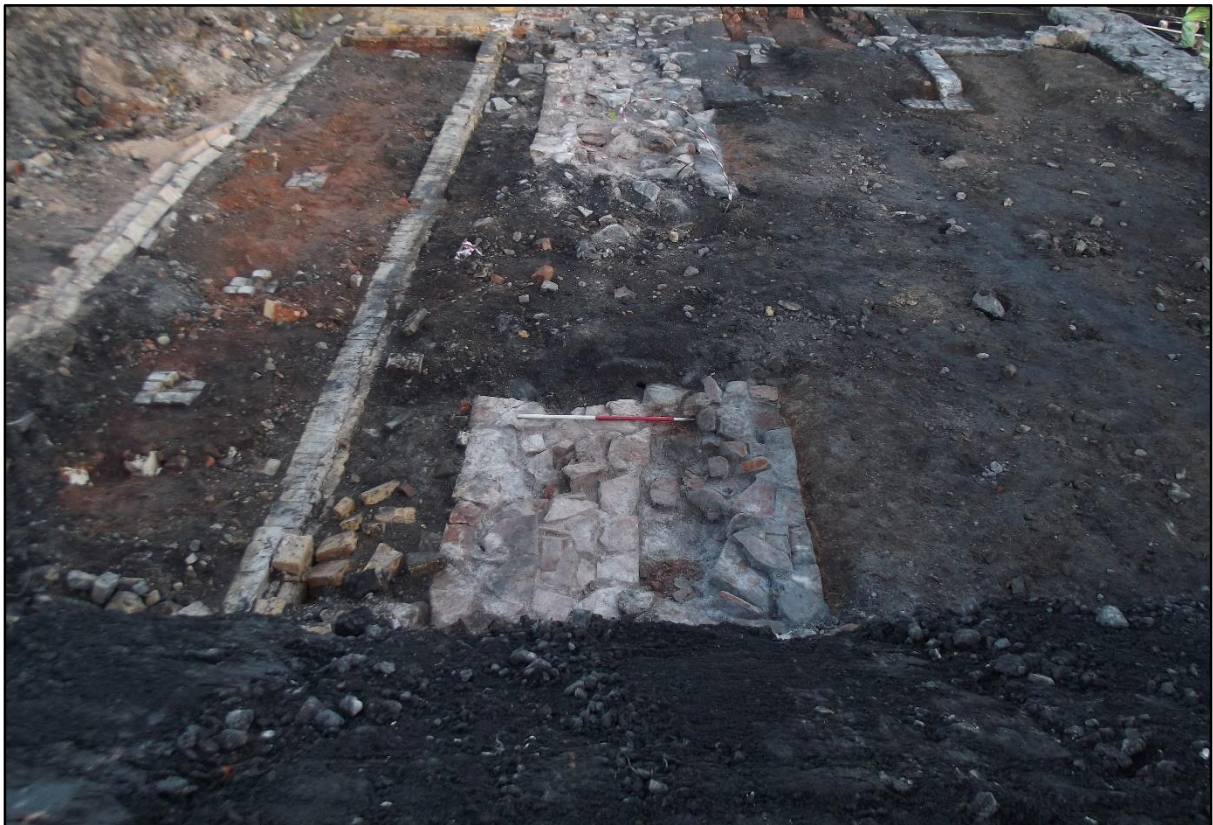
Plate 126. South Coppée coke oven flue complex, exposed remains of the north coke rammer wall (wall elements 2537, 2570, 2533 and 2534). The double skinned nature of the masonry is evident, as is the later wedge shaped cut (cut2530) through the wall, associated with either construction or demolition of the Thorn Lighting works. View to east.

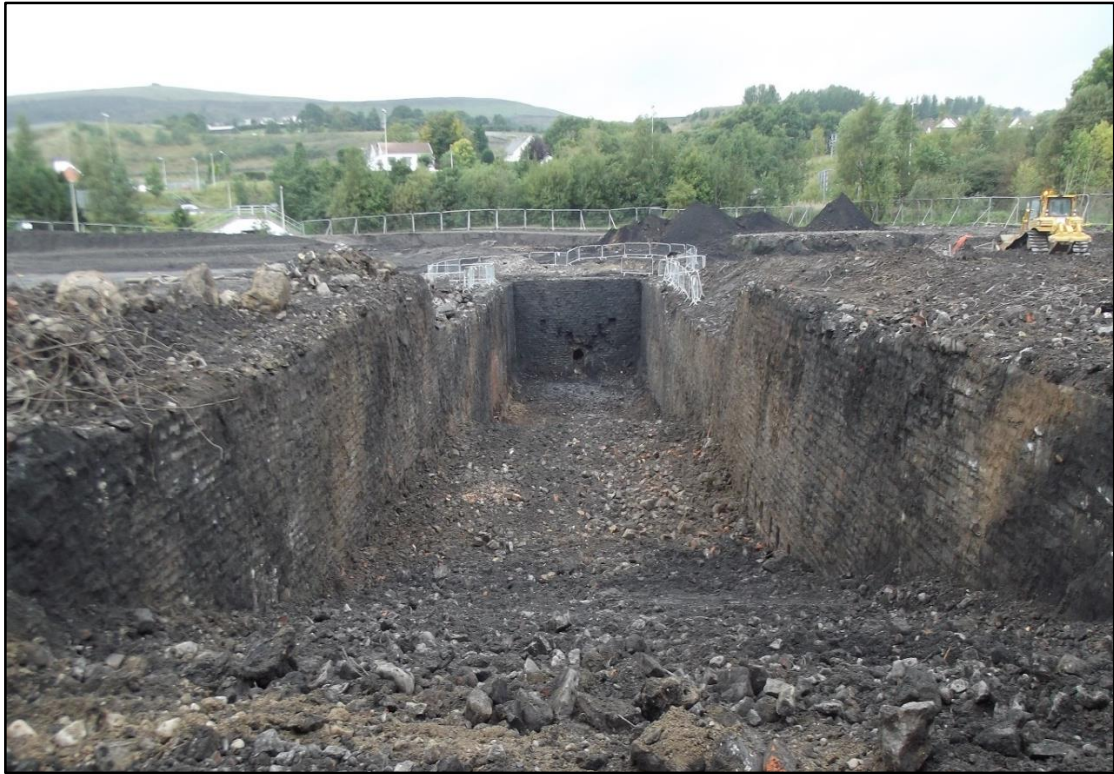
Plate 127. General view to the west of the central coke bin formed by masonry walls 2181, 2198 and 2199.

The surviving elements enclosed a space 9.07m wide and 38.8m long, oriented east to west (Plate 127). All three walls were of the same construction, being made of generally rectangular, grey sandstone blocks bonded with hard, grey coal rich mortar. The quality of the stonework was good, with the joints between the irregularly coursed stones being well made. The blocks themselves varied in size from 0.07m by 0.05m to 0.56m by 0.17m and the walls had an average thickness of 0.67m. The upper courses of the walls were missing but otherwise the condition was good, having benefitted from being buried. Initially, the walls were only exposed to a height of 1.8m, but on final ground reduction, demolition fill 2200 was removed, exposing the walls to their approximate base and revealing a surviving height of 5.2m. Both the north (2199) and south (2198) walls of the coke bin contained a 0.6m wide recess to house a vertically mounted cast iron pipe, made of separate sections bolted together (Plate 128). The function of these pipes is unclear, particularly as they appeared to have been capped or terminated at the upper end; nothing is visible on the 1890s photograph of the coke bins that suggests what they were used for. Both the north and south walls also contained a number (in excess of 27 on each side) of rectangular recesses, each containing an iron box insert measuring 0.15m by 0.35m and spaced apart at widths ranging from 0.4m to 0.6m. These recesses were arranged in a horizontal line 2.35m below the surviving level of the walls (Plate 129). Again, the function of these recesses is unclear but it is possible they may have supported a framework for a floor level within the coke bins. This would have permitted space beneath the floor for a system of trap doors and dandies that took the coke from the bins to the furnace tops, although no evidence of this flooring was found. It is difficult to imagine how else such a system would have worked if there was no false floor to the bins and the inserts are likely to represent the only visible remnants of this floor.

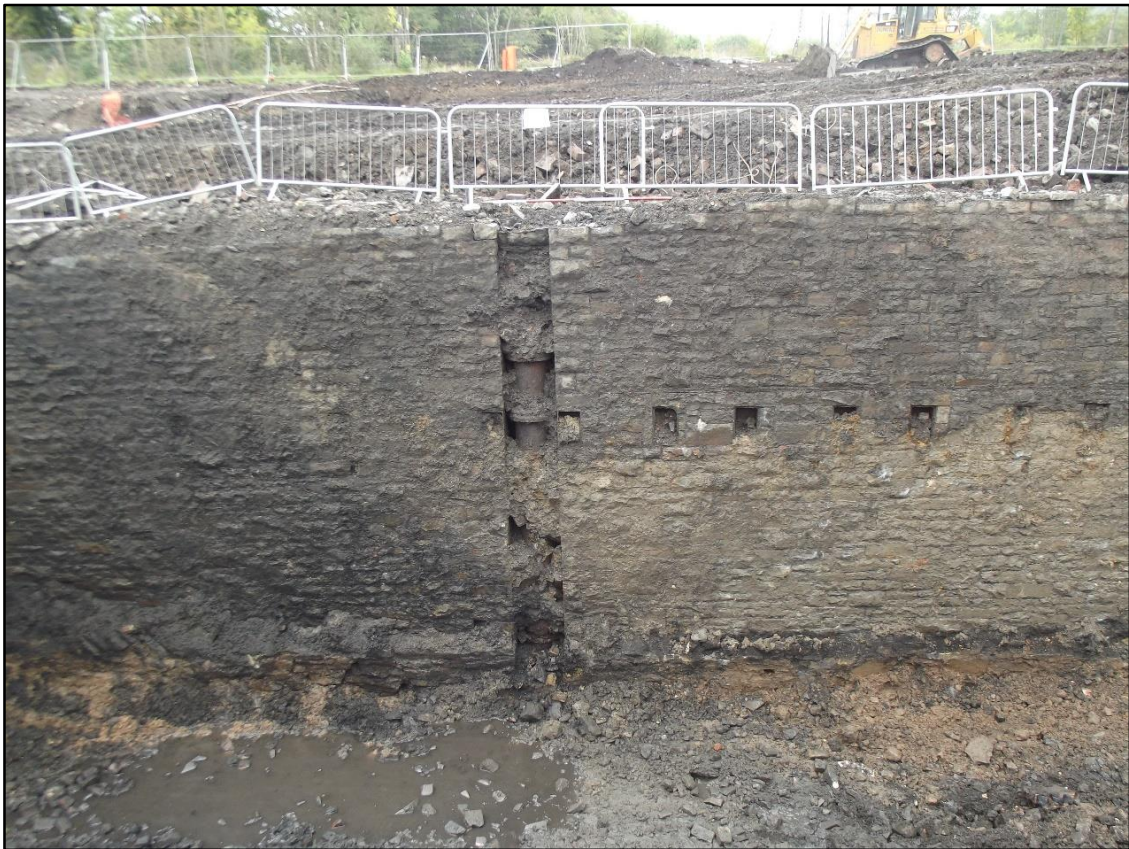
Plate 128. The vertically mounted iron pipe set within the recess in the north coke bin wall. View to north. Note also the smaller recesses fitted with iron box inserts, which probably supported a false floor within the coke bin area.

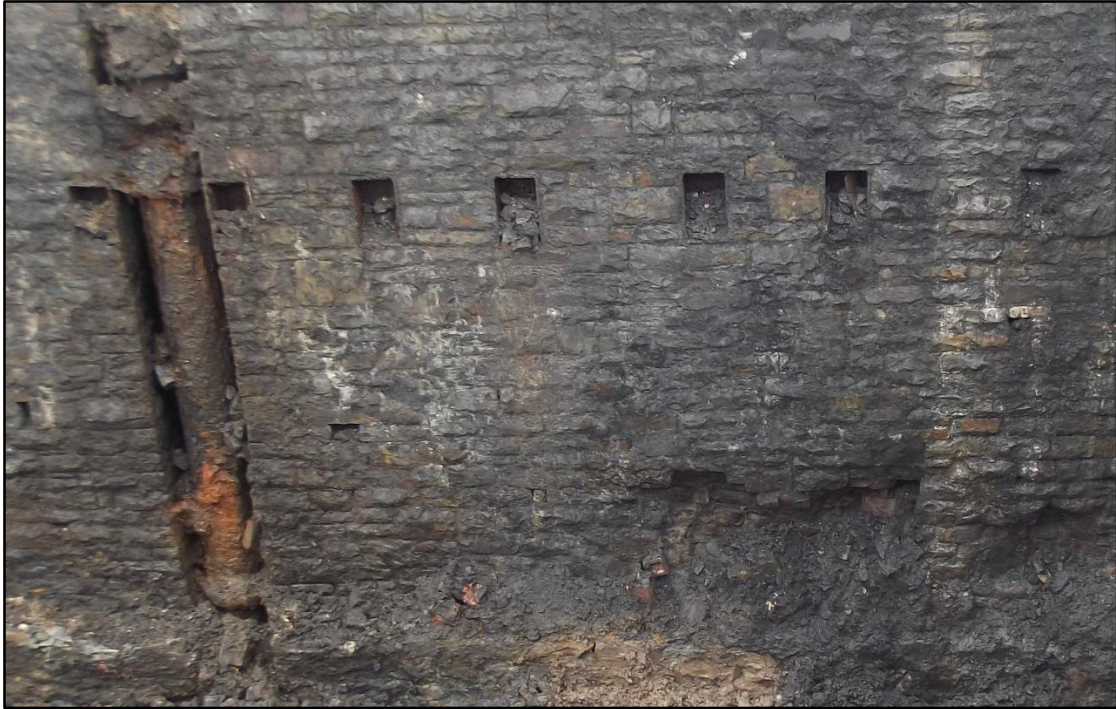
**Plate 129. Closer view of the horizontally arranged floor supports in the south wall of the coke bin (2198).
View to south**

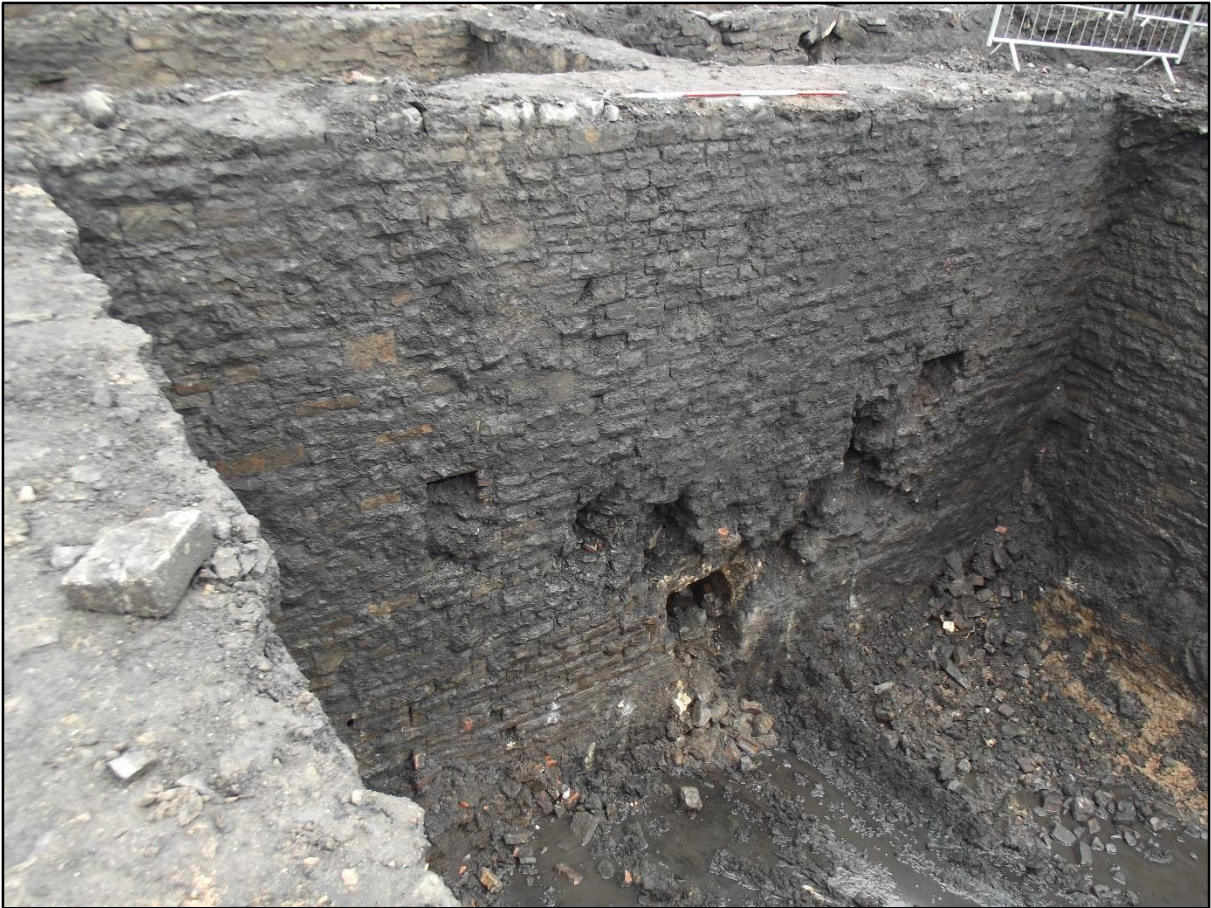
Plate 130. View of the west wall of the coke bin (2181) showing the damaged recess that was probably part of the transport system for moving the coke from the bin to the furnace tops. View to north west

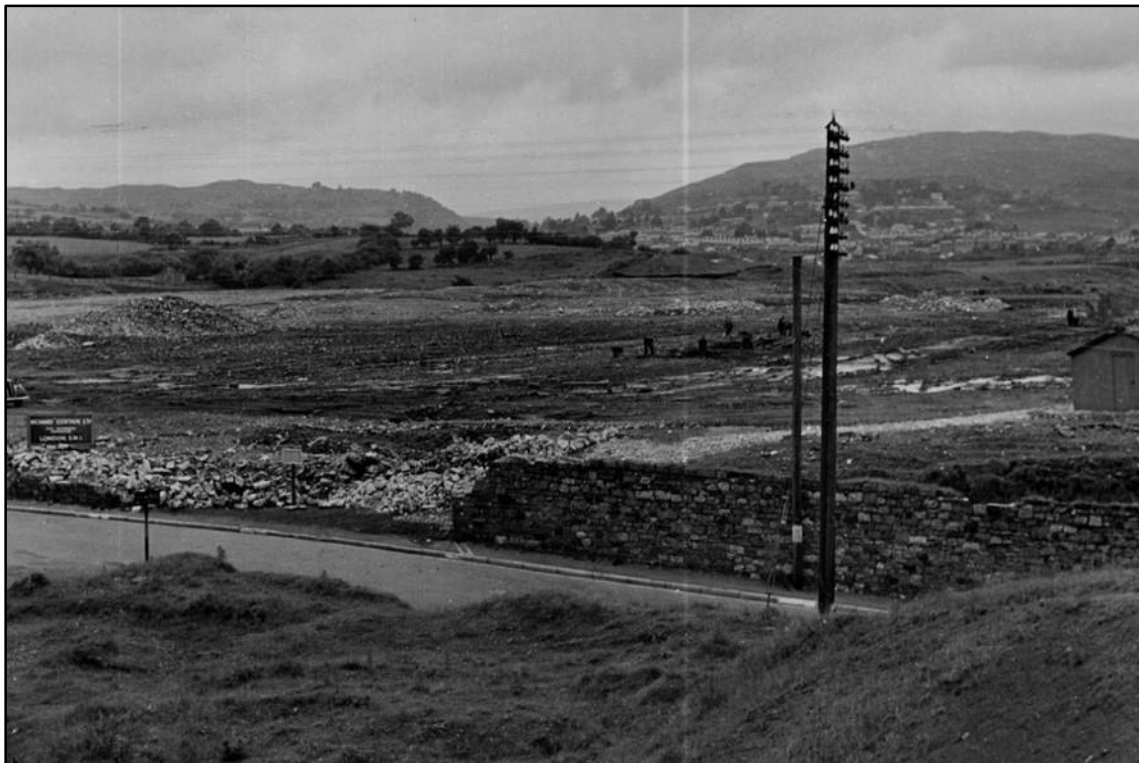
Plate 131. View to the north west across the development area taken in 1947 prior to construction of the Thorn Lighting Works. Note the extensive deposits of brick and stone and the absence of vegetation, suggesting recent demolition of the final remains of the coke and brickworks. The photograph was taken from the historic spoil heap that dominated the southern part of the Cyfarthfa site, with the smithy area being located close to the centre right of the image. (Alan George)

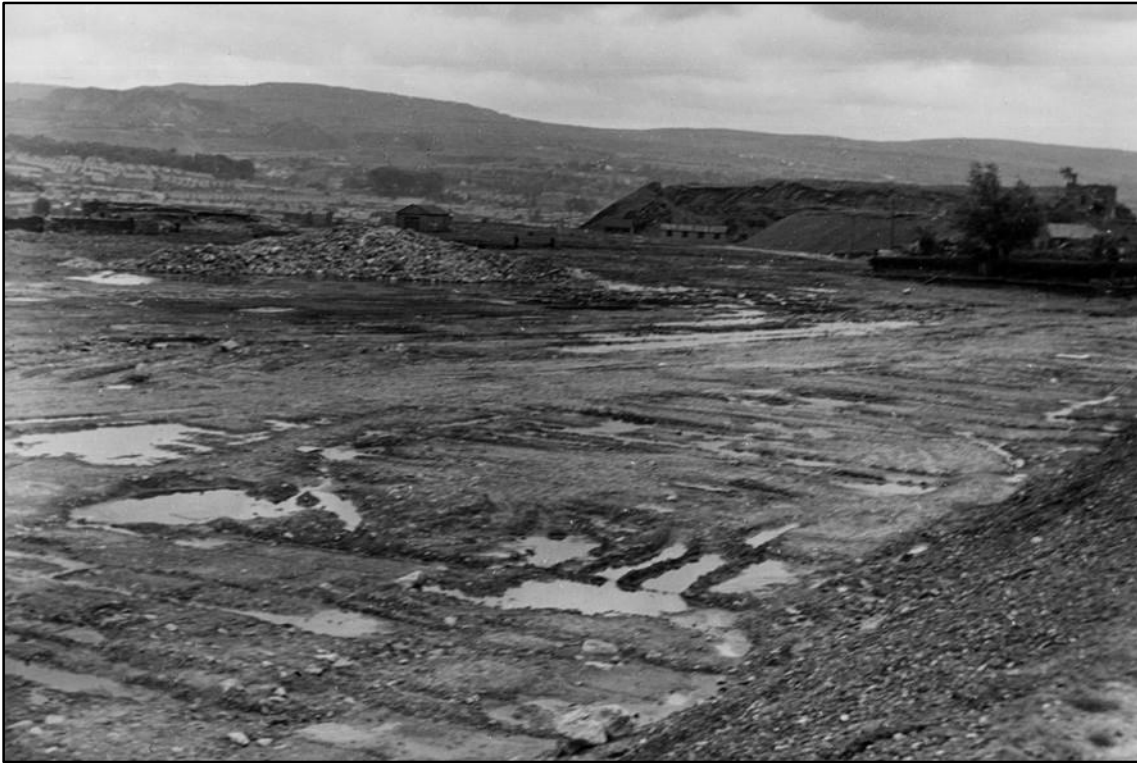
Plate 132. View to the south east across the development area taken in 1947 showing recent demolition. Note the historic spoil heap in the middle distance and the possible remains of the associated engine house at the right edge of the heap. The same spoil heap can be seen from different angles in photographs of the 1890s, shown elsewhere in this report (Alan George)

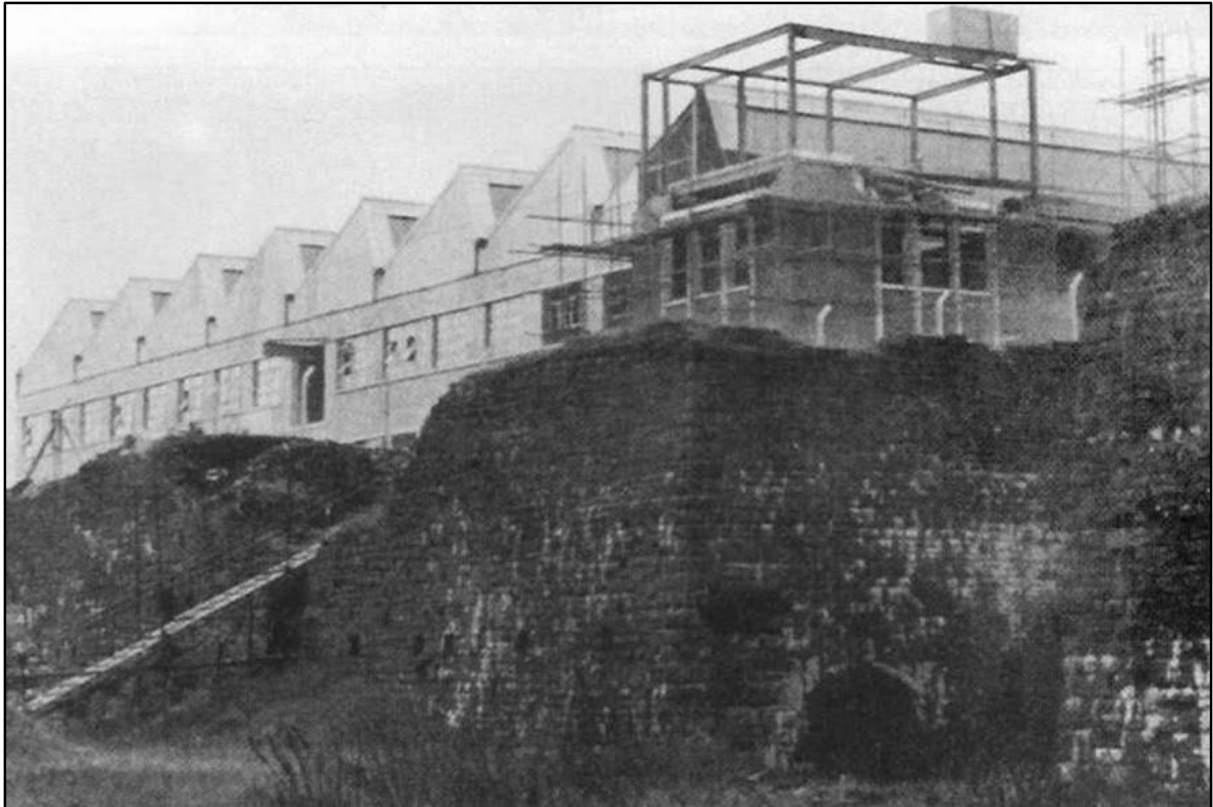
Plate 133. Photographs of the Thorn Lighting works under construction. The engineered break in the massive masonry walls is, in fact, the outlet for the storage bunkers between the two coke oven batteries. The image strongly suggests that construction of the Thorn works accounts for the extensive truncation of the southern coke battery when compared to the north. View to south (Alan George).

One photograph appears to have been taken from the base of the storage bunker between the two former coke benches and shows the Thorn works dominating the upper level of the south coke ovens (Plate 133). This is strongly supportive of the idea that the south coke oven battery was severely truncated by the construction of the works and accounts for the differential survival of the same compared to the north battery.

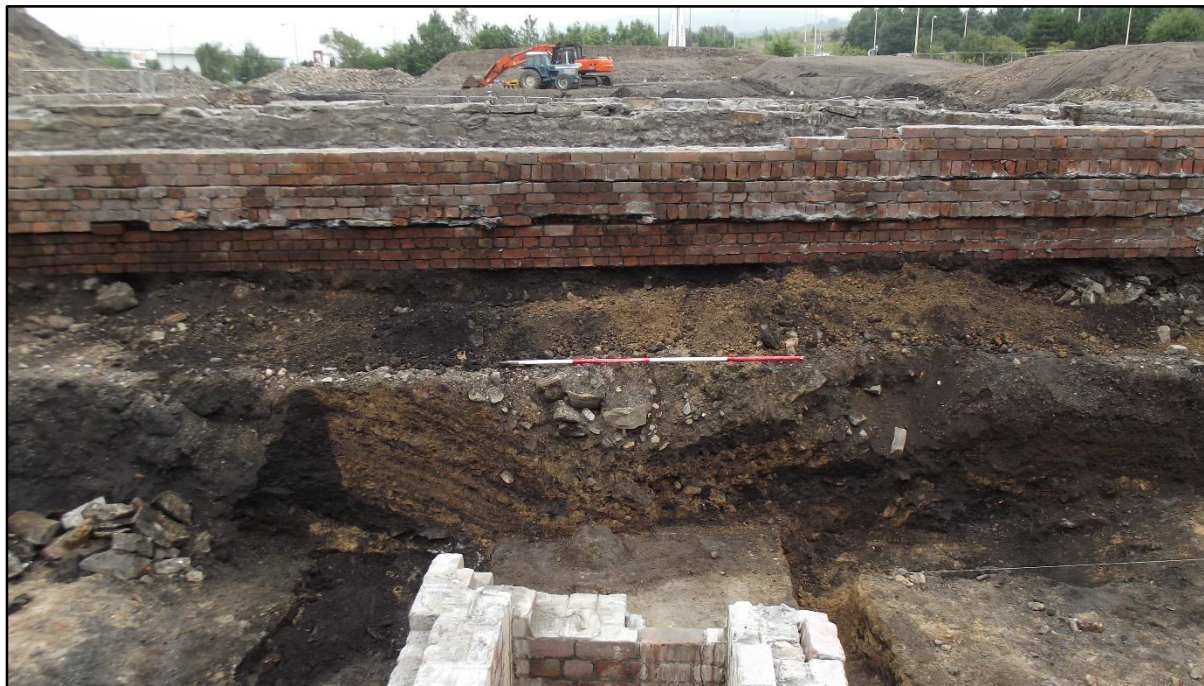
Plate 134. North Coppée coke oven coke bench, cut for modern brick chamber 2309.

The bricks used in the construction of chamber 2309 were frogged, red coloured and bonded with dark grey coal rich mortar. The chamber itself appeared to have been positioned to sit astride the line of the former first phase canal, and indeed, on further excavation, one section of the probable stone canal wall was uncovered (Plate 134) The canal itself appeared to have been capped by a horizontal roof of yellow refractory brick bonded and rendered with a thick mid grey mortar. The construction cut for the chamber (cut 2310) was clearly visible as a diagonally sided cut through an almost pure coal dust surface and, in places, had been cut

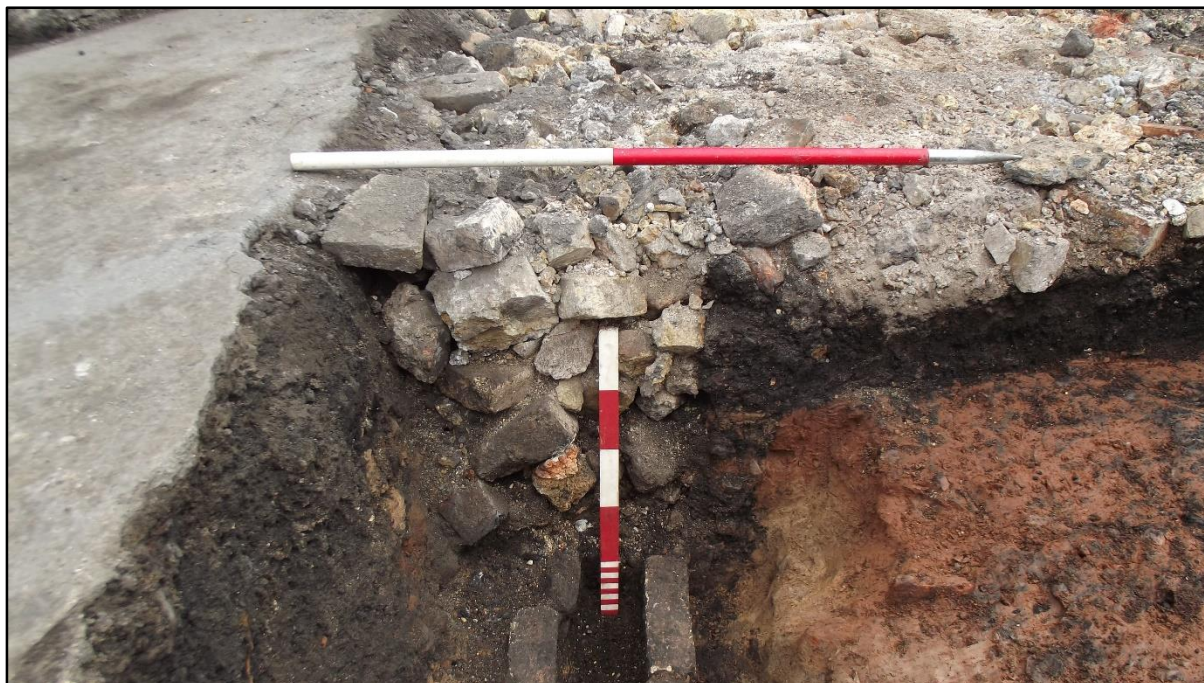
Plate 135. North Coppée coke oven coke bench, construction cut 2310 showing the rubble packing and the cut through a coal dust layer and possible re-deposited clay. Note the drain like feature at the base of the cut. View to south.

through part of the possible natural clay ground, which had an orange colour, unlike that noted in other areas of the site, which was yellow in colour; it is possible that the clay associated with the construction cut had been re-deposited. The space between the cut and the structure had been packed with rubble (Plate 135). An apparent drain or similar made of two rows of brick laid edge down was noted at the base of the packing material but the purpose of this was unclear.

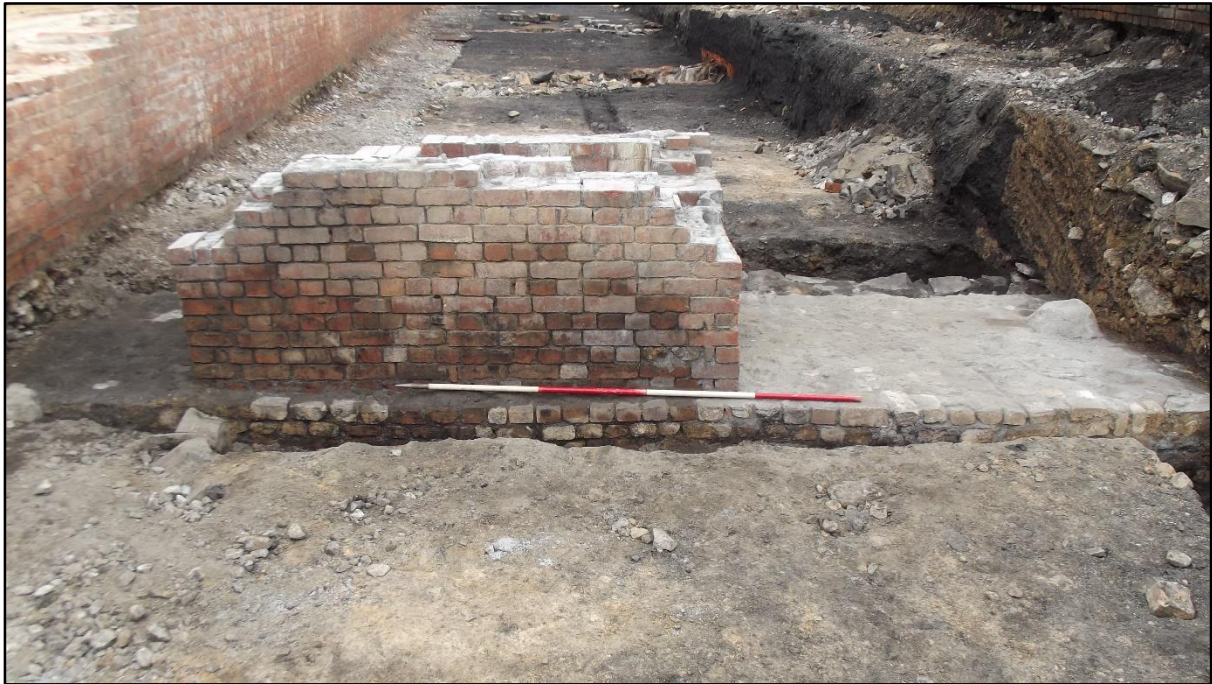
Plate 136. North Coppée coke oven battery, chamber 2309 and the capping over the canal. Note that these features have cut the construction cut for the south retaining wall of the coke ovens (construction cut 2300).

The capping for the canal feature appeared to underlie the brick trough that had contained the watering hose system for the north coke bench and it is possible that the chamber was a method of utilising any water still carried by the canal to help supply the prodigious quantities of water that would have been required to douse the coke as it came out of the ovens. However, there is no evidence on the historic photograph of the coke bench of an access to any chamber. Furthermore, although not completely excavated, the interior of the chamber itself proved to be absolutely dry and showed no evidence of ever having carried water. The capping over the canal appeared to be later than the construction cut for the flanking wall of the north Coppée battery (Plate 136) but this does not mean the feature is not broadly contemporary.

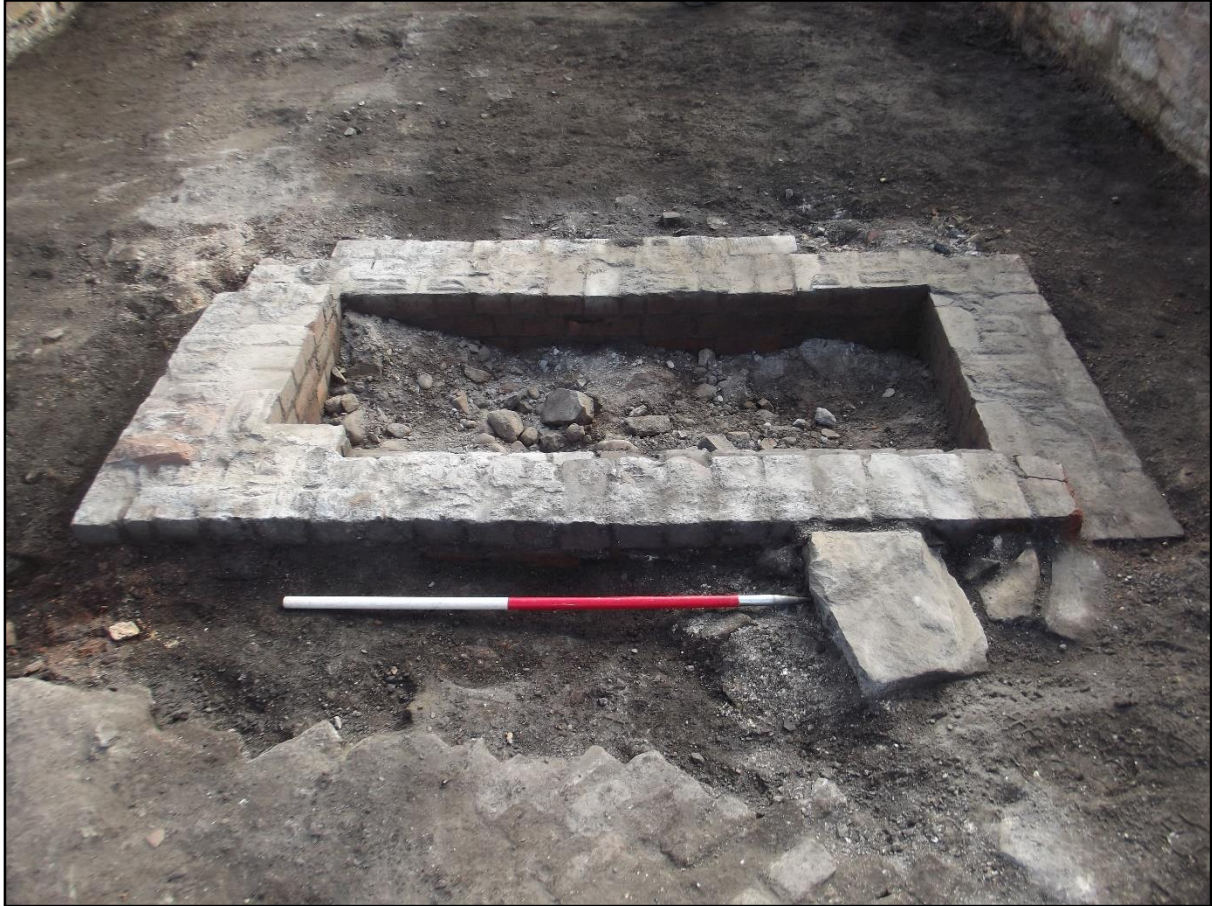
Plate 137. North coke rammer wall area, brick chamber 2341 showing the poorly defined constriction cut through the Thomas oven coke bench. View to east.

Chamber 2341 was constructed in a virtually identical fashion within the footprint of the northern coke rammer support structure. The chamber was built of frogged red brick bonded with light grey lime based mortar. The chamber was oriented north/south and measured 2.55m in length by 1.45m in width; it was not exposed to any great height, surviving to a maximum of two courses where seen (Plate 137). The interior was filled with demolition material and remained unexcavated but it is likely that the interior contained an arched channel as in the case of 2309. Chamber 2341 possessed a rather poorly defined construction trench which had cut the coke bench for the Thomas ovens (surface 2372) but there was no sign of the construction cut having followed the course of the earlier canal, as was the case for 2309. The positioning of chamber 2341 would place it within the probable centre line of the trackway for

the coke ramming engine and it is therefore highly likely that the feature is later than the period in which the ramming engine was in operation.

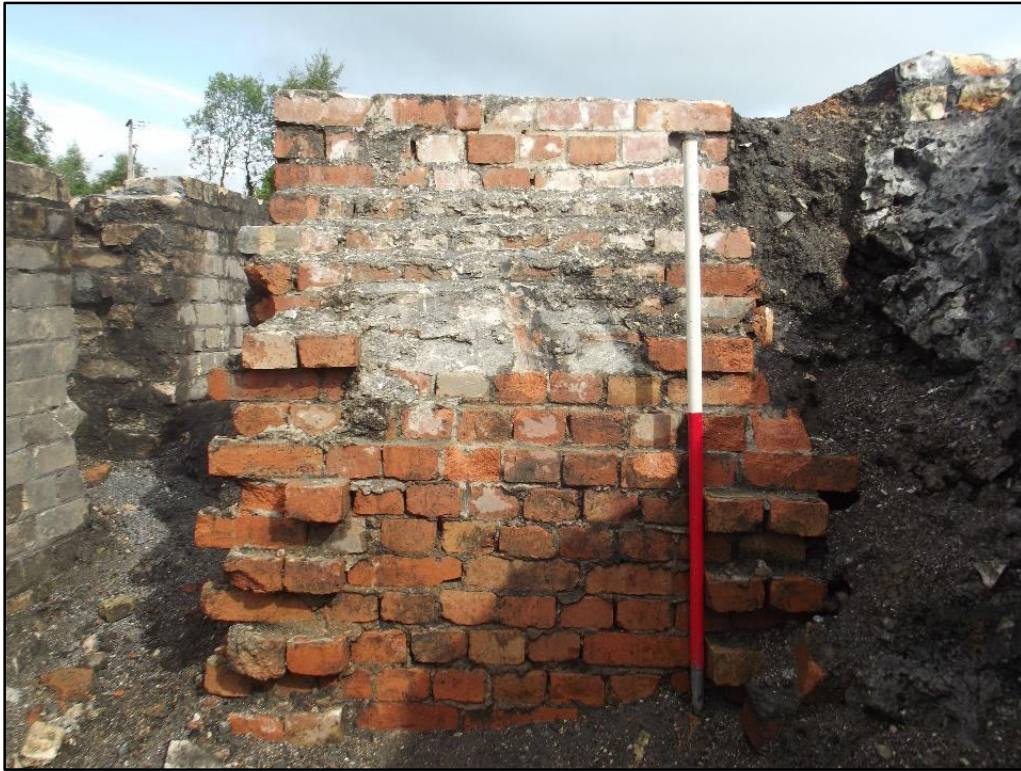
**Plate 138. Manhole 2034, which had truncated the south east corner of the Carr's disintegrator building.
View to north.**

Manhole 2034 (Plate 138) was located straddling the south east wall of the structure housing the Carr's disintegrator. The manhole consisted of a red brick built chamber measuring 1.05m square; the internal area measured 0.6m by 0.56m and bonded with a white coloured concrete mortar. The surviving height of the chamber was 1.3m but the chamber was filled with debris, preventing an assessment of its full depth. The construction of the chamber had destroyed part of the south east wall of the disintegrator structure, providing basic phasing evidence.

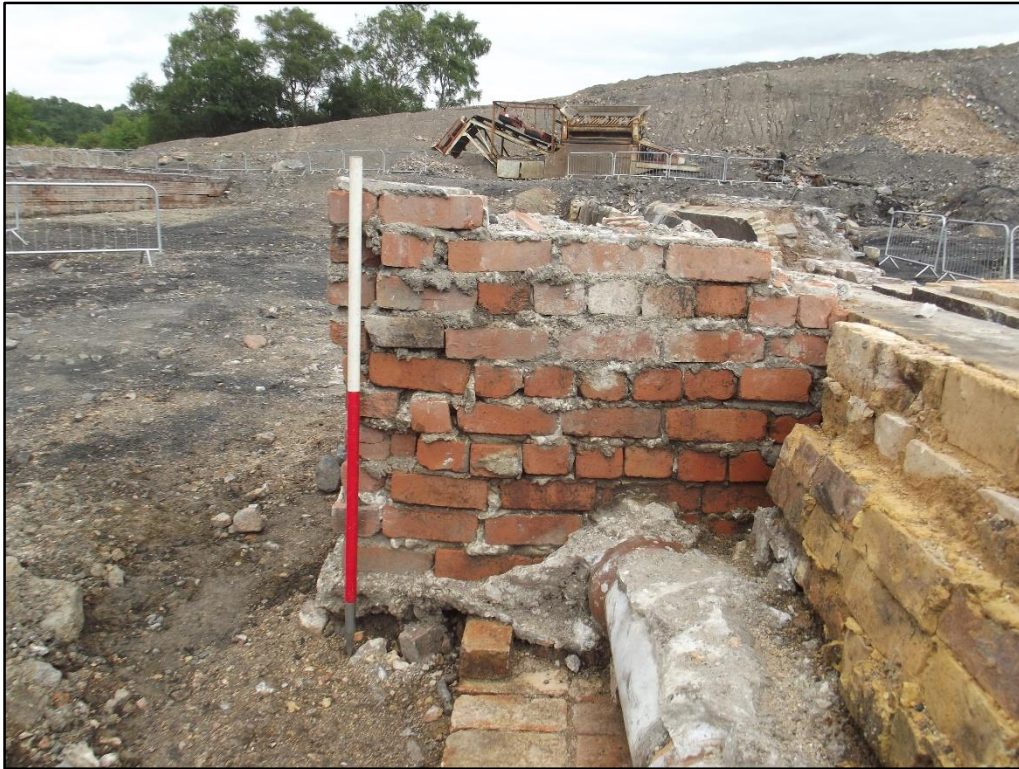
Plate 139. Inspection chamber 2139 cutting the north wall of the main flue for the southern coke ovens. This was almost certainly part of the Thorn Lighting works. View to east.

A further manhole/inspection chamber, 2139, had been built adjacent to the main flue of the southern Coppée oven battery (2011). The structure measured 1.2m by 1.14m and as exposed to a height of 0.95m above the ground surface. The feature had been constructed of red bricks stamped with “NCB Tredegar” and bonded with a clean grey concrete mortar. The brick element had been built onto a concrete base which was at least 0.1m thick, and the south part of the chamber had been cut into the north wall of flue 2011 (Plate 139).

The bricks used in the manufacture of the manhole were manufactured by the former Tredegar Iron and Coal Company's brickworks. Their bricks had formerly been stamped "TIC and later simply Tredegar" but on Nationalisation of the colliery and brickworks in 1946, the bricks were stamped "NCB Tredegar" (Penmorfa.com). Thus a relatively modern date is certain for the inspection chamber and a 1946 attribution for the bricks fits very well with the construction of the Thorn Lighting works in 1947.
