Cyfarthfa Coke Works (The Old Thorn Lighting Works) Merthyr Tydfil

Excavation report and analysis

October 2017

GGAT report no. 2017/051
Project no. P1844
National Grid Reference:
SO 03708 06785

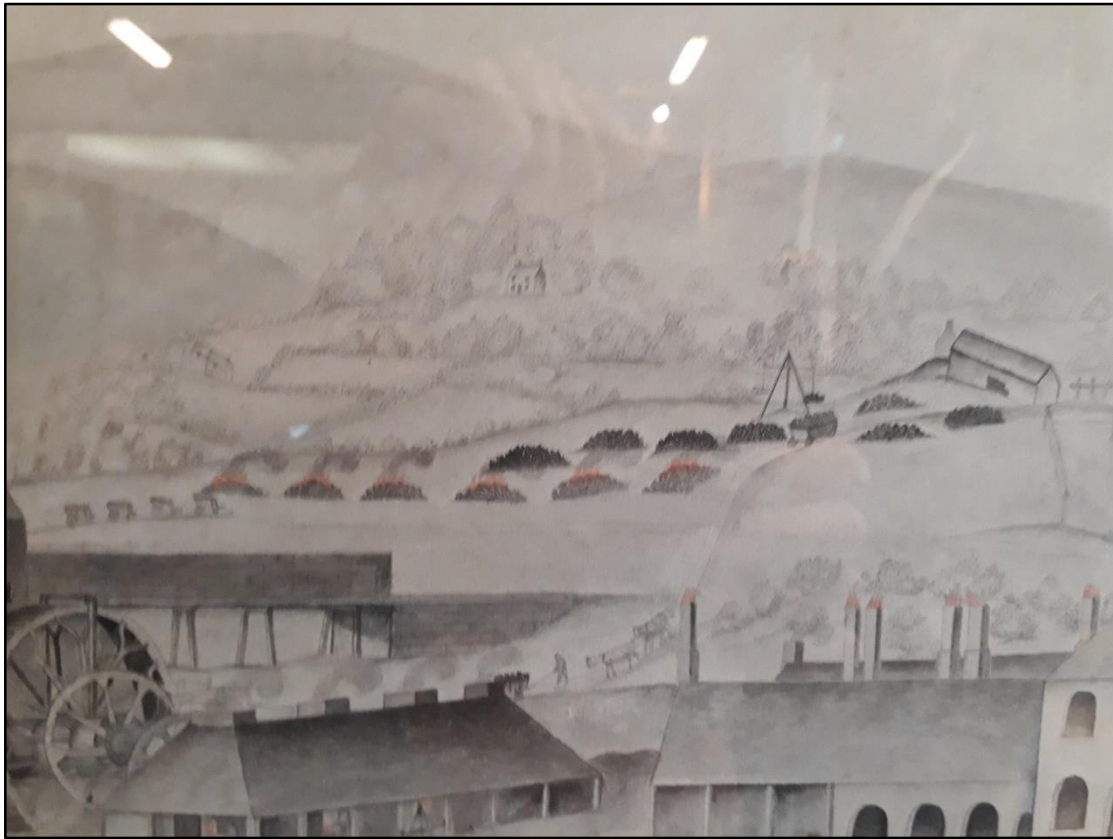
Plate 140. Close-up photograph of the coke yard drawn around 1798 by William Pamplin. Although some artistic licence may be expected, this depicts the coke yard as it would have looked in Phase 1. Curiously, no canal is depicted, although it was certainly in existence at the time. (Author's collection).

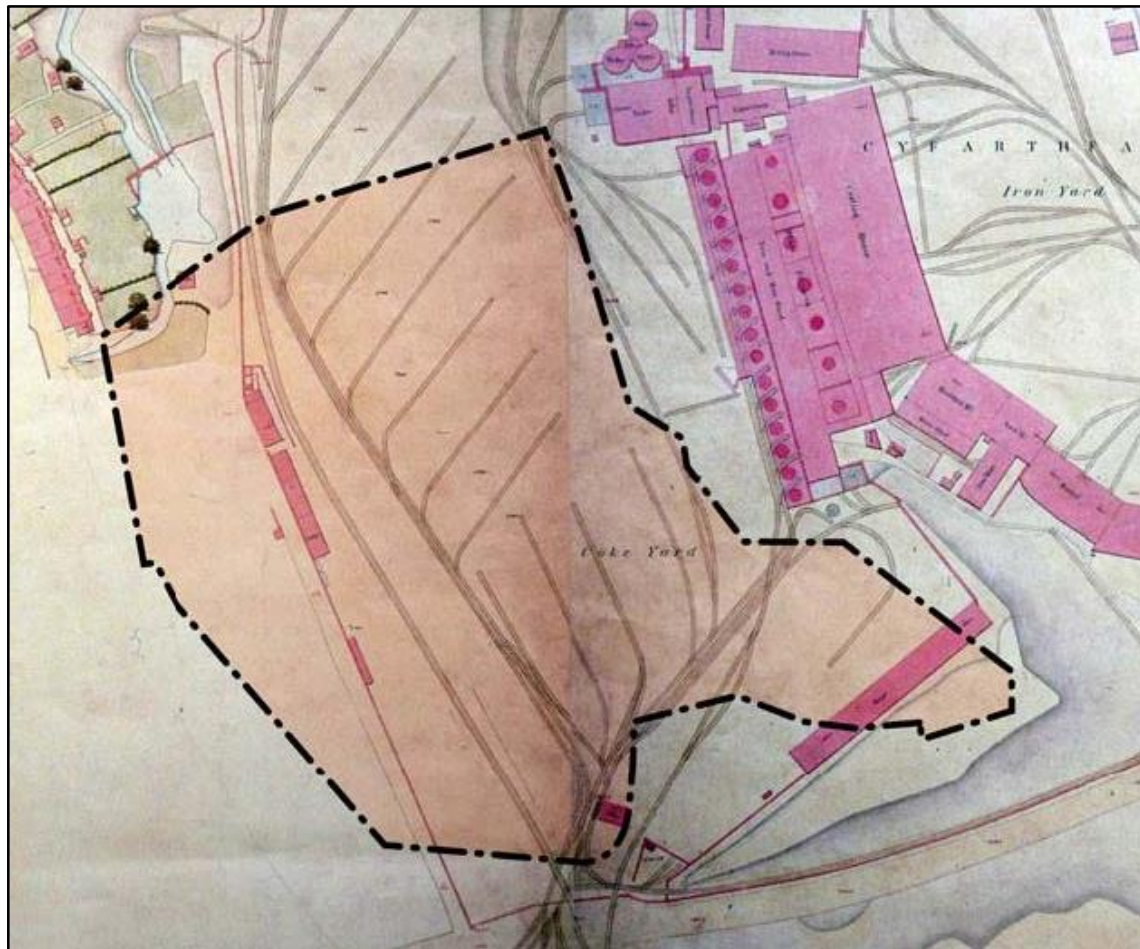
Plate 141. Extract from the 1851 Merthyr Board of Health map showing the coke yard area (development area is outlined). No coke ovens are depicted and coking in heaps is almost certainly the technology employed. This is likely to be similar to the coke yard layout depicted by Pamplin in 1798.

The ironworks of this middle and later period was shown in detail on the Board of Health map of 1851 (Plate 141). The works were located either side of the River Taff and connected by two tramroad bridges, in addition to Pont-y-Cafnau. Notable features extant at the time, apart from the blast furnaces, were casting sheds, a smithy, and a coke yard (similar to that illustrated by Pamplin in 1800, Plate 140) with extensive coke ovens to the rear of the charging bank and the Tai-mawr leat to the northwest of the works.

The Thomas ovens can be dated fairly accurately through cartographic evidence to between 1851 and 1856 (Plates 141 and 142). It is possible that the decision not to completely abandon the method of coking in heaps and to retain that method in tandem with the Thomas ovens may have been the first sign of the technological conservatism that appears to have bedevilled the Cyfarthfa works from the 1850s onwards. Even after construction of the Coppée ovens in 1882, one a set of Thomas ovens appears to have been retained, possibly as a redundancy measure but also indicating a failure to fully trust the new technology.

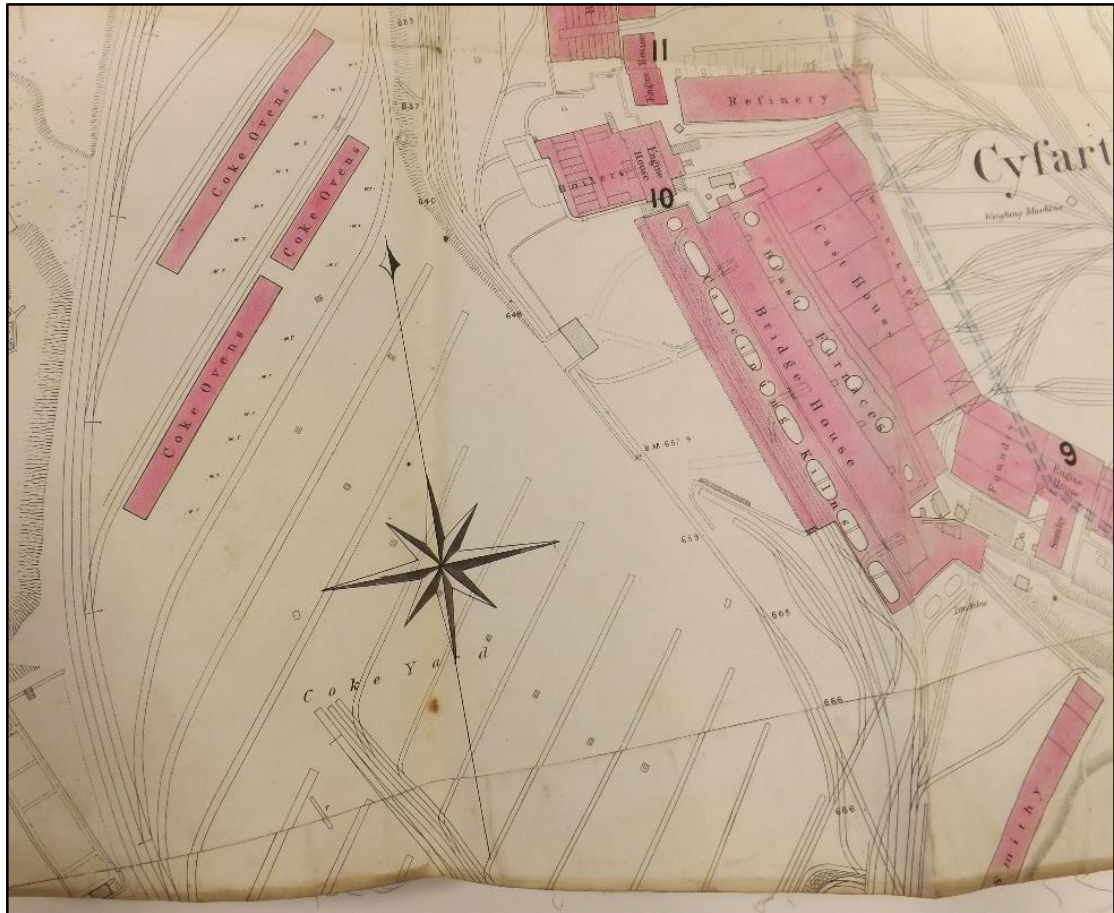
Plate 142. The coke yard depicted in 1856 by Mr Cope Pearce. The Thomas ovens have been constructed, indicating a construction date of between 1851 and 1856. (Glamorgan Archives DG/F/9/10)

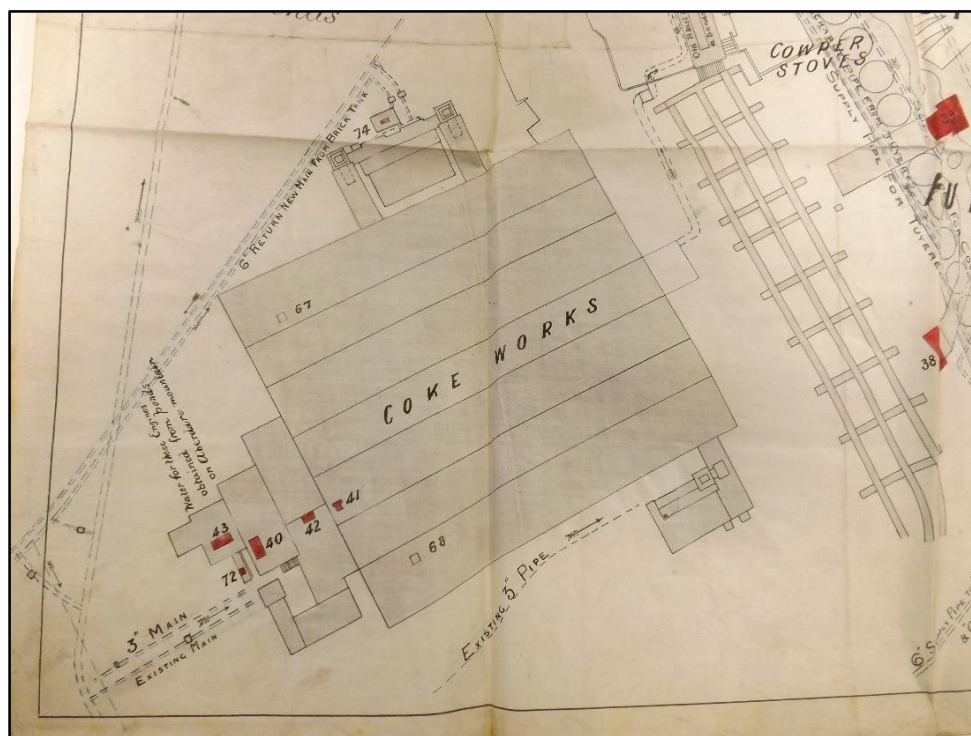
Plate 143. Plan of the Cyfarthfa Coppée coke oven dated 23rd February 1892. This is the form of complex prior to construction of the Sheppard washery in 1894/5. The red squares indicate the location of steam engines (Glamorgan Archives DG/F/9/10).
